National Aeronautics and
Space Administration

November 17, 2009

SUBJECT: AMS Burst Disk Vent Duct Redesign and Certification

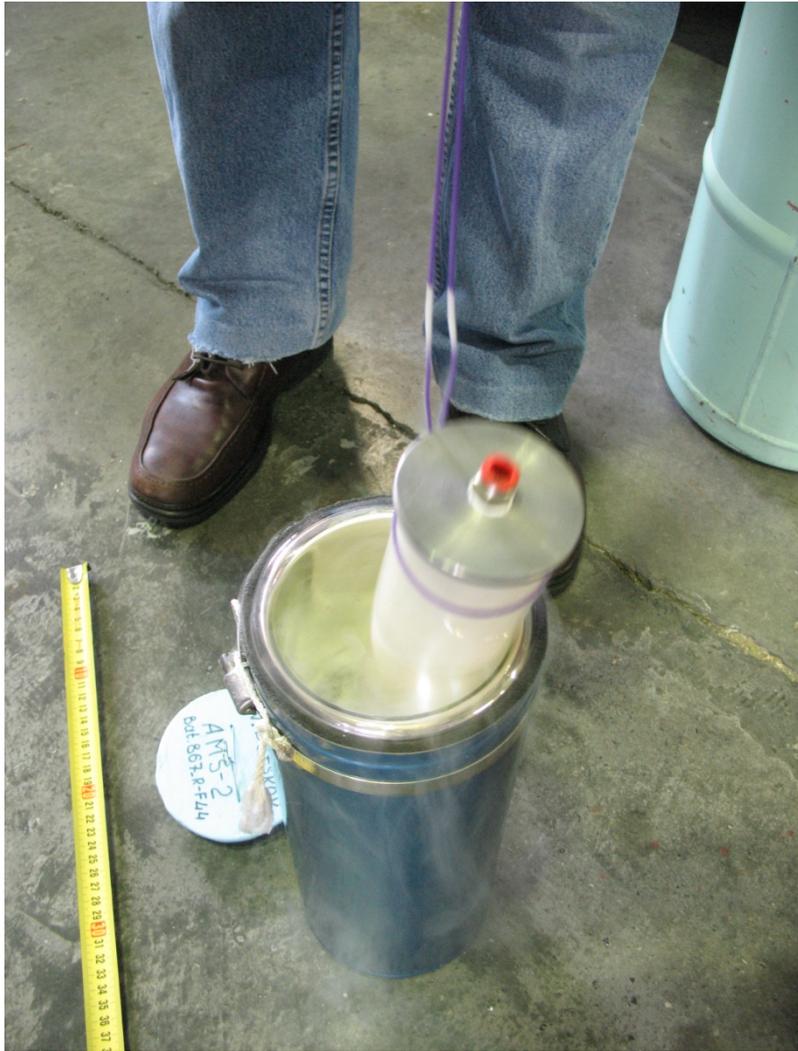
BD03/06 Telescoping Tube Tests

No cracking, delamination of epoxied interfaces, or leakage of LN2 into the Telescoping Tube was observed

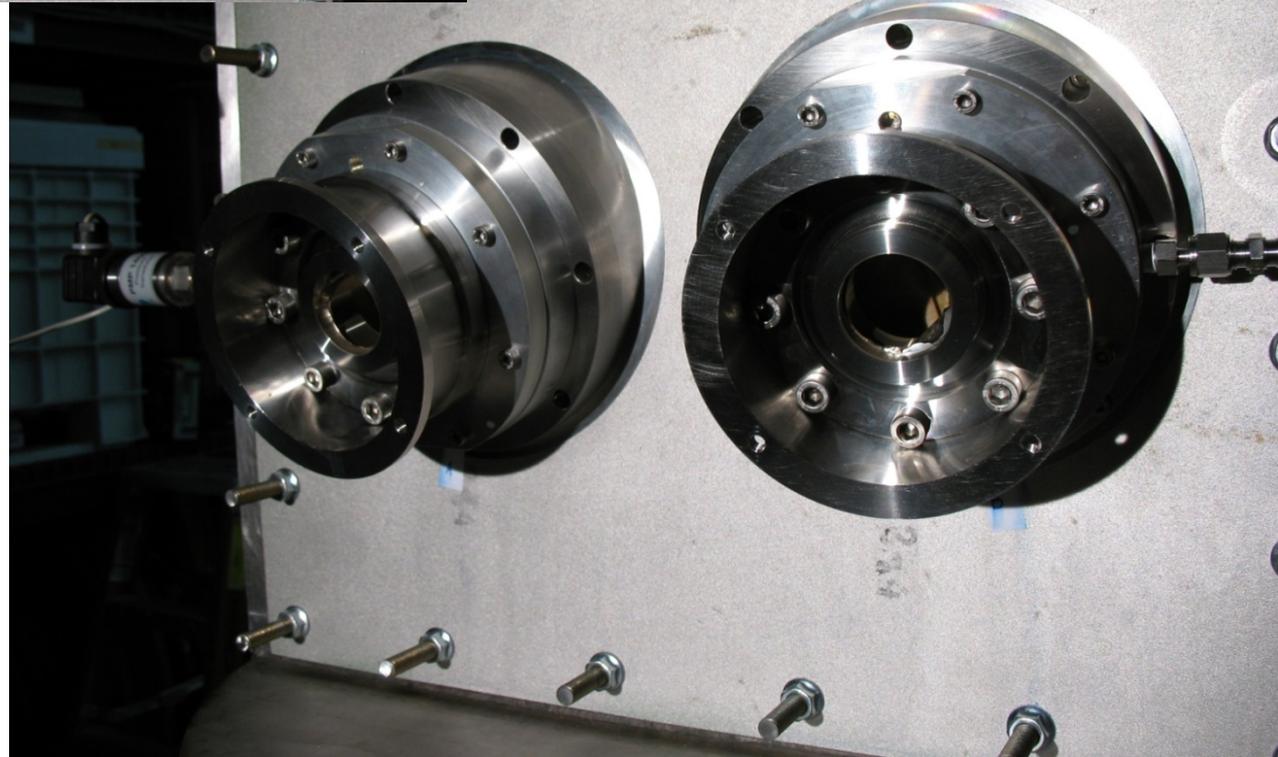
Both BD06A & B opened simultaneously. Both BD06 discs fragmented and came free of the test disc flanges. Several pie-shaped pieces of the radiation shield were found in the parking light. Disassembly and inspections will continue tomorrow.

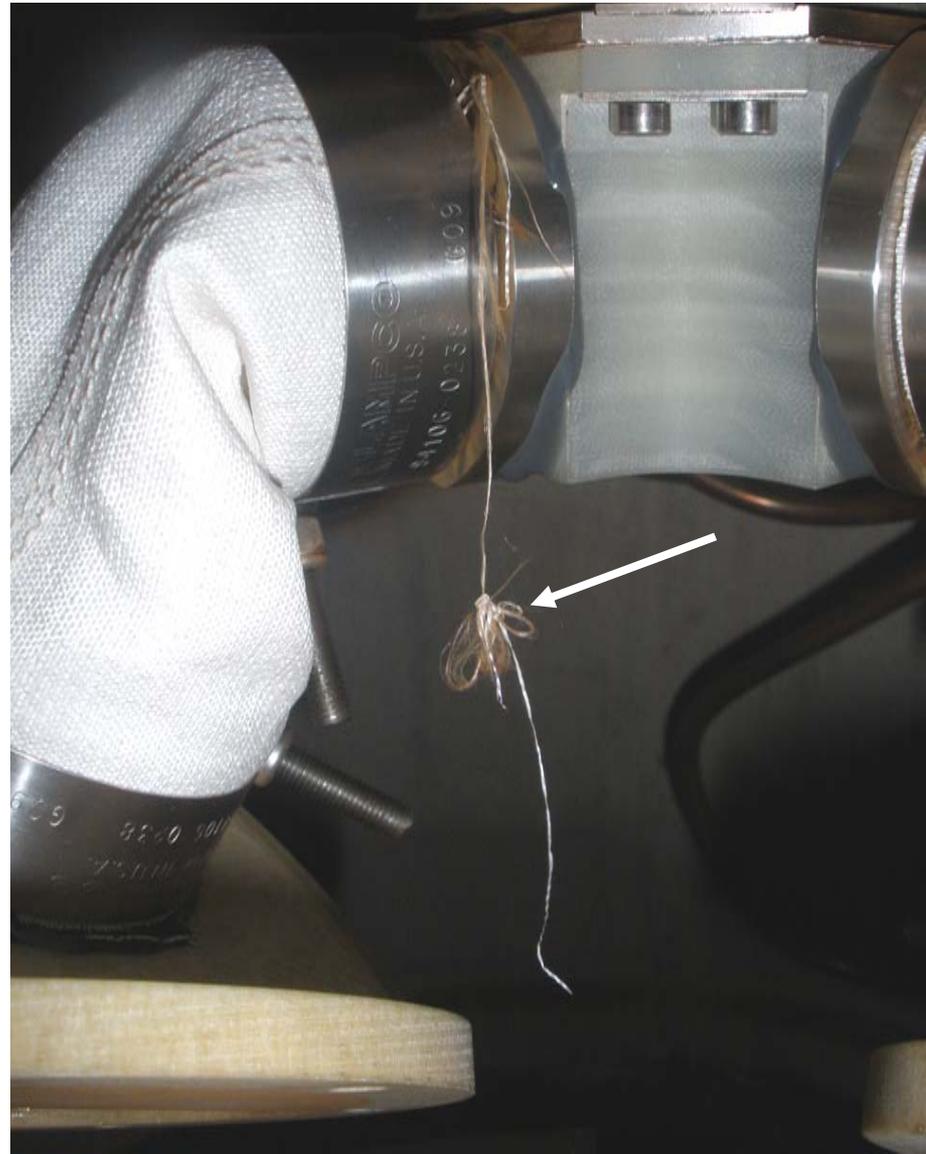
The only noticeable damage to the outside of the test article was some thread that had separated from the ortho fabric sock.

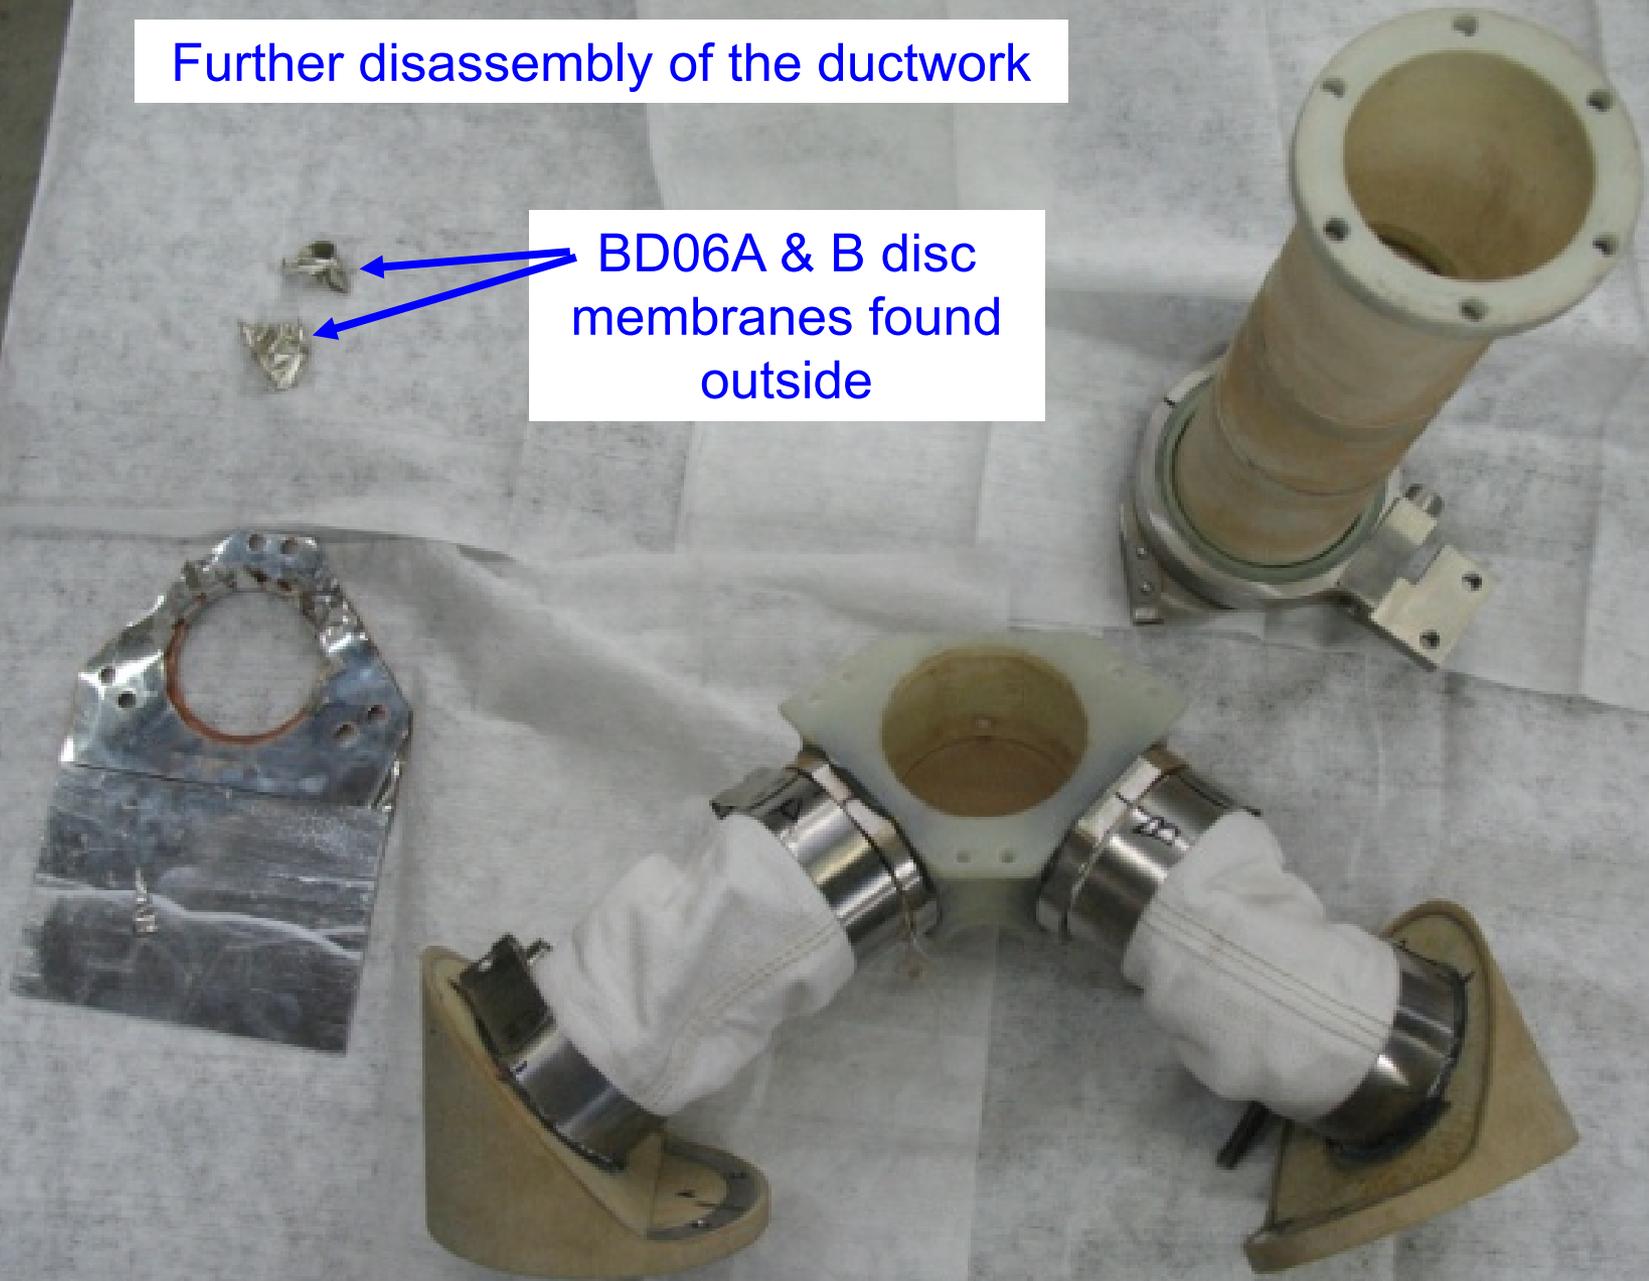
BD06A & B disc
membranes found
outside

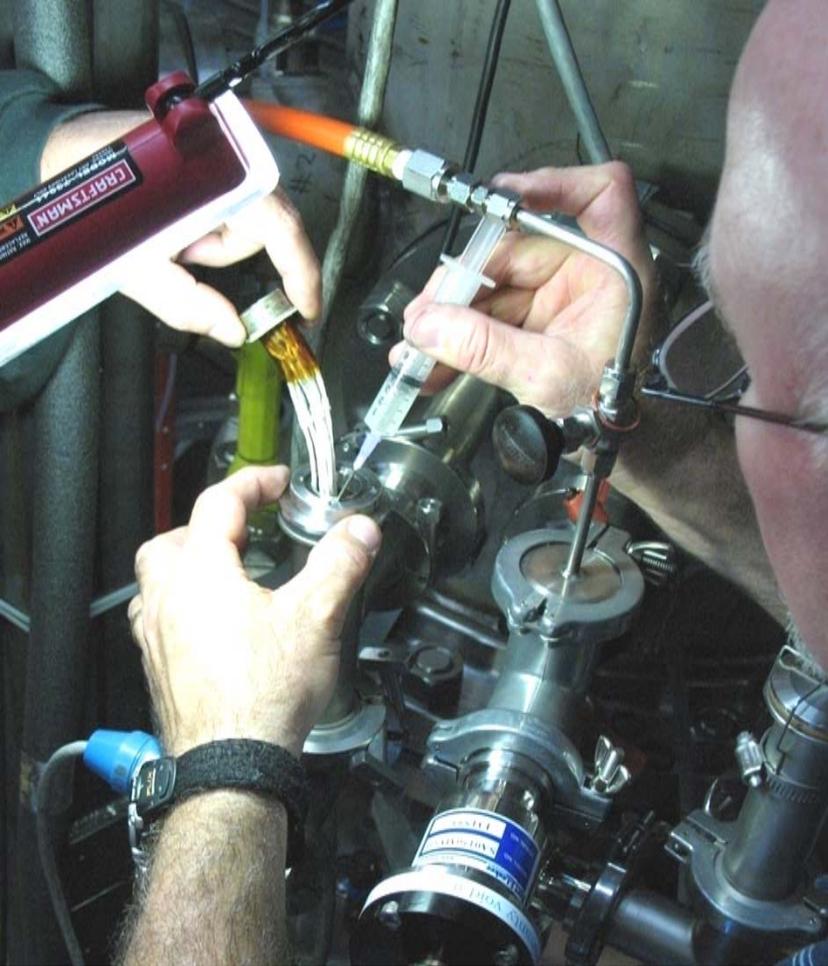
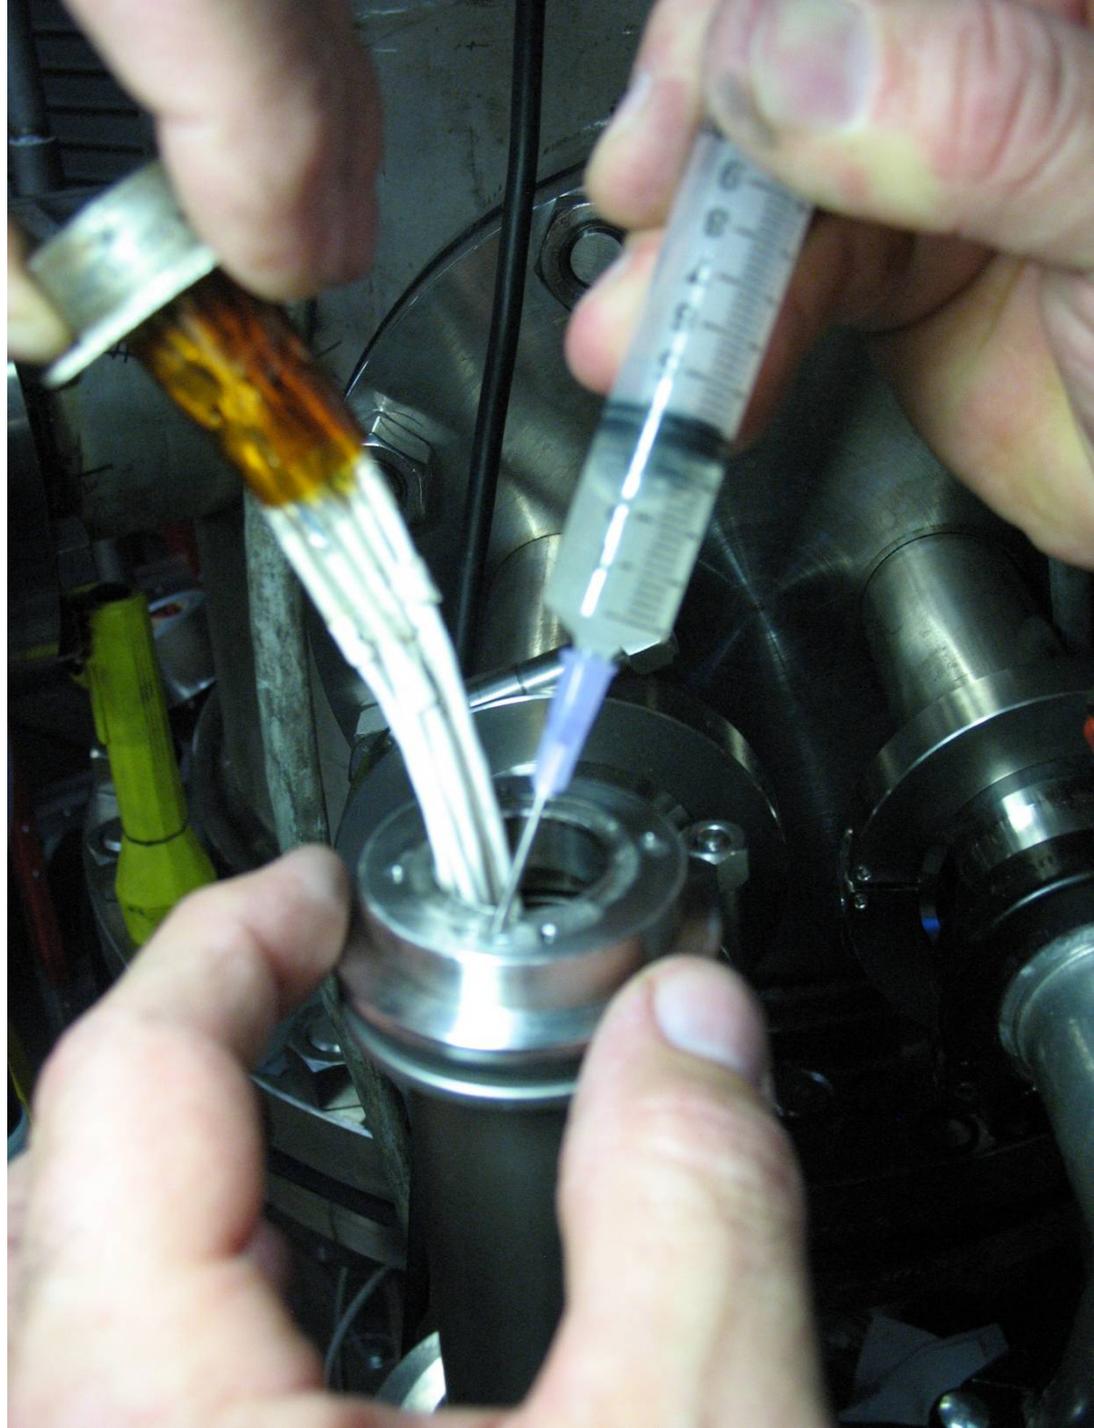
Several attempts were made to repair the leaking fitting with the cracked welds for the electrical connector

We eventually used epoxy to permanently seal the connector to the fitting

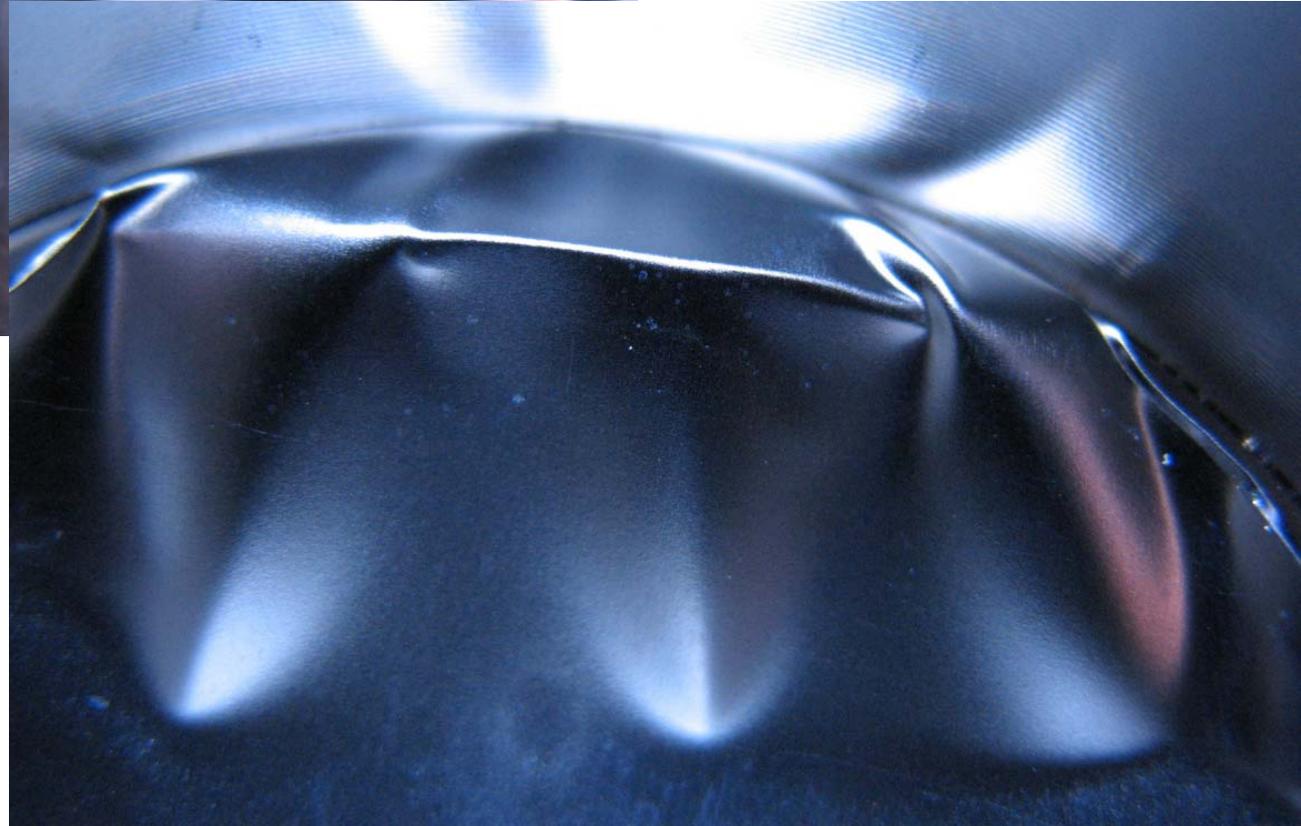
Closeups of the hinge
line under different
lighting conditions.

Closeups of tooth penetration of the burst disc membrane on the upstream side. This is where helium leaked into the vacuum space after the membrane reversed.

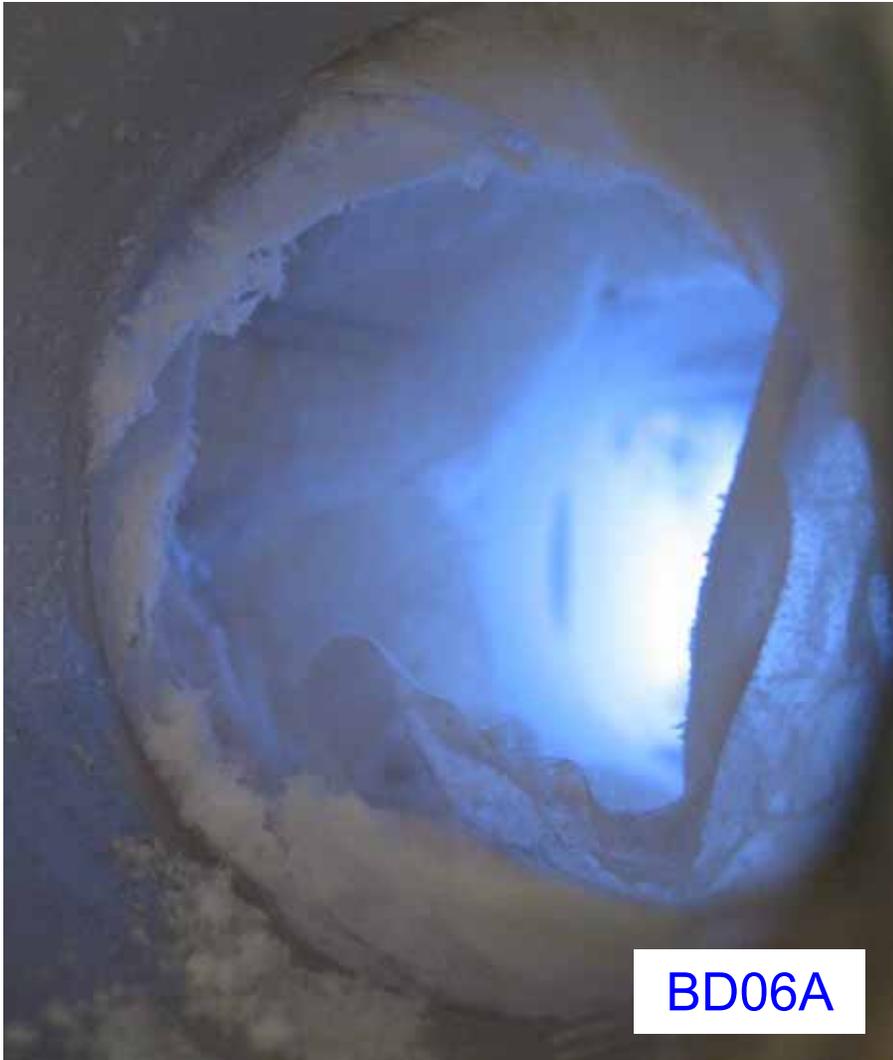
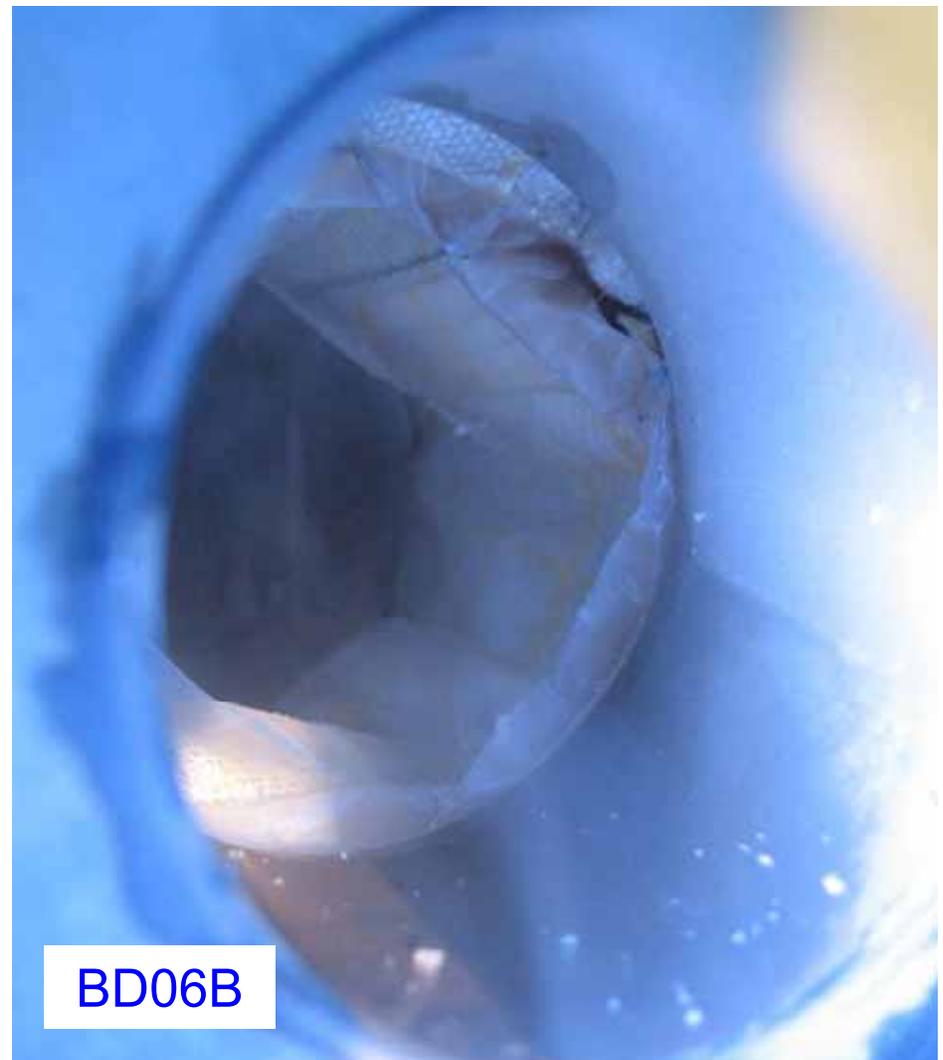
Both ortho-fabric flexible tubes were intact. The PTFE liner was torn on the BD06A side that was used to exhaust all the gas. The BD06B side that was blanked off was intact. It was difficult to tell the actual conditions of the components because of frost buildup.

BD06A (from a flight BD07A/B) performed well. The membrane was still in the housing though it had torn along a significant portion of the hinge line.

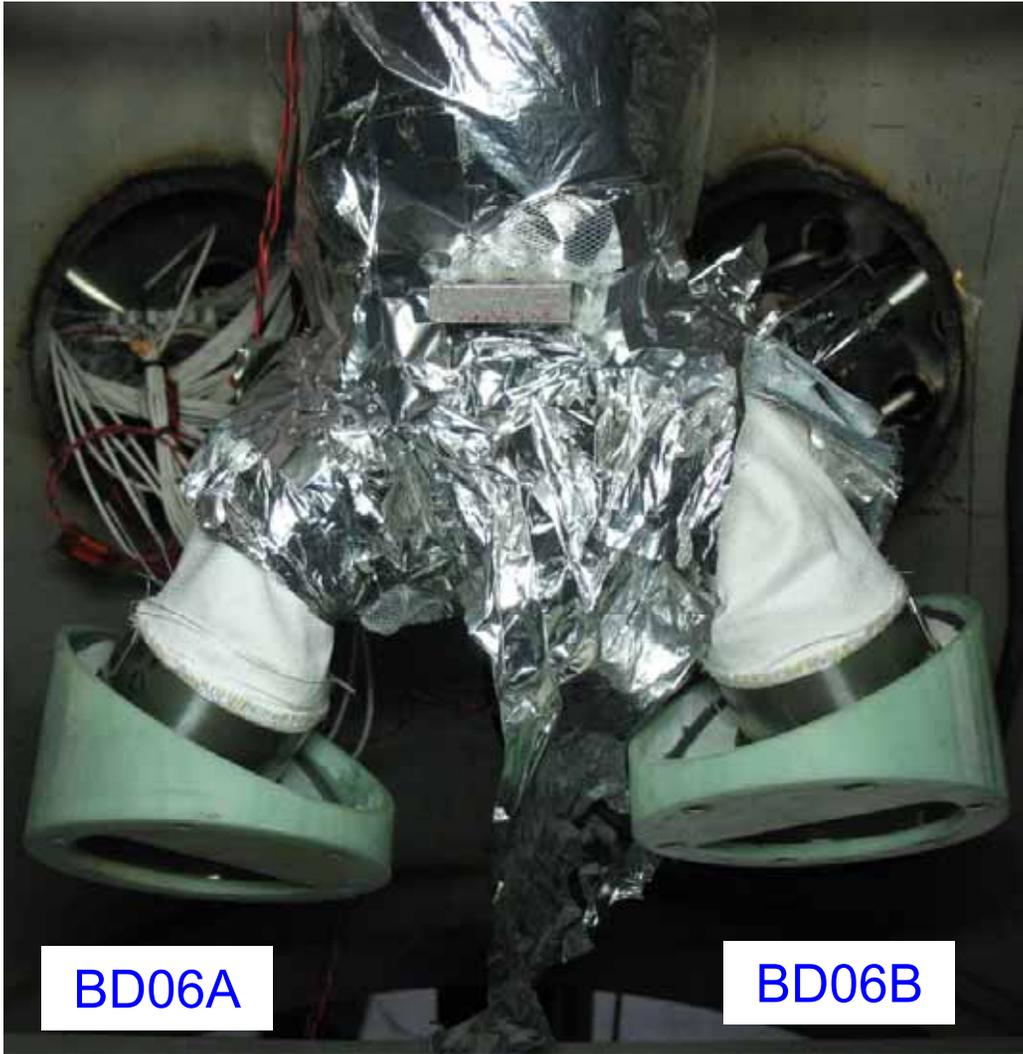
One layer of superinsulation was missing in this area.

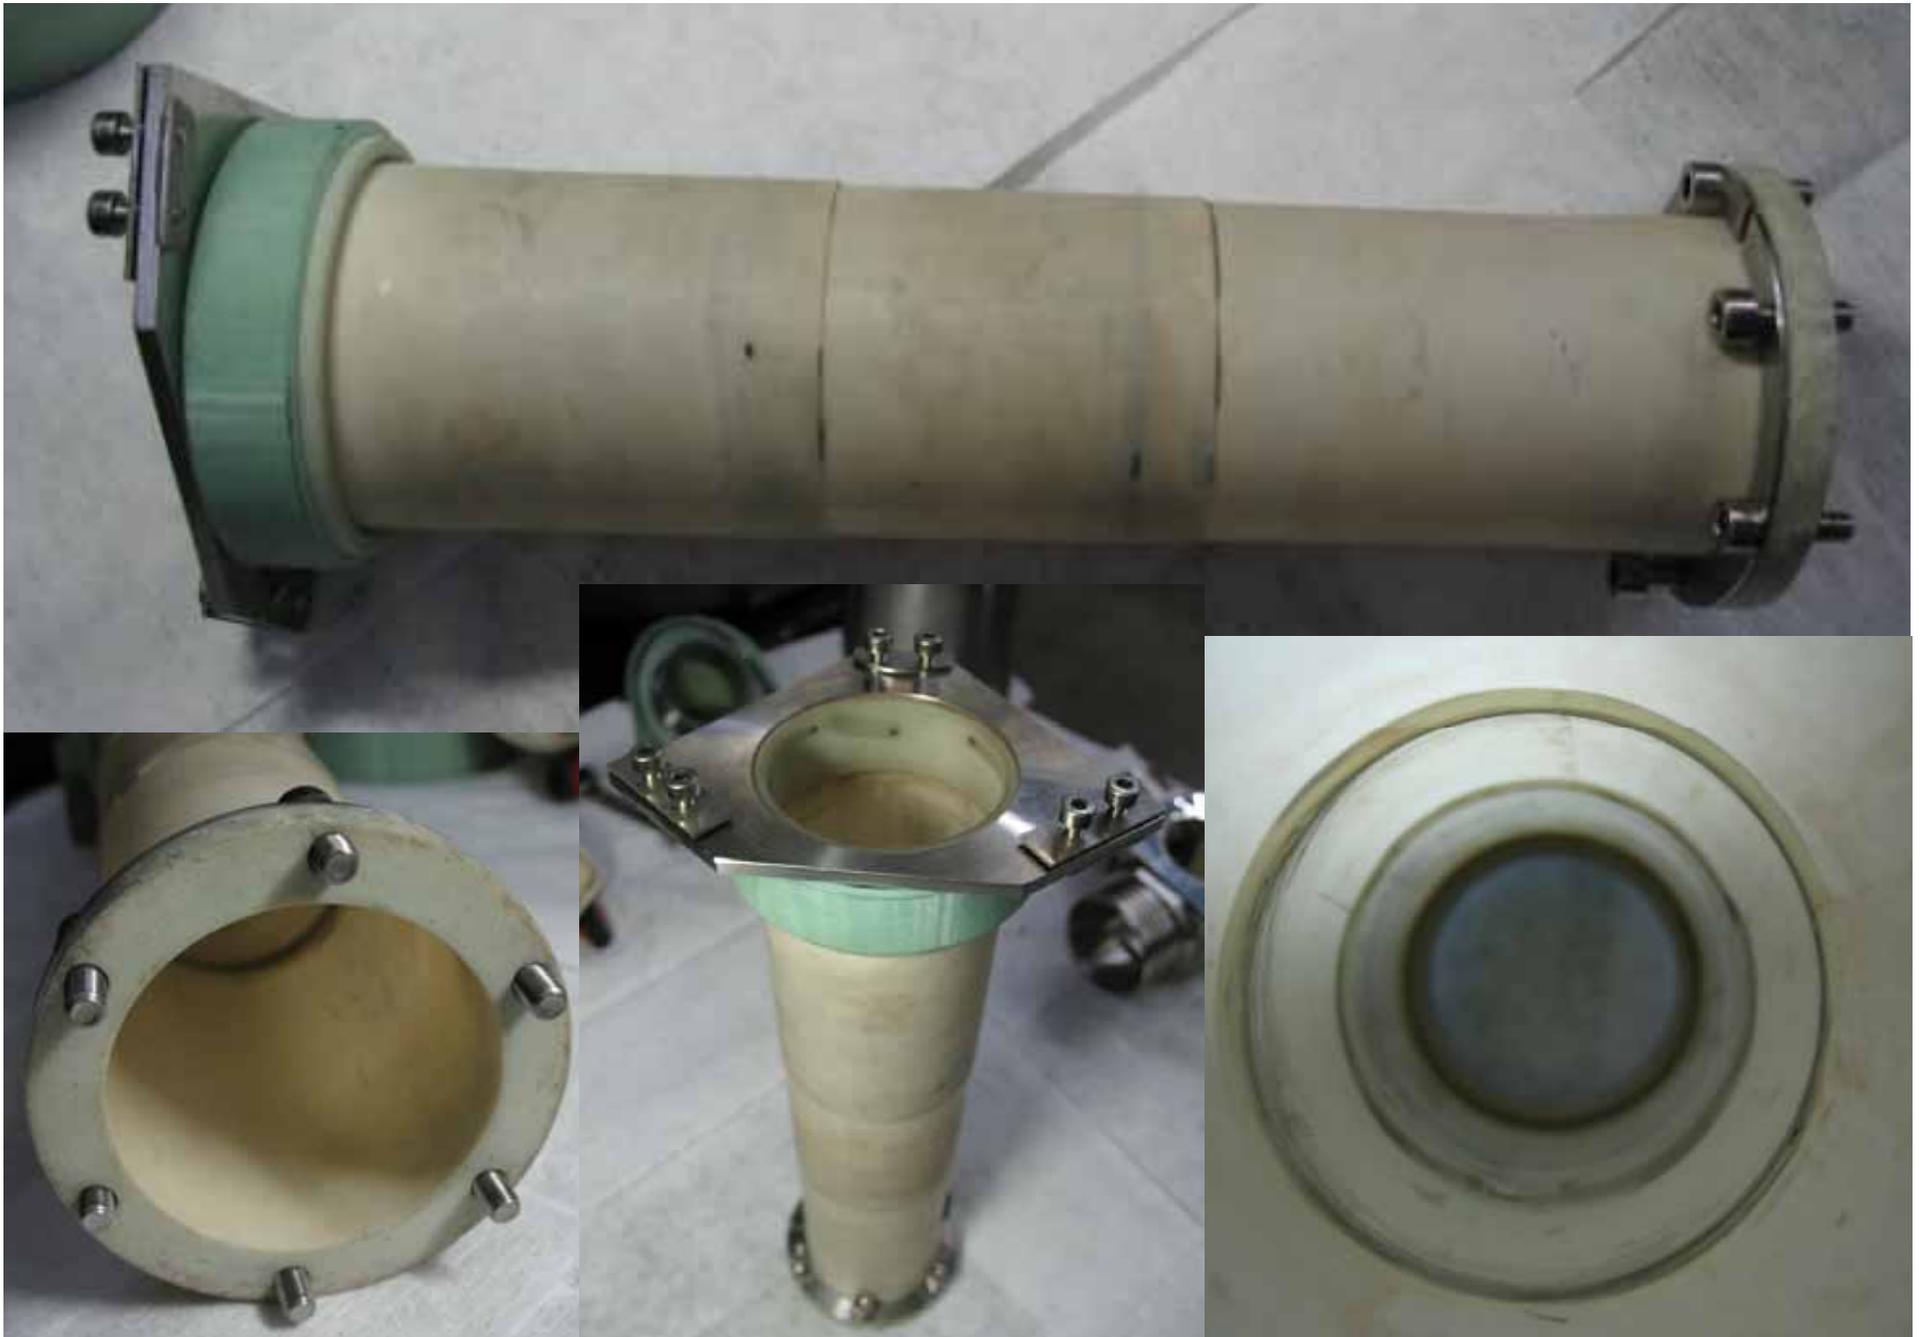
The Telescoping Tube also appeared to be unaffected.

The Collar around the telescoping tube that interfaces with the bracket on the window was cracked. This is not significant for the configuration of the flight unit and was confirmed with Corrado Gargiulo.

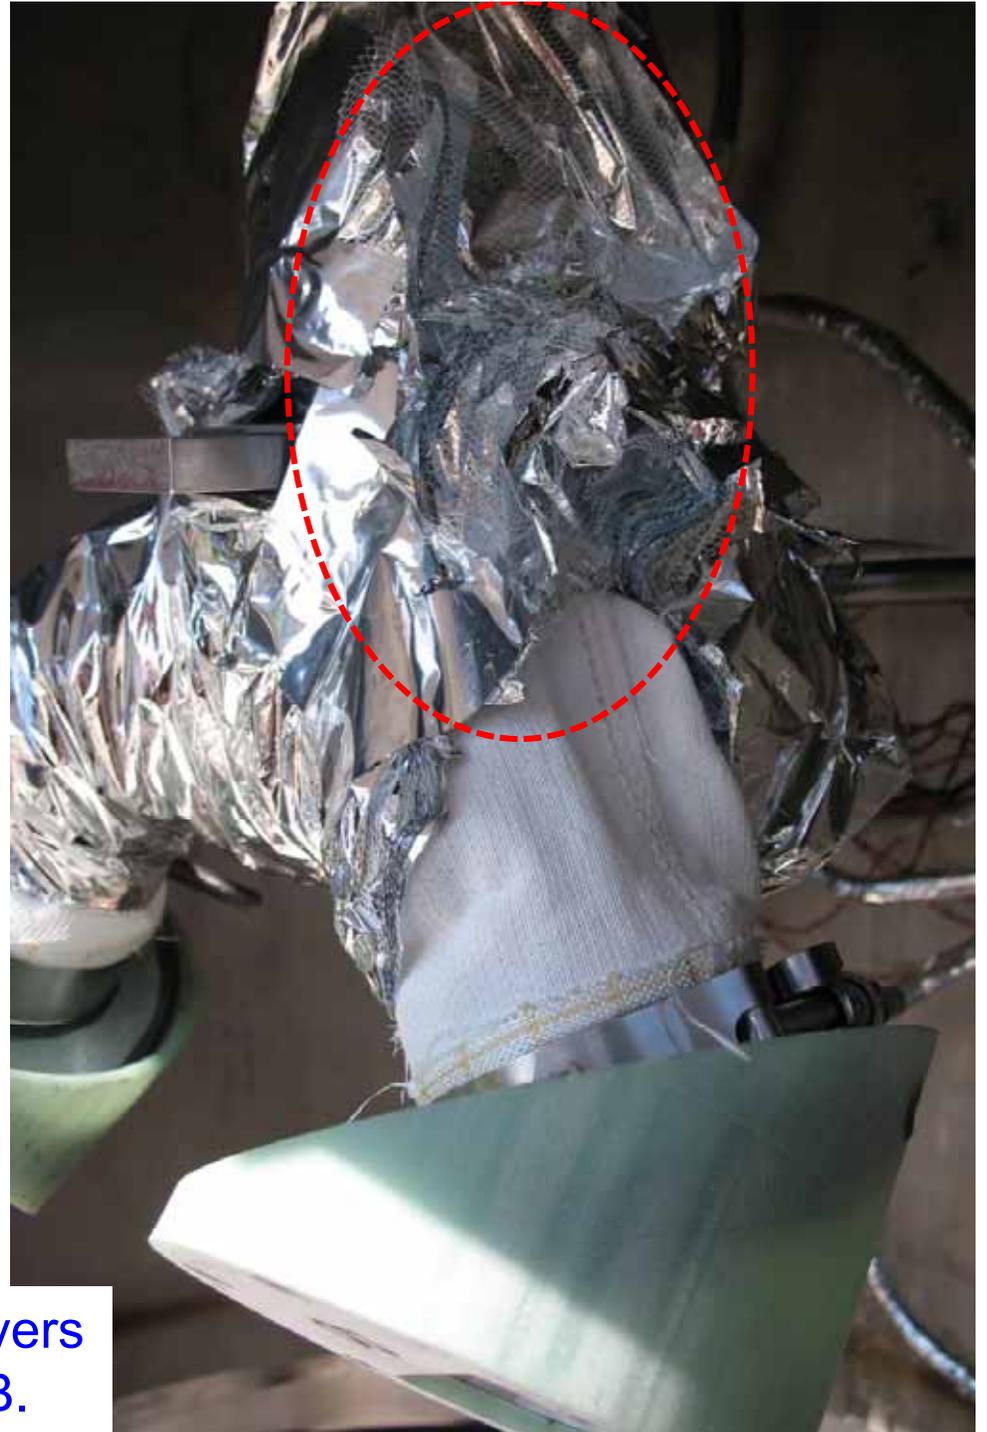
BD06B

The only noticeable damage was to layers of MLI on the flexible tube for BD06B.

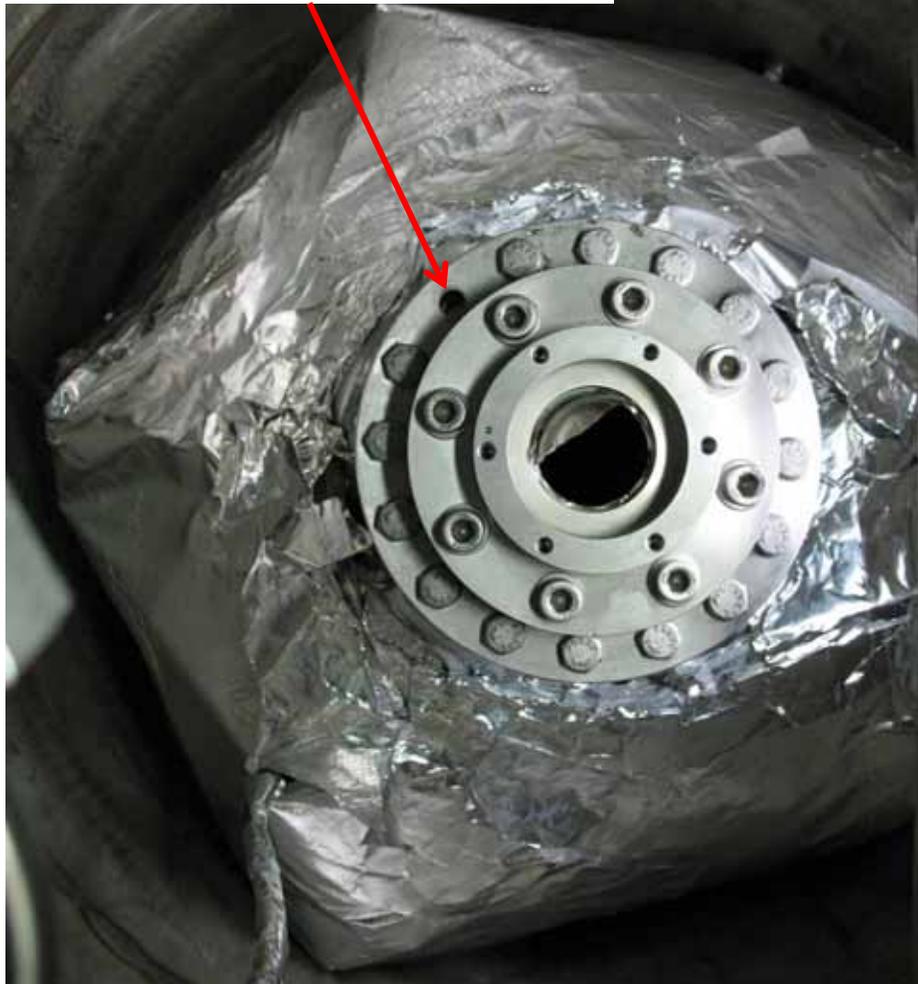
The BD03 disc was still cold, frosty, and intact after removal of the Telescoping Tube. The helium vessel MLI was unaffected.

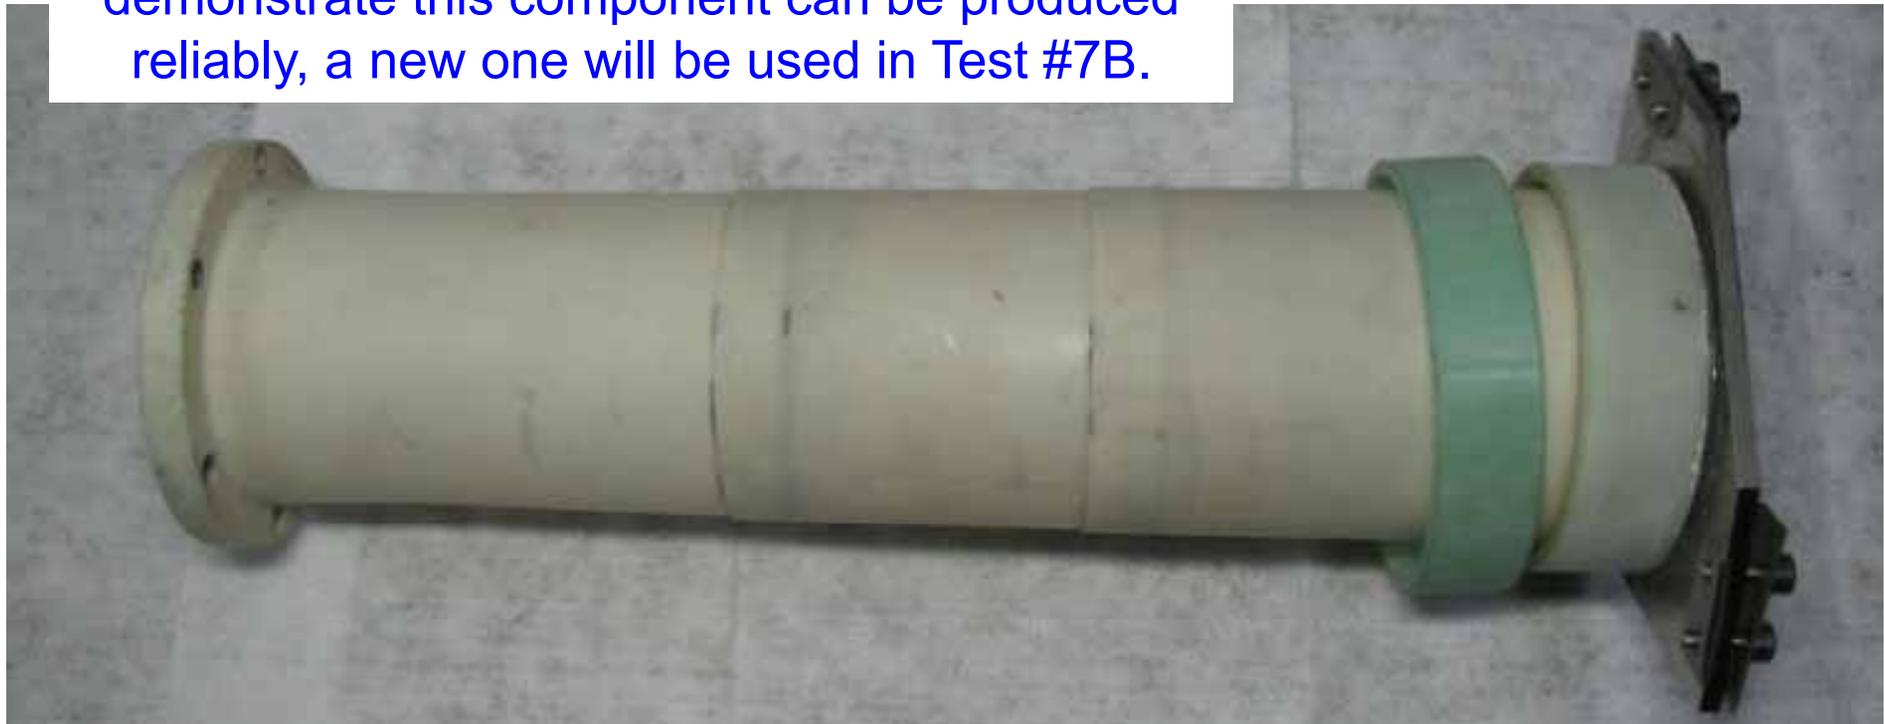
The Telescoping Tube showed no damage. To demonstrate this component can be produced reliably, a new one will be used in Test #7B.

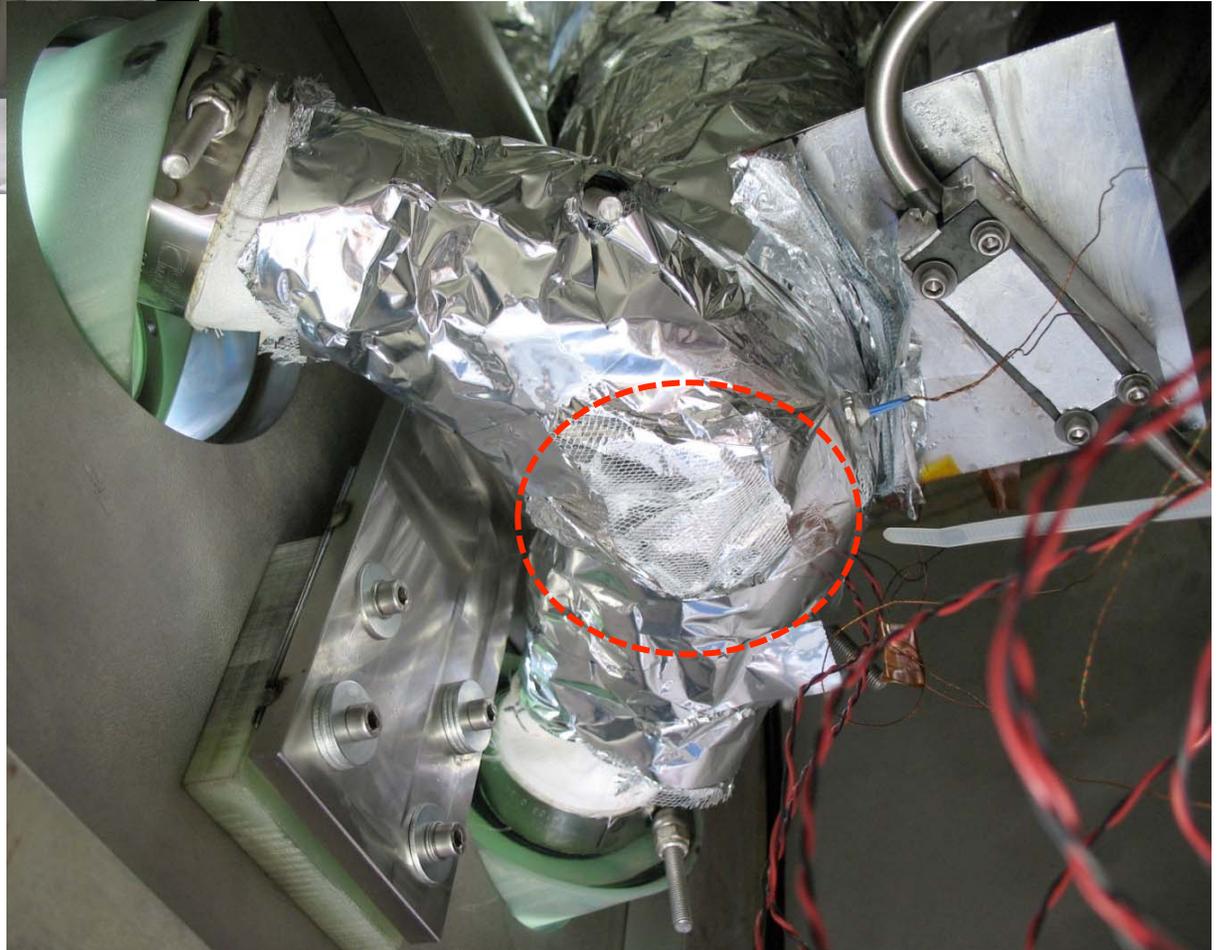
The MLI had minimal damage.
Part of one layer was torn from
the bottom of the Tee Box

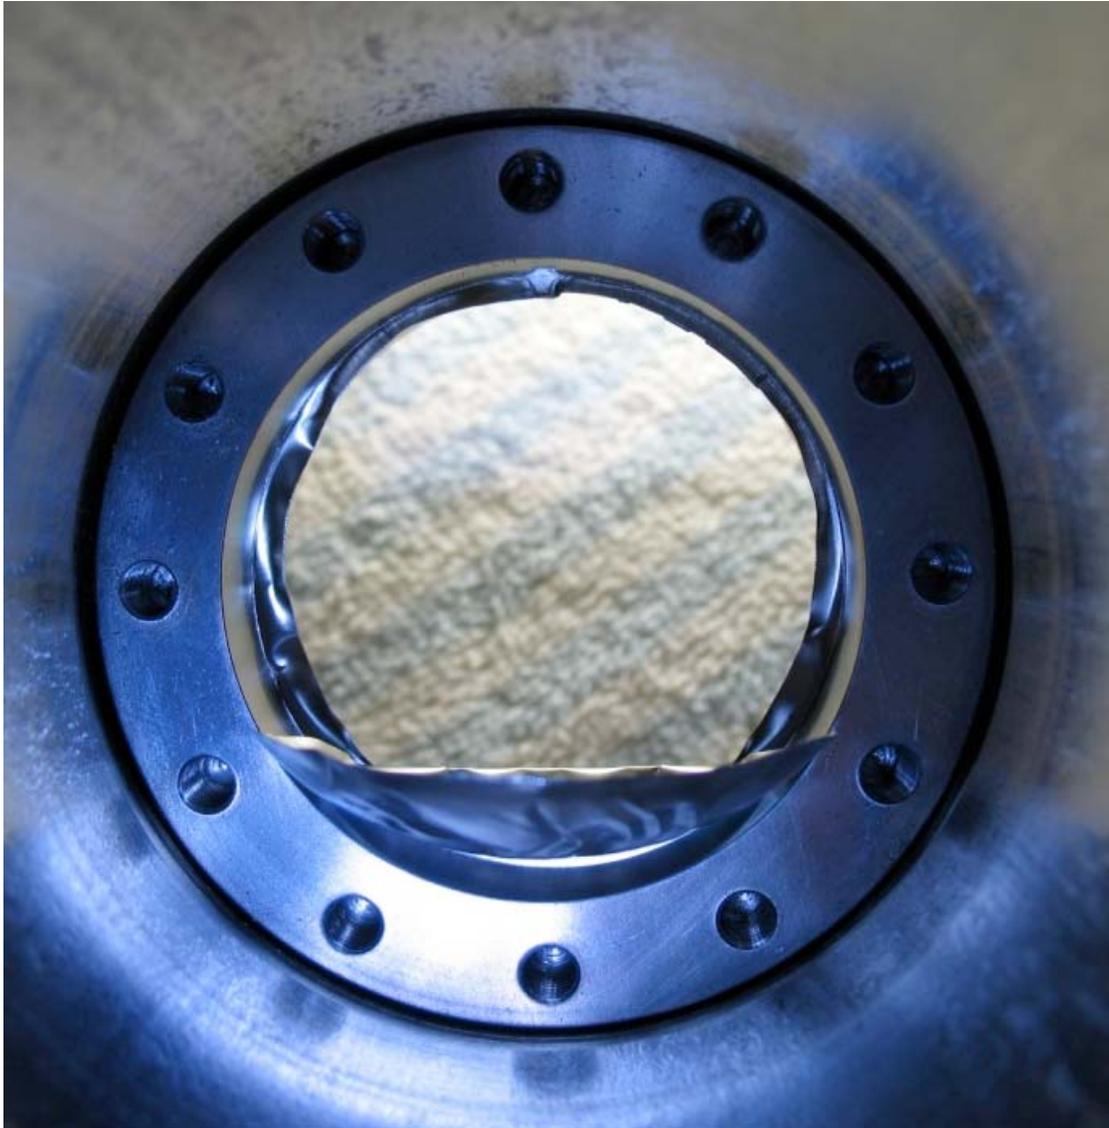
Inspection of the exhaust side of the BD03 flight-like assembly revealed nothing unusual either.

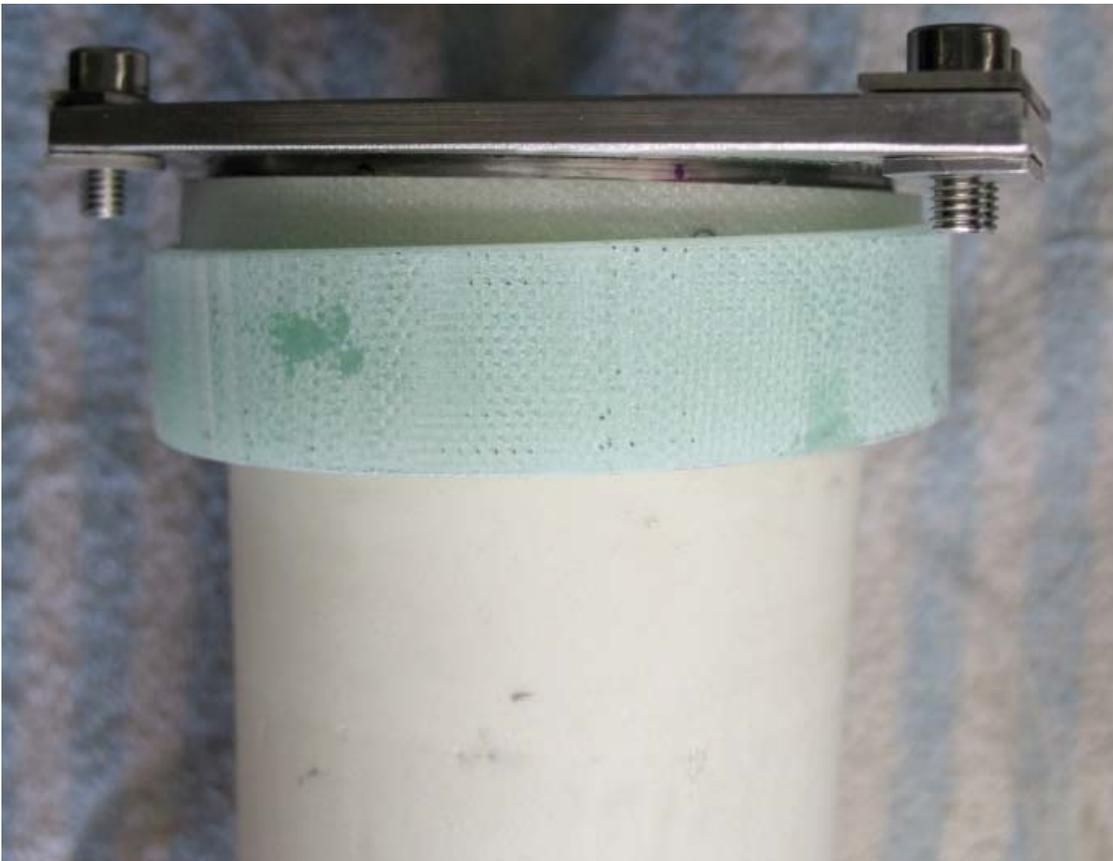
The only thing of note was that the external collar on the Telescoping Tube was found to be at an angle. This may have occurred during removal from the test set-up. It was realigned and the entire assembly will be reused in Test #8.

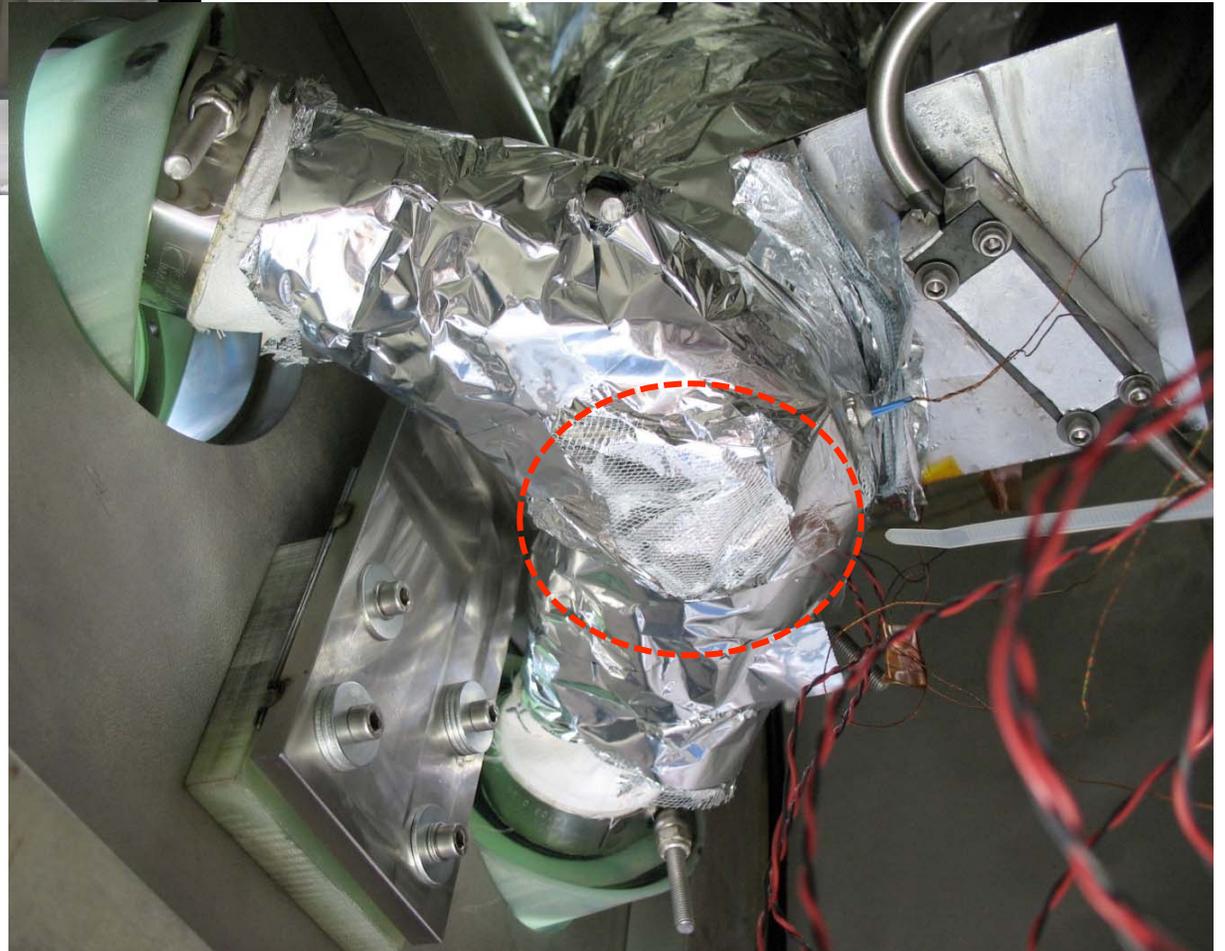
The MLI had minimal damage.
Part of one layer was torn from
the bottom of the Tee Box
