National Aeronautics and
Space Administration

November 17, 2009

SUBJECT: AMS Burst Disk Vent Duct Redesign and Certification

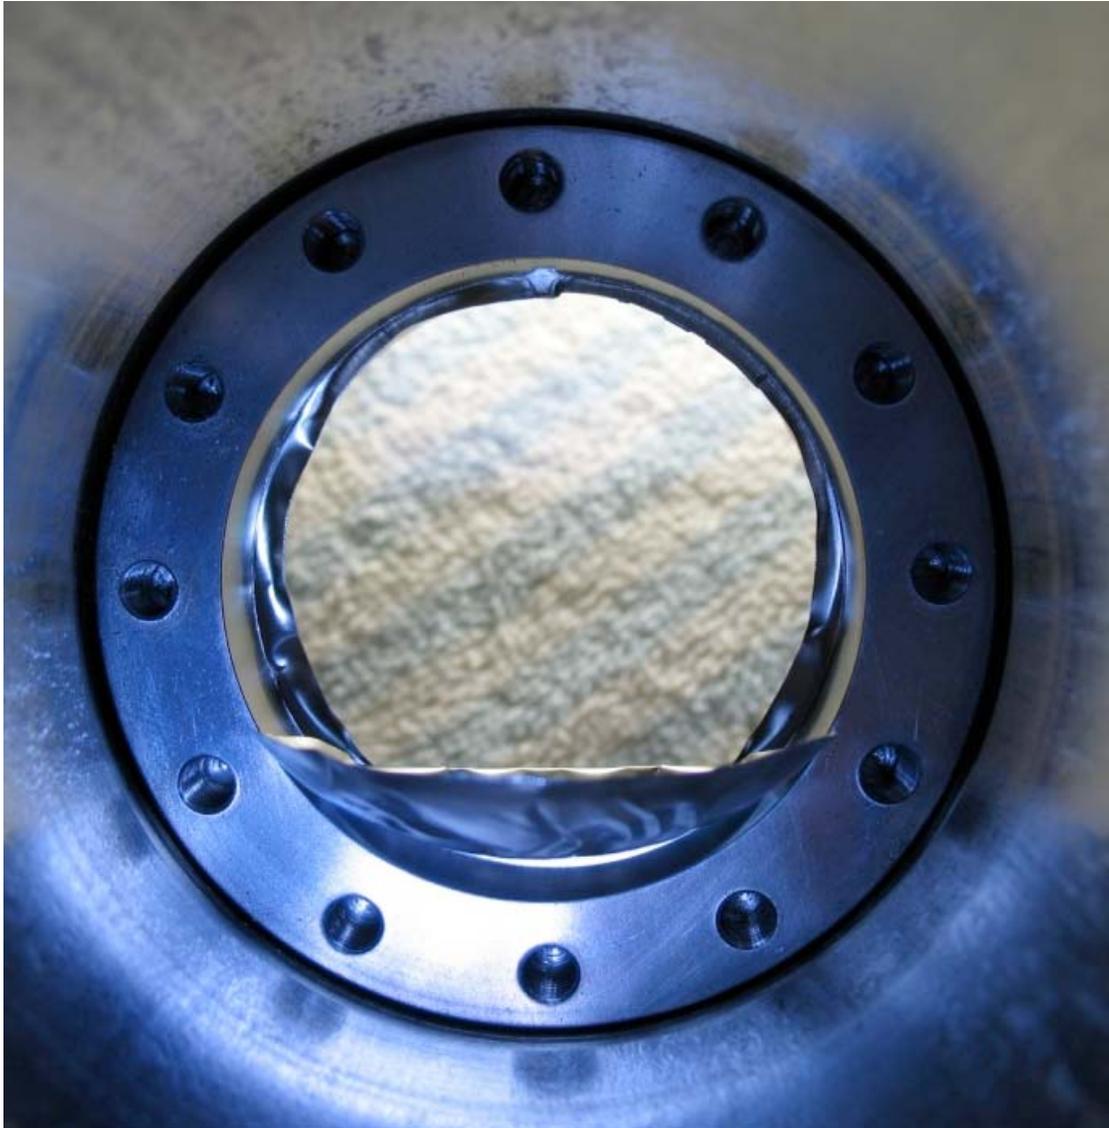
Inspection of the exhaust side of the BD03 flight-like assembly revealed nothing unusual either.

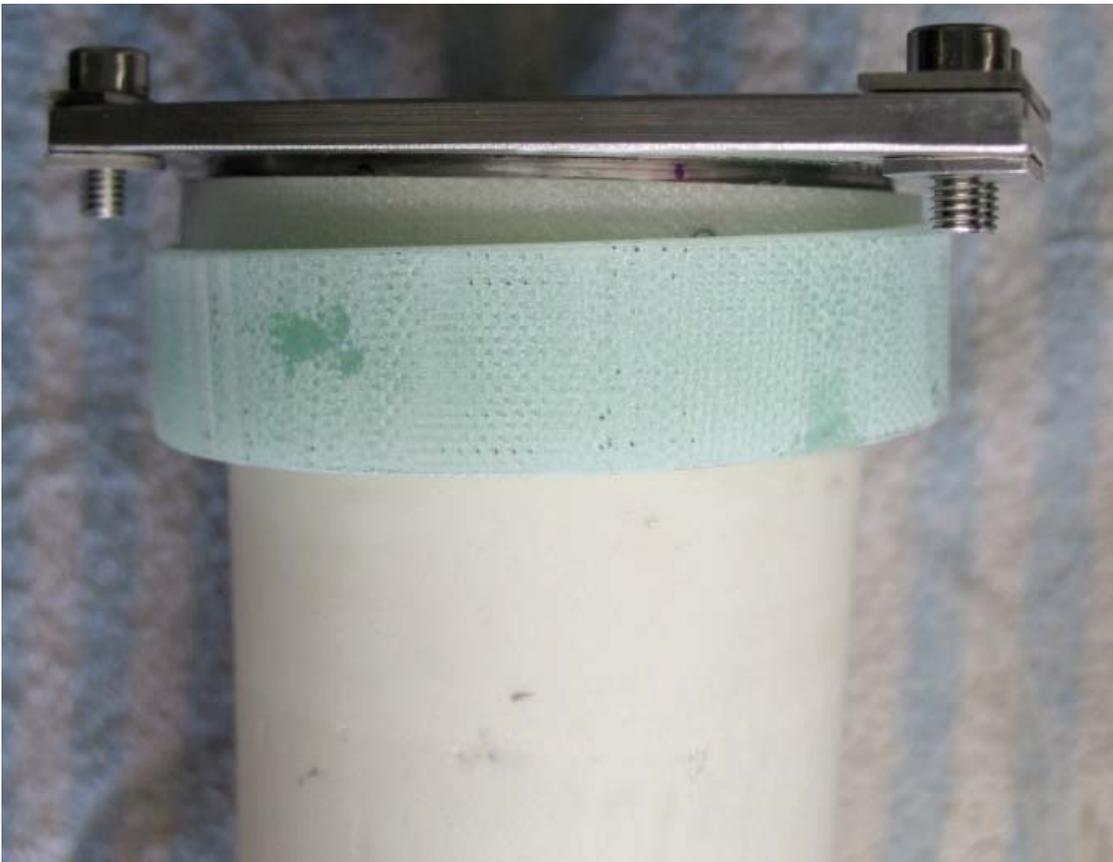
The only thing of note was that the external collar on the Telescoping Tube was found to be at an angle. This may have occurred during removal from the test set-up. It was realigned and the entire assembly will be reused in Test #8.
