NON CONFORMANCE REPORT

Non conformance Record Number	NCRN002
System	AMICA Star Tracker
Subsystem	ASTC - AMICA Star Cracker Camera
Part Name	
Part Number	240.001
Serial Number	001
Problem Description	The cable ASTC-ASTE (244.610) does not provide a stable connection on the ASTC side. The connector shows a mechanical interference with the the fasteners on ASTC-side due to the ASTS_CONNECTOR_PLATE height that increases the nominal bolts height by approximately 1mm. See drawings on next page.
Proposed solution	Reduce 25 pin - MR75-80-25-S-1-B-P (244.623) bolts height by 1 mm.

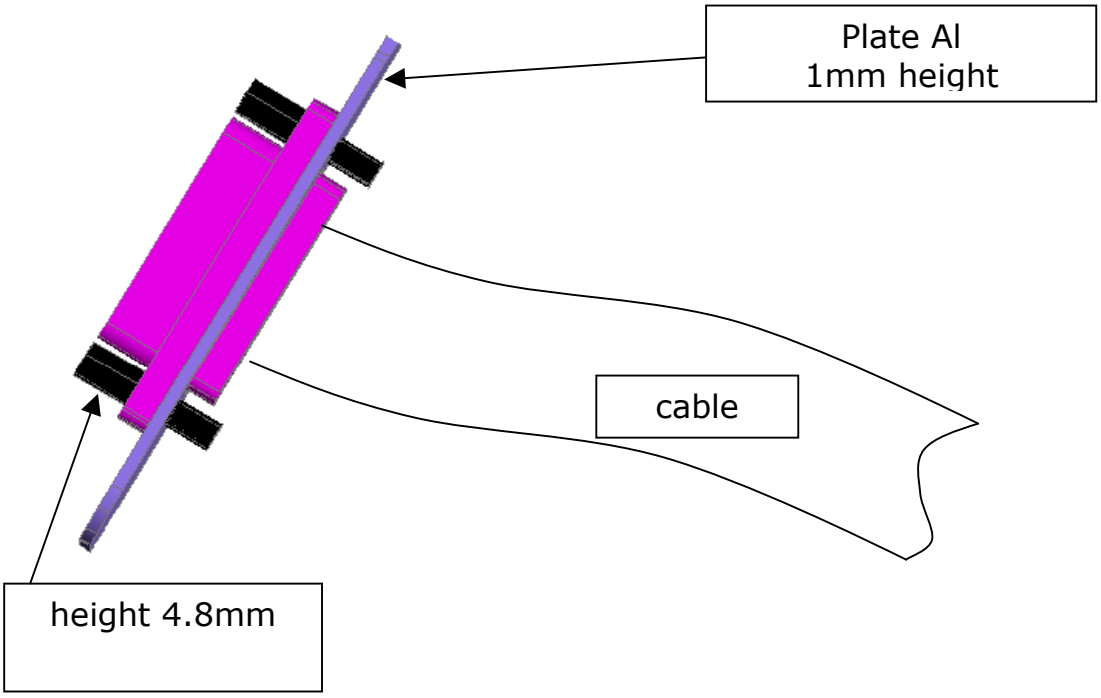
The correct connector assembly is not viable due to the cable termination on PCB (soldering ang potting already performed). As a consecuence, the connector is mounted as in the pictures, behind the plate. This is why the bolts height is increased with respect to the standard. To compensate the difference in height, the bolts have to be smaller (replace or rework is needed).
