National Aeronautics and
Space Administration

November 17, 2009

SUBJECT: AMS Burst Disk Vent Duct Redesign and Certification

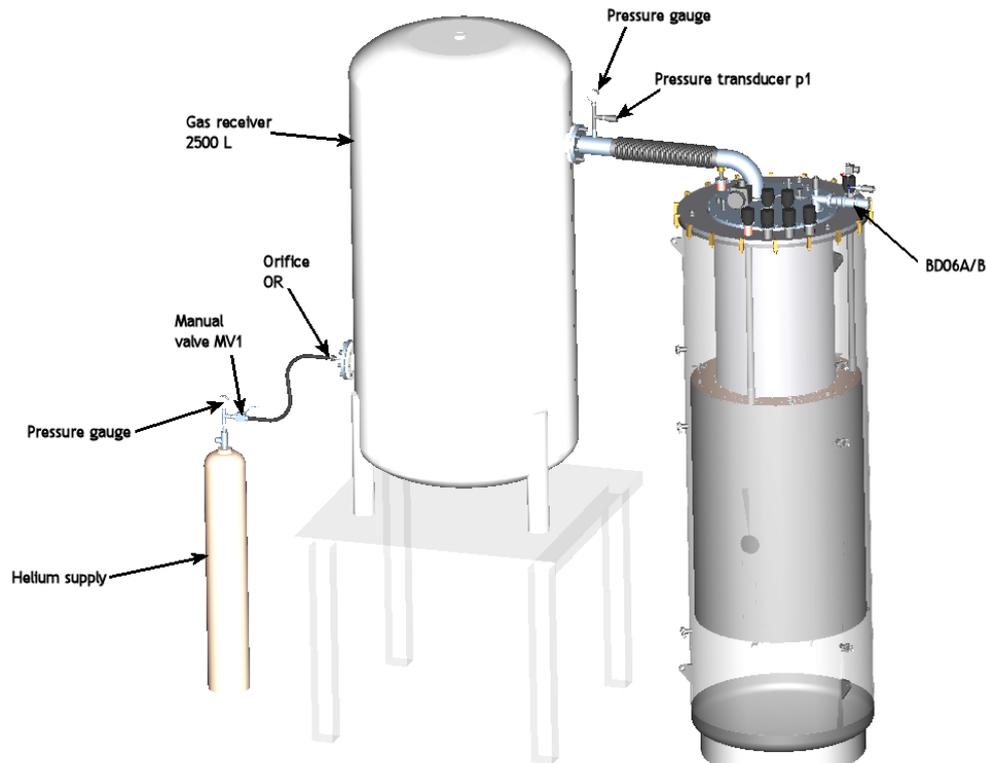
Figure 1

After the failure during testing of the AMS vacuum vessel burst discs BD07A/B/C, it was decided to test the other three-in-a-row burst disc combination - BD03/06A/06B - to check that they did not experience a similar problem (failure of the second disc to open completely).

A test rig was designed and constructed (Figure 1) which allowed the flight spare discs to be mounted at the end of a 2.7 m³ volume which could be pressurised to 3 bar or higher in order to burst the discs. Although the gas in the system was warm, heat exchange with a liquid nitrogen bath was included so that the inner disc (BD03, operates in the flight system at 1.8 K) could be cooled to a temperature close to 77 K.

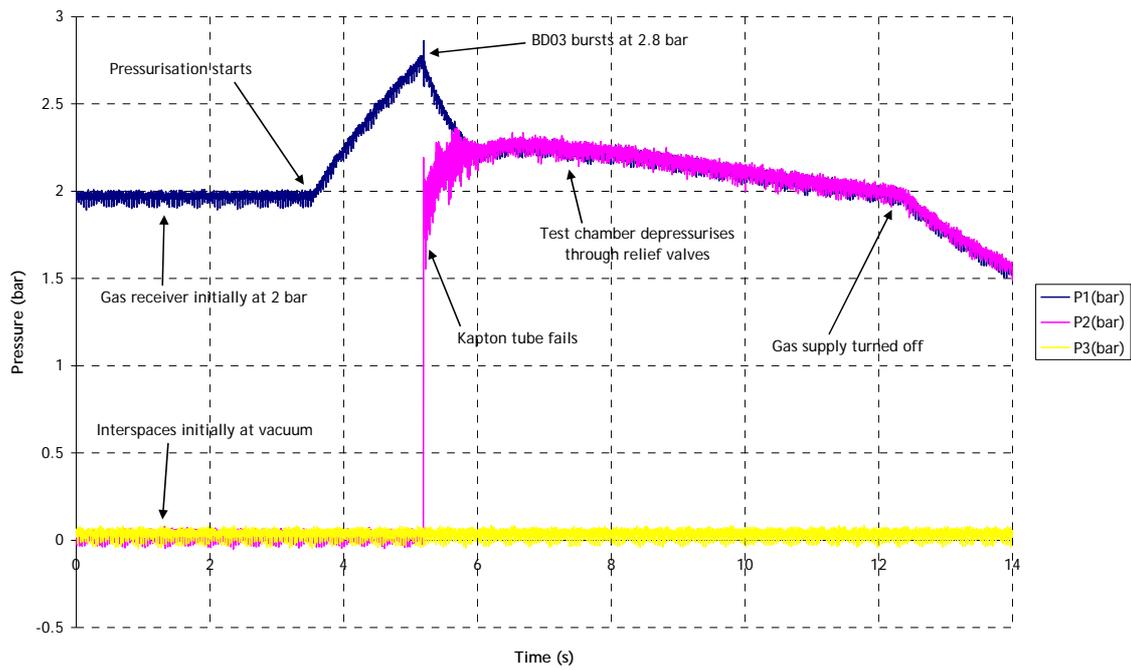
Figure 5

The sequence of events is also manifest in the logged data from the pressure transducers (Figure 5). At the start of the test the receiver had been pressurised to 2.0 bar, but the interspaces between the burst discs were evacuated. When the valve to the gas bottles was opened, the receiver pressurised to 2.8 bar in 1.2 s, at which point BD03 ruptured. Transducer p2 registered the opening of BD03 as a very rapid pressurisation of the interspace between BD03 and BD06.

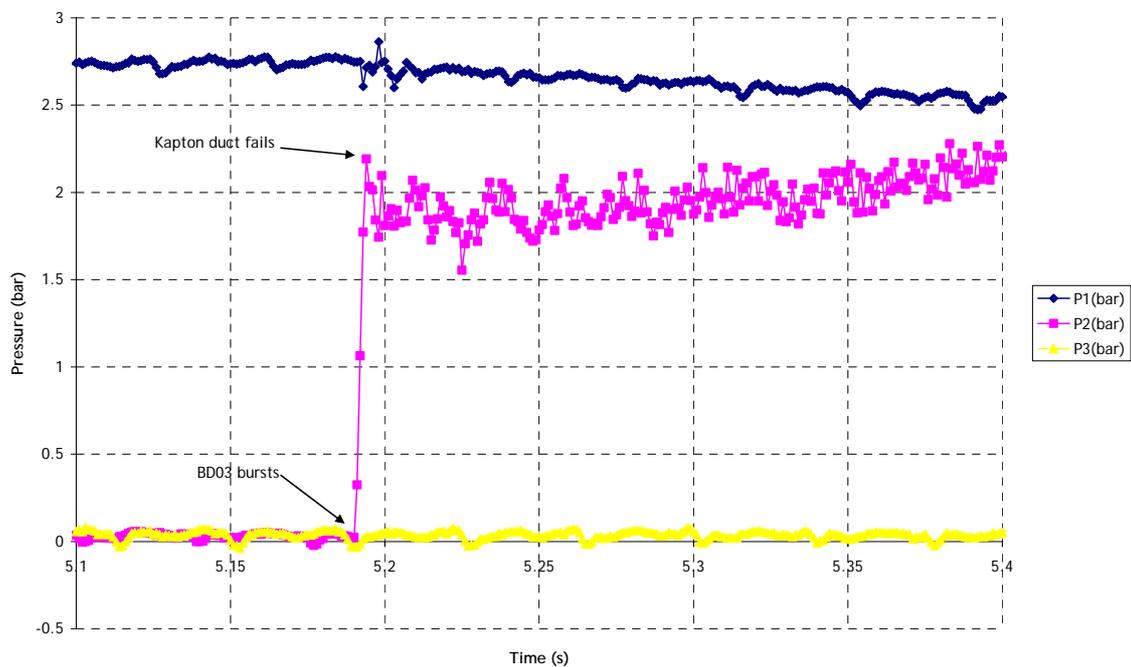
Figure 6 shows the time between the rupture of BD03 and the failure of the Kapton duct in more detail. With sampling at 1 kHz, the data acquisition system was able to detect the rate of rise of pressure over a number of readings after BD03 burst. The plot shows that the pressure rose from zero to 2.2 bar in 4 ms: it is clear that this is the point at which the Kapton duct failed.

It is not immediately clear why the Kapton duct failed in the burst disc test. A number of identical Kapton tubes had been tested before: although some of them had failed this was

only ever seen at very much higher pressures. It had been considered that there was sufficient margin between the observed failures and the real system pressures (determined by the burst discs) that there was no significant risk in the flight system or the burst disc test of the Kapton tube failing.

It is notable that the failure of the Kapton tube was at the warm end, so the cooling does not seem to be significant. This is also the position of the short stainless steel spigot for mounting, which was a new feature shared neither by the previous Kapton tube tests nor by the flight system.

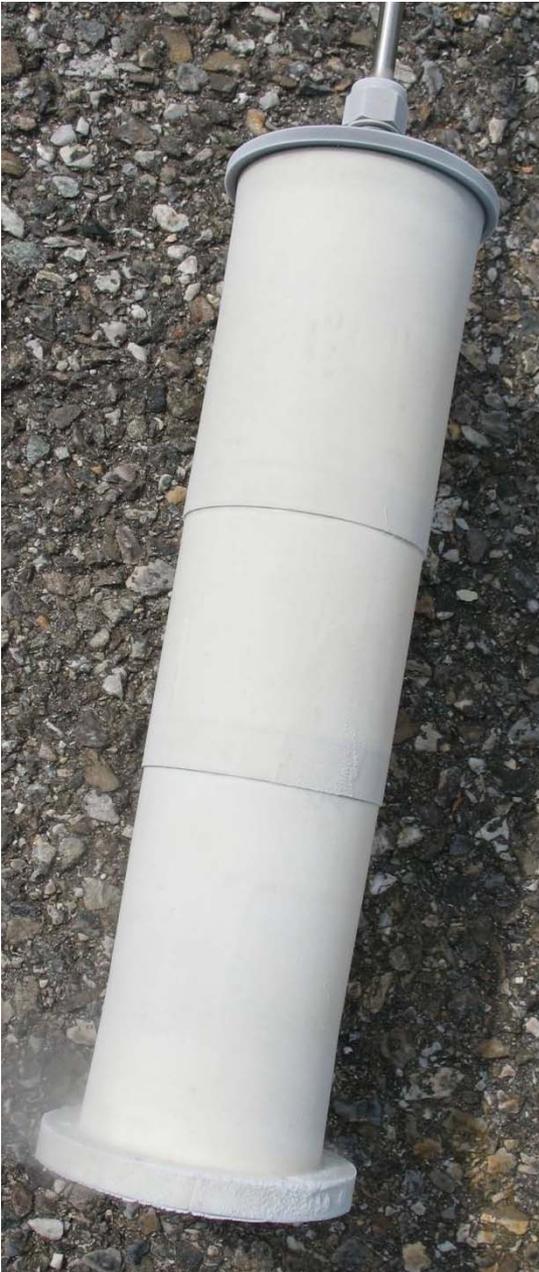
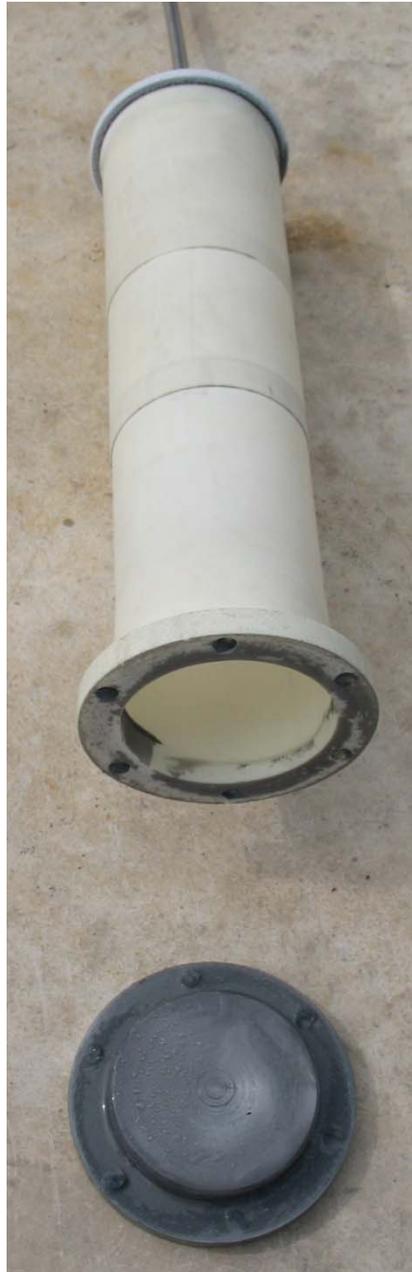
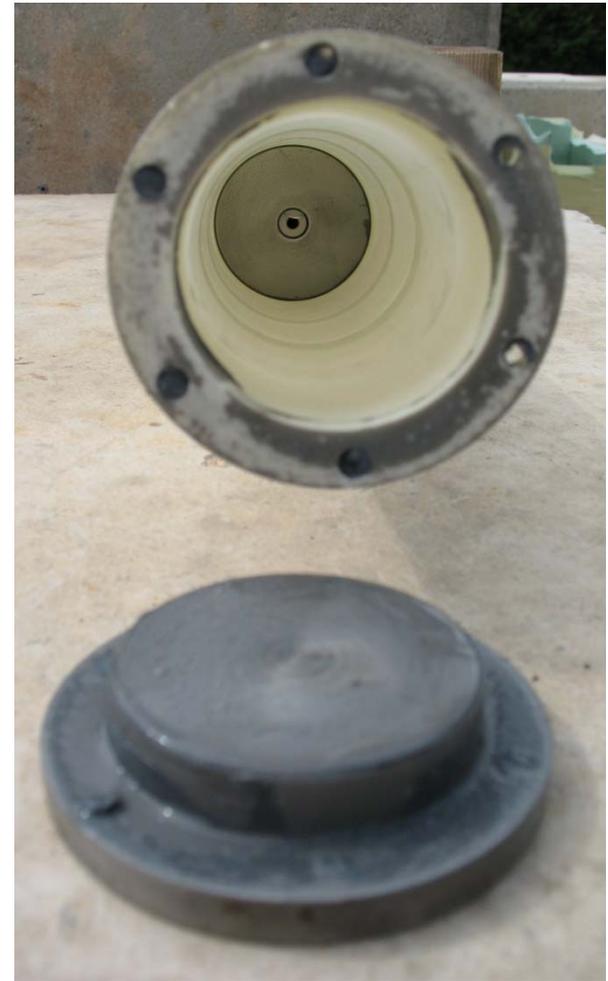
BD03/06 Telescoping Tube Tests

The glued interface to the end cap for the test failed while the tube remained intact. When this is bolted to the BD03 flange, it will be a stronger joint.

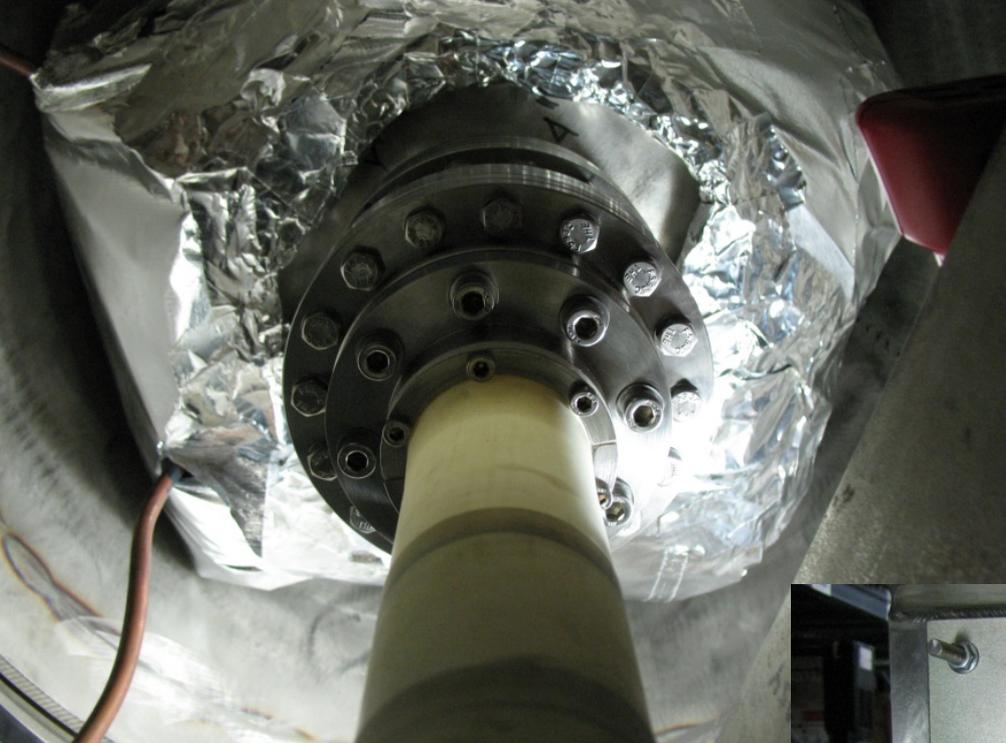
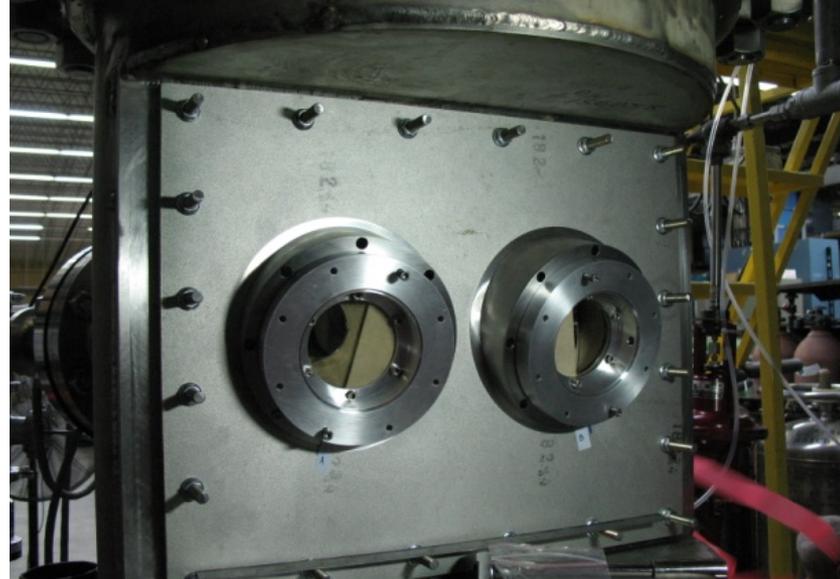
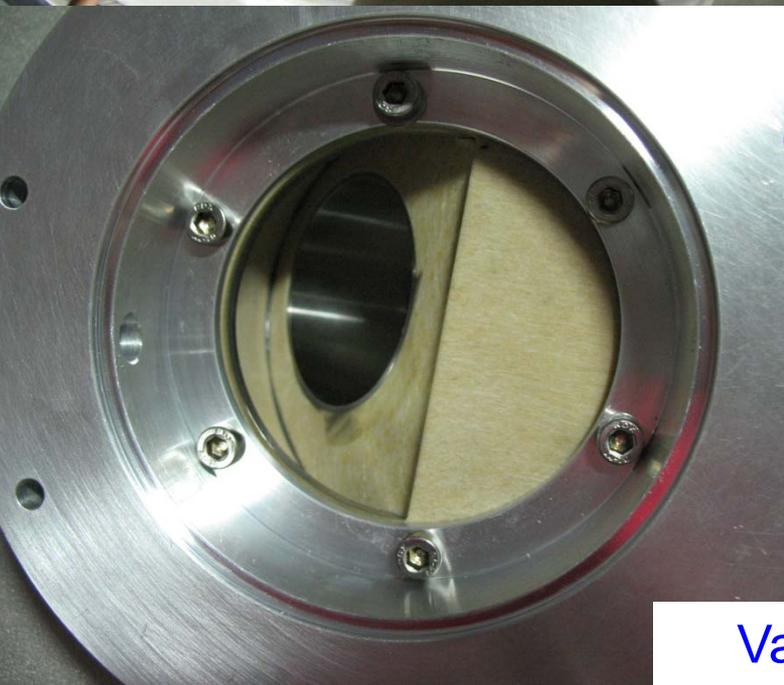
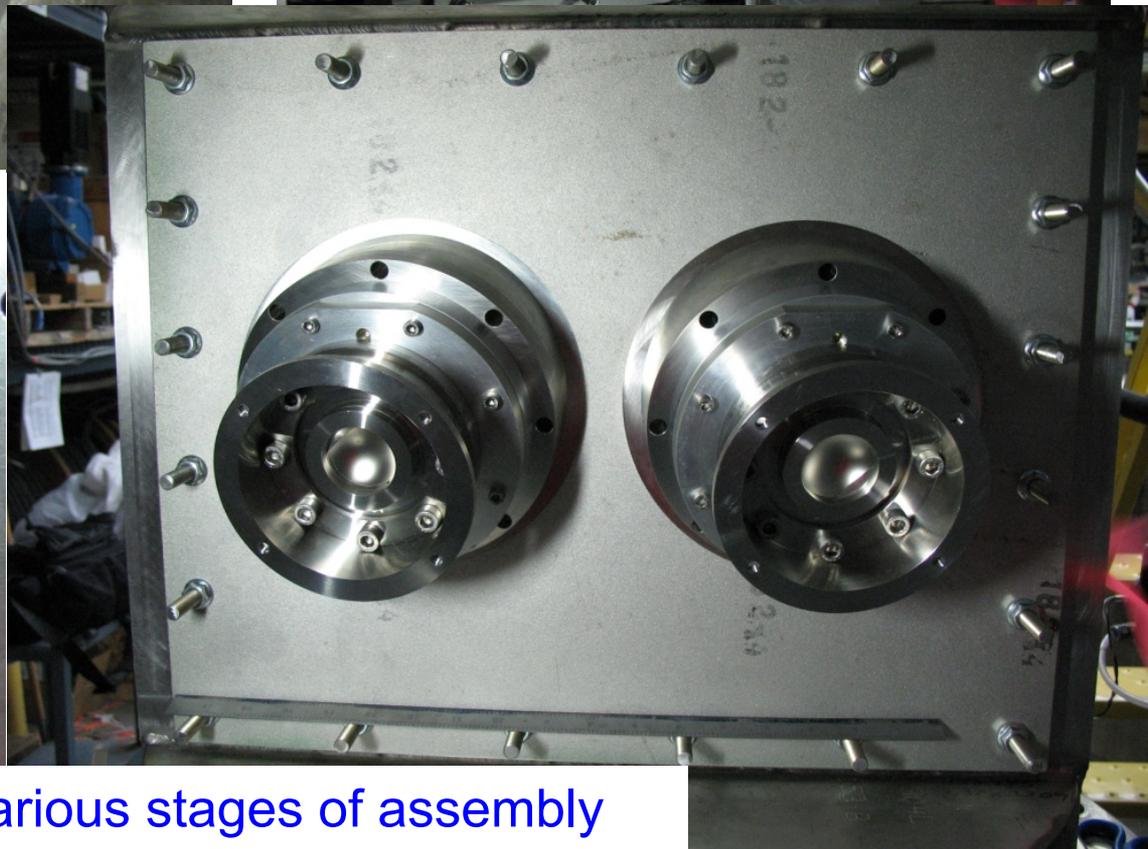
Various stages of assembly

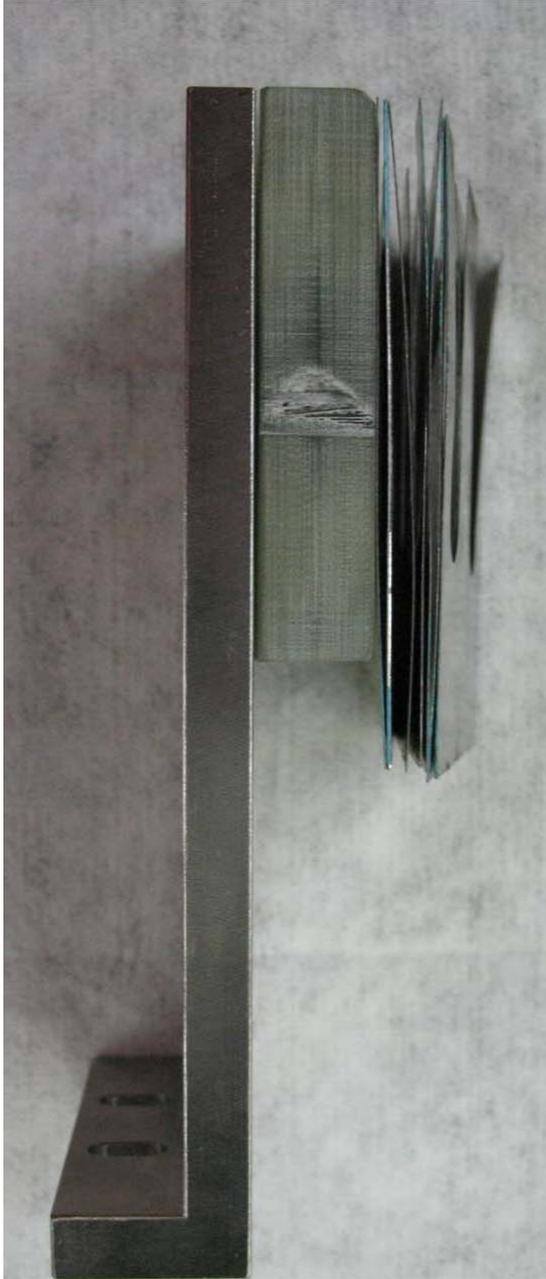
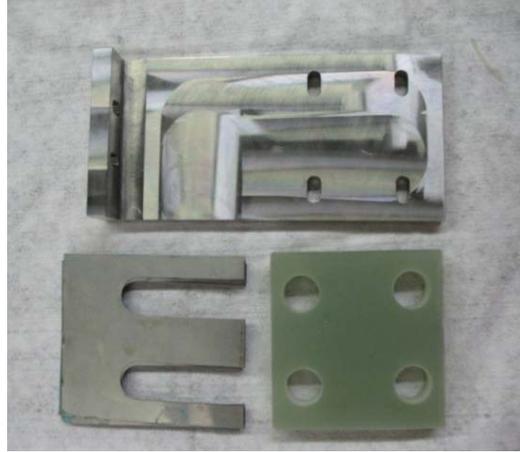
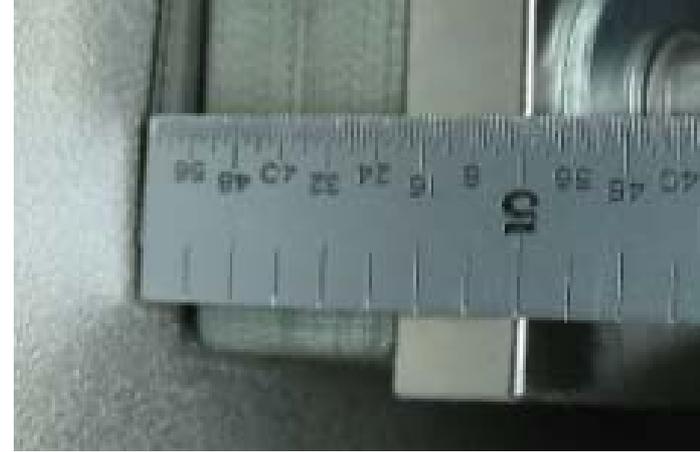
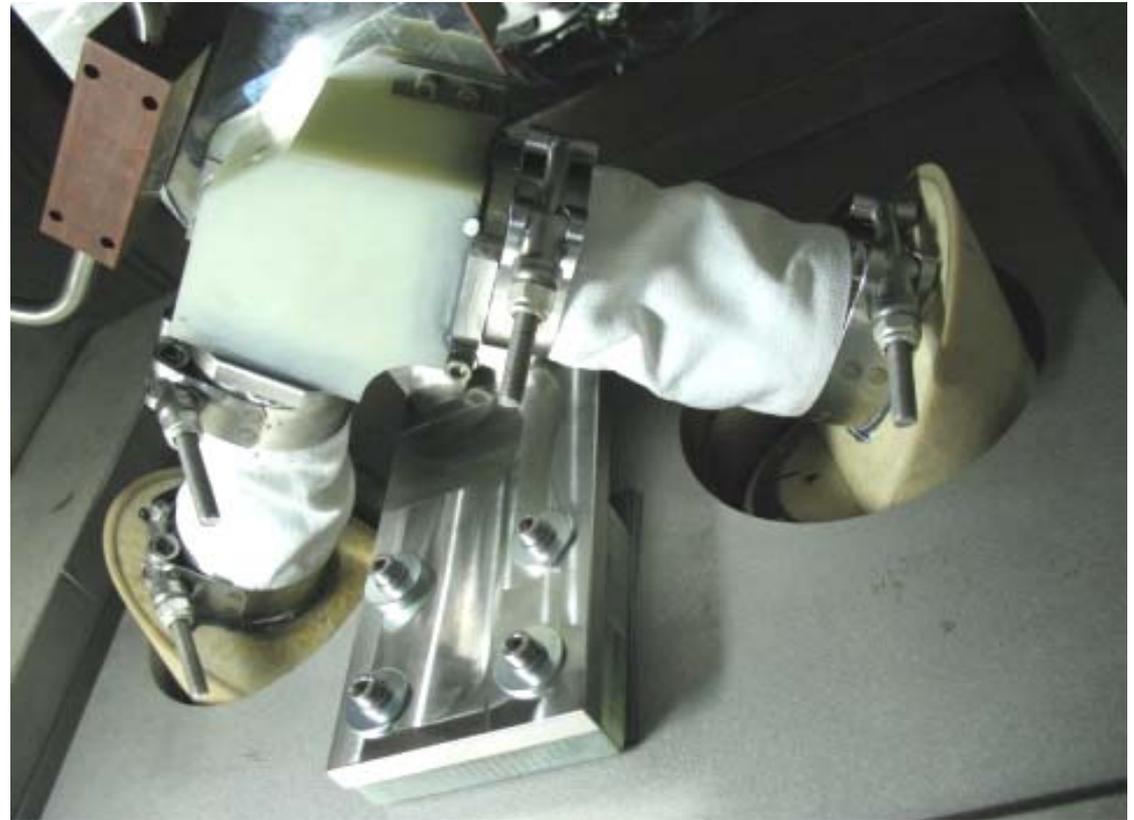
A spacer and shims were used to fill the gap between the inside of the Window Plate and the bracket that holds the Telescoping Tube in place

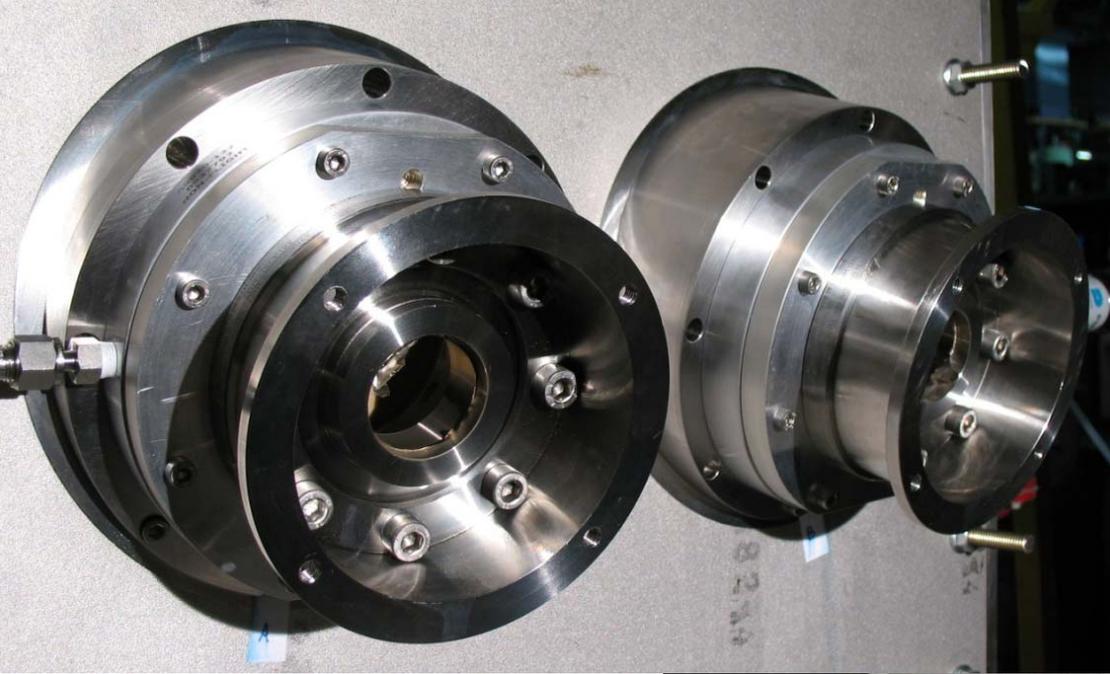
Both BD06A & B opened simultaneously. Both BD06 discs fragmented and came free of the test disc flanges. Several pie-shaped pieces of the radiation shield were found in the parking light. Disassembly and inspections will continue tomorrow.

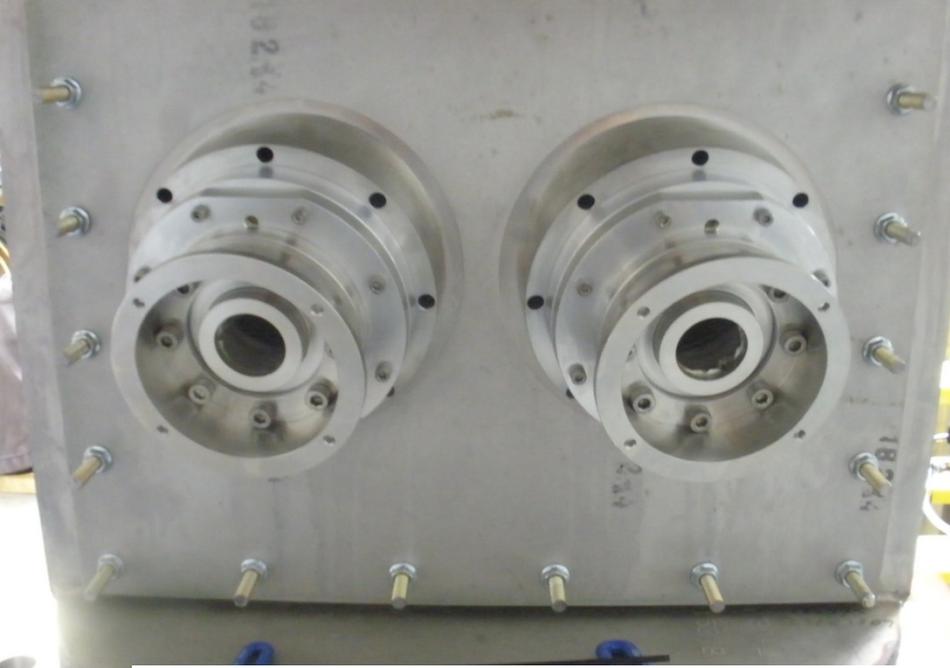
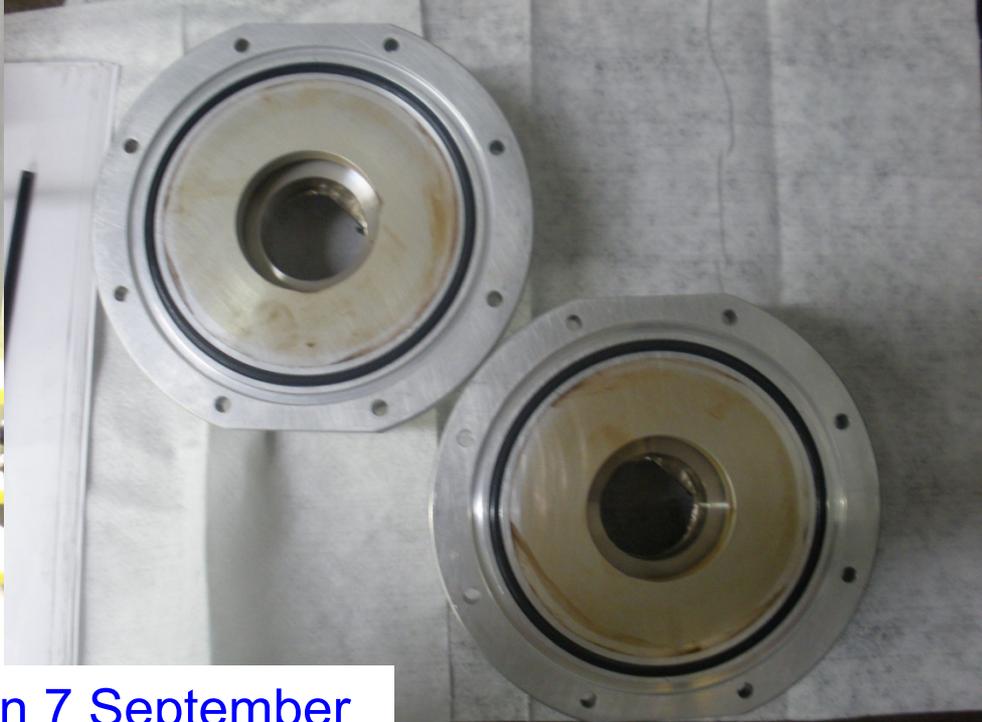
Various Stages of disassembly on 7 September

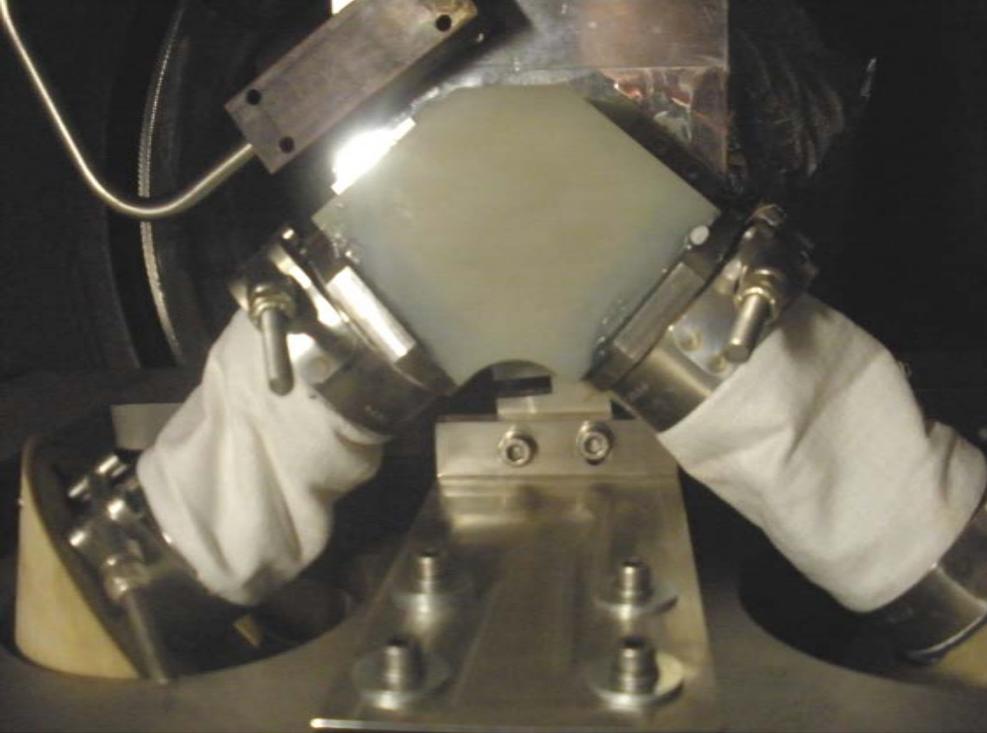
The only noticeable damage to the outside of the test article was some thread that had separated from the ortho fabric sock.

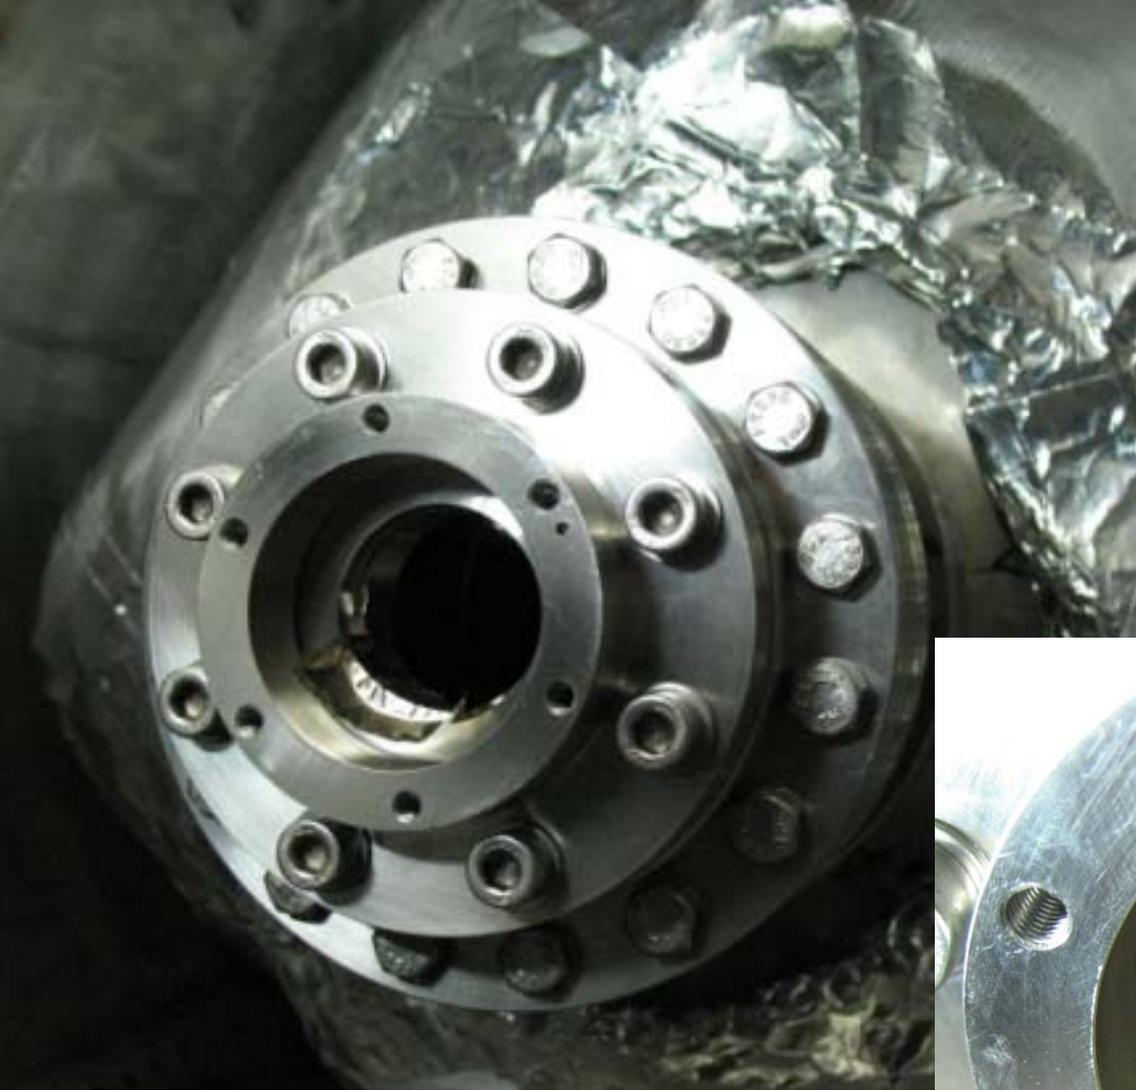
The BD03 test disc
membrane stayed
attached

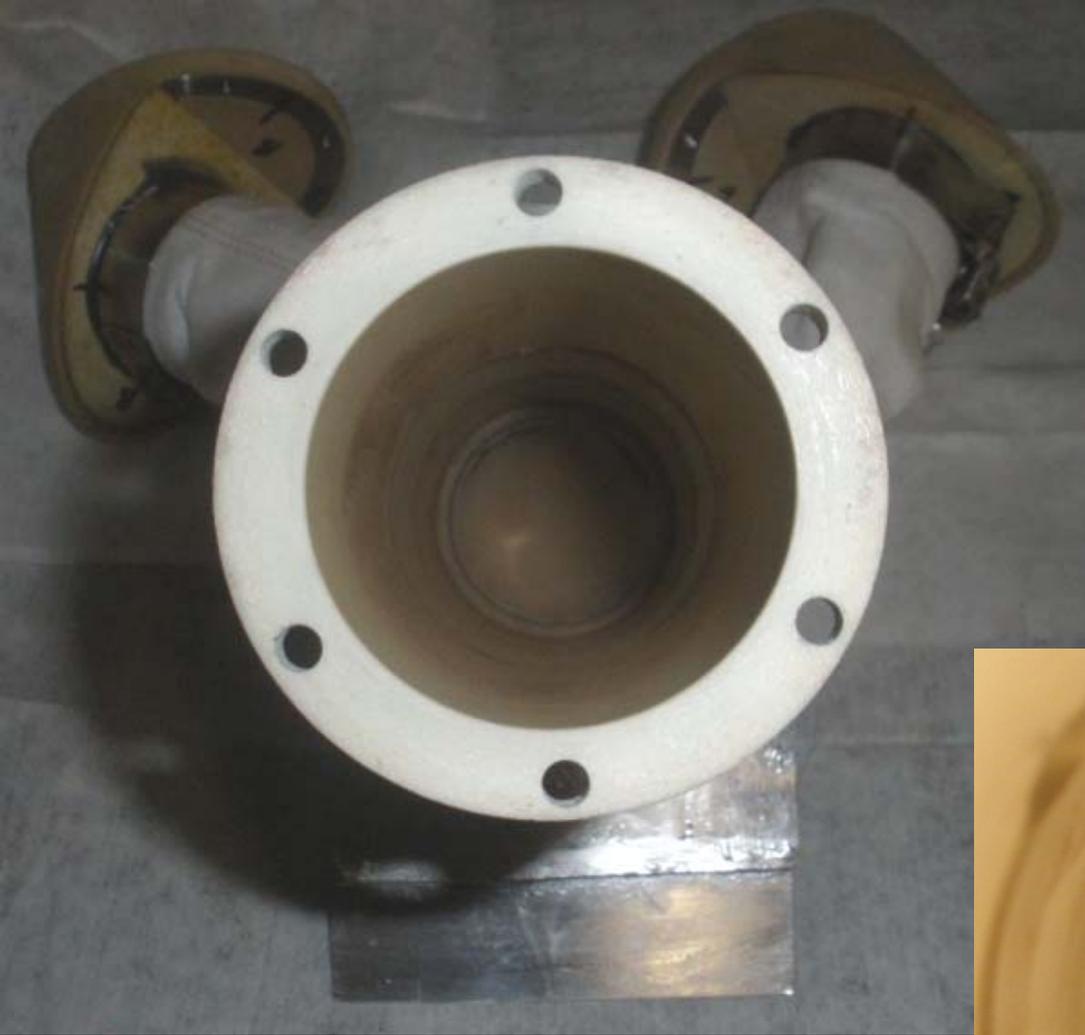
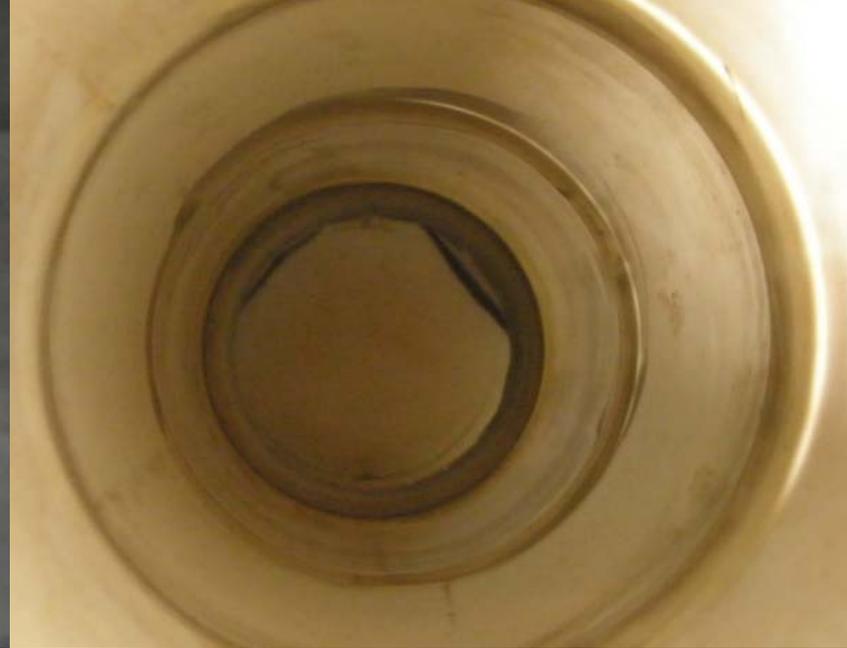
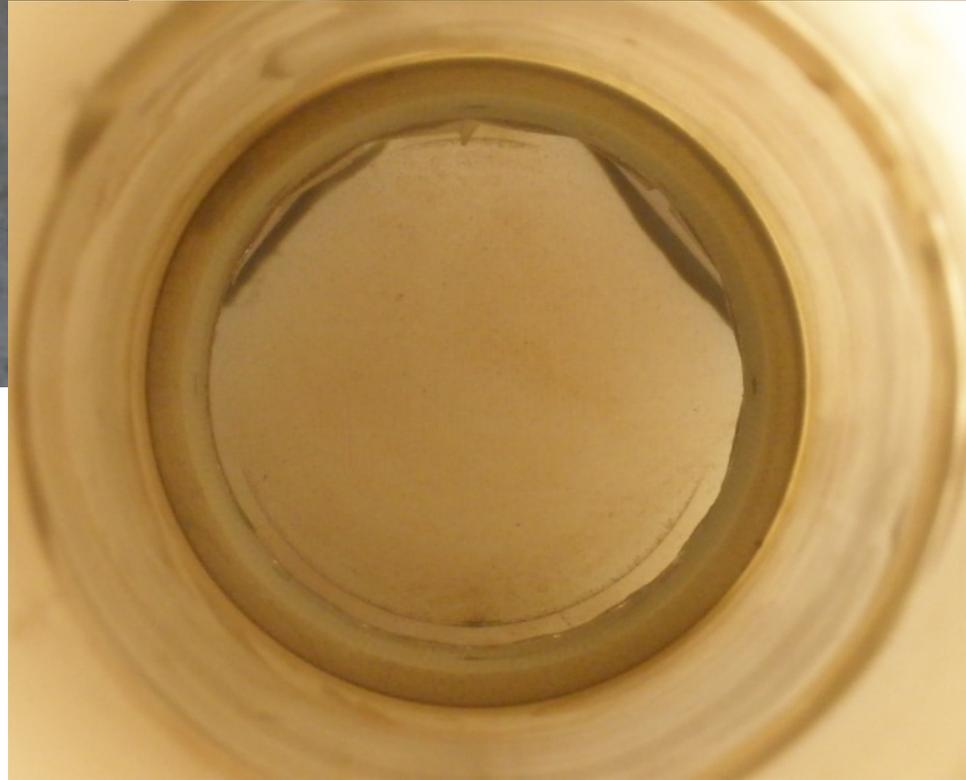
The petals of the radiation shield folded back completely or separated

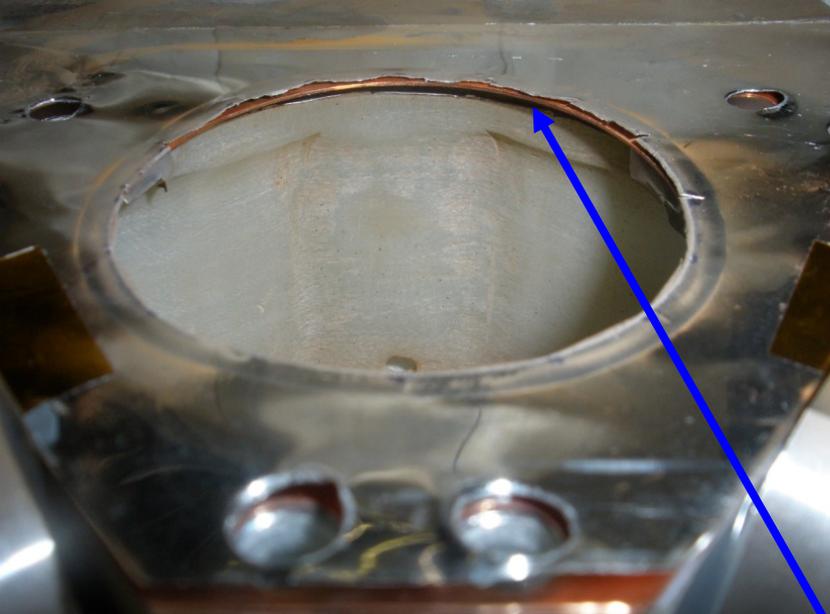
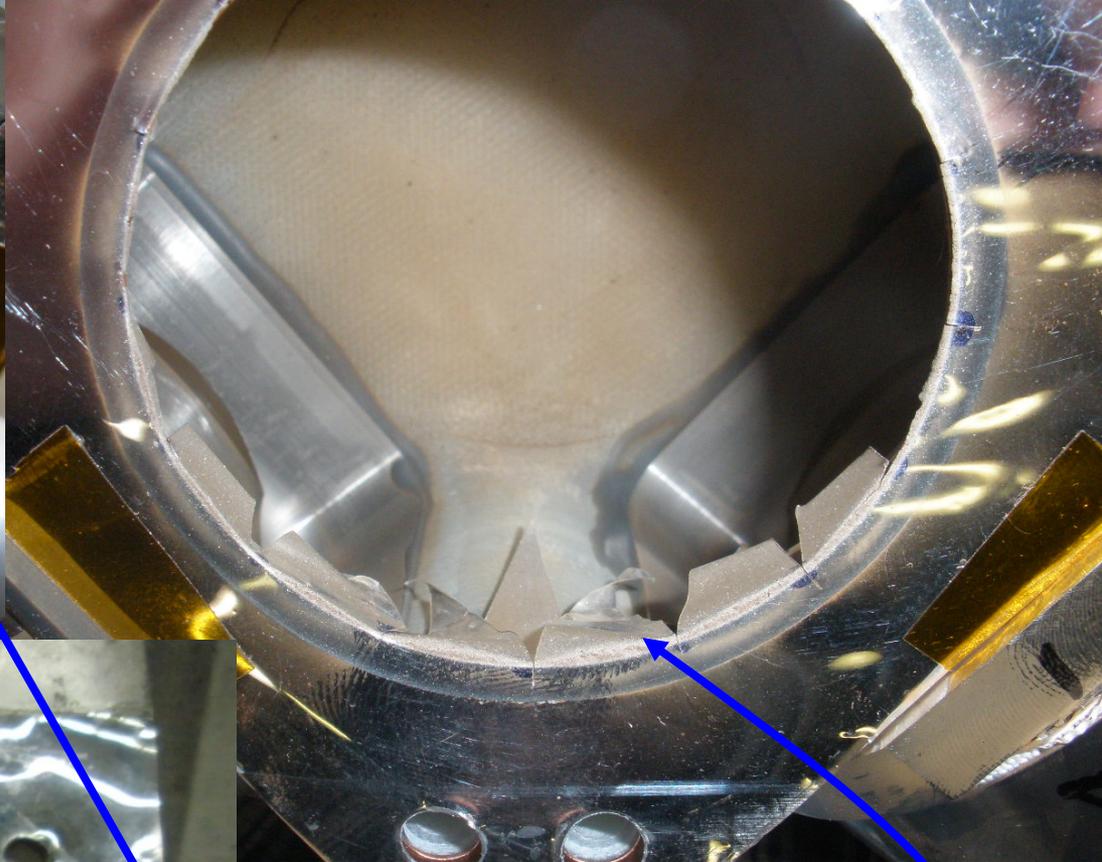
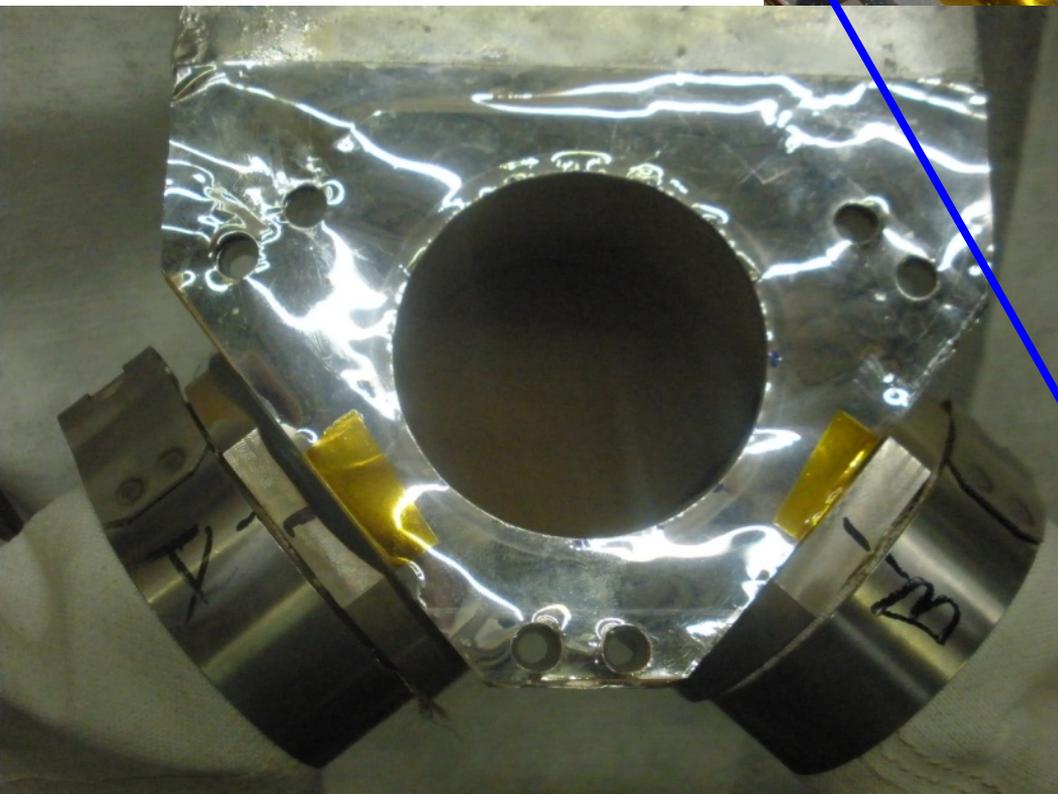
The radiation shield petals completely separated on the back side of the Tee box while the ones between the two exit ducts stayed attached.

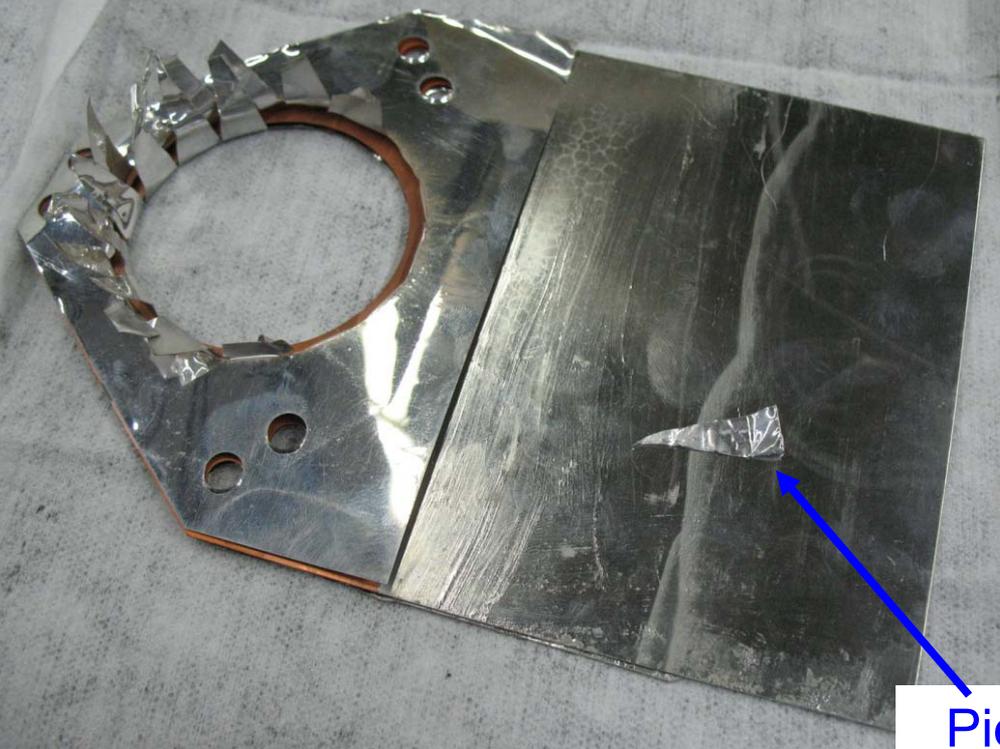
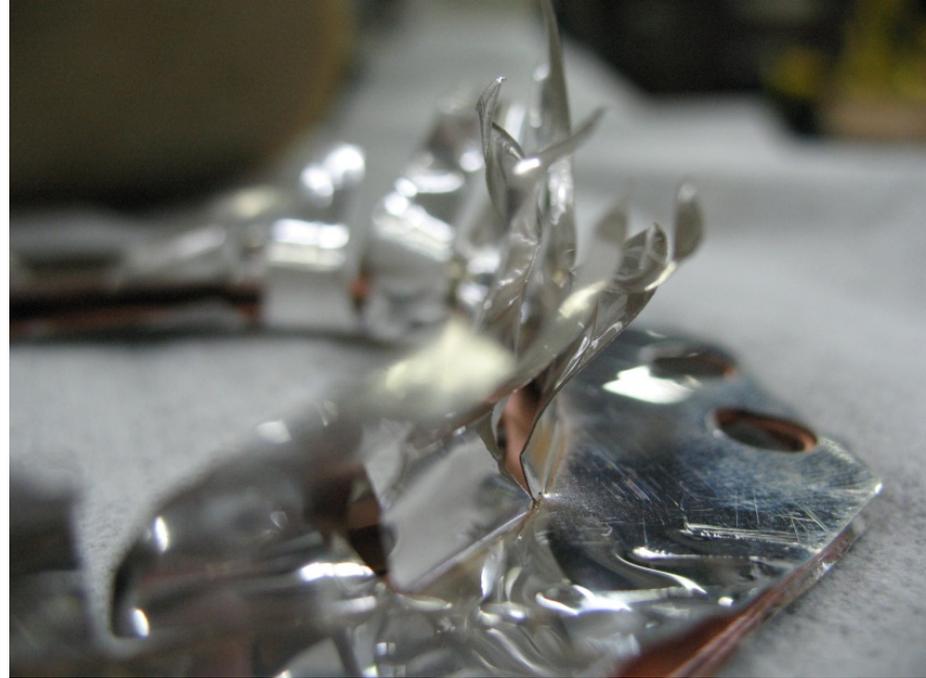
Piece of Radiation Shield found outside

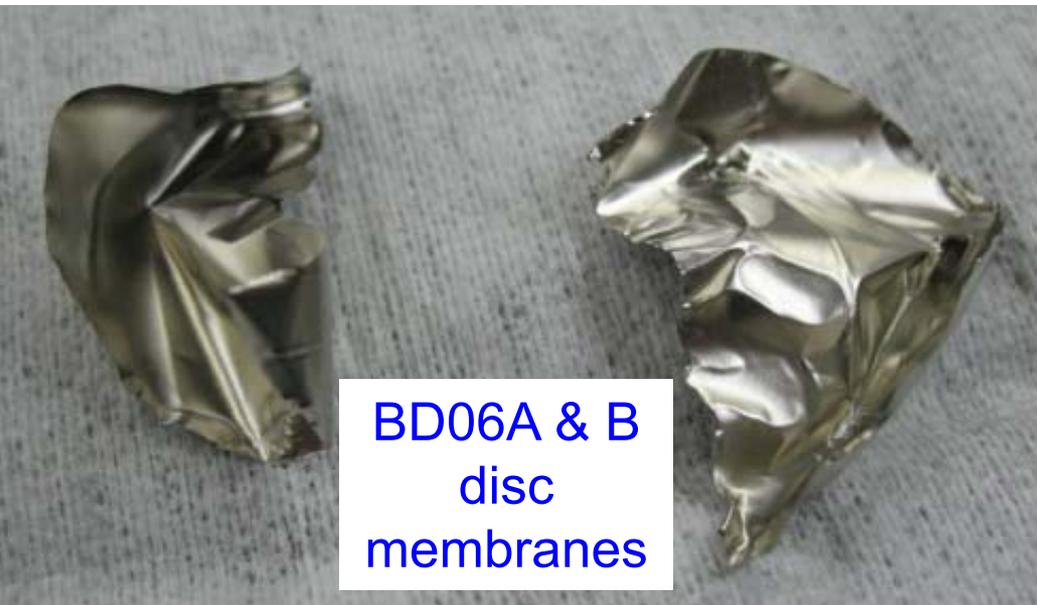
BD06A & B
disc
membranes

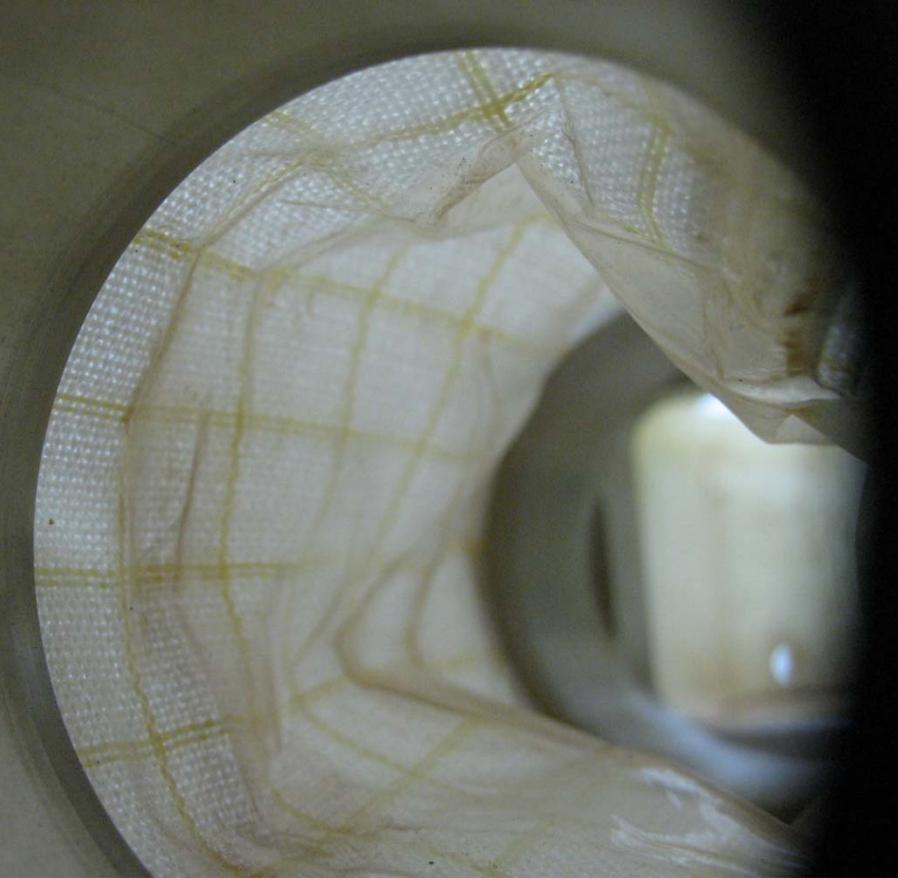
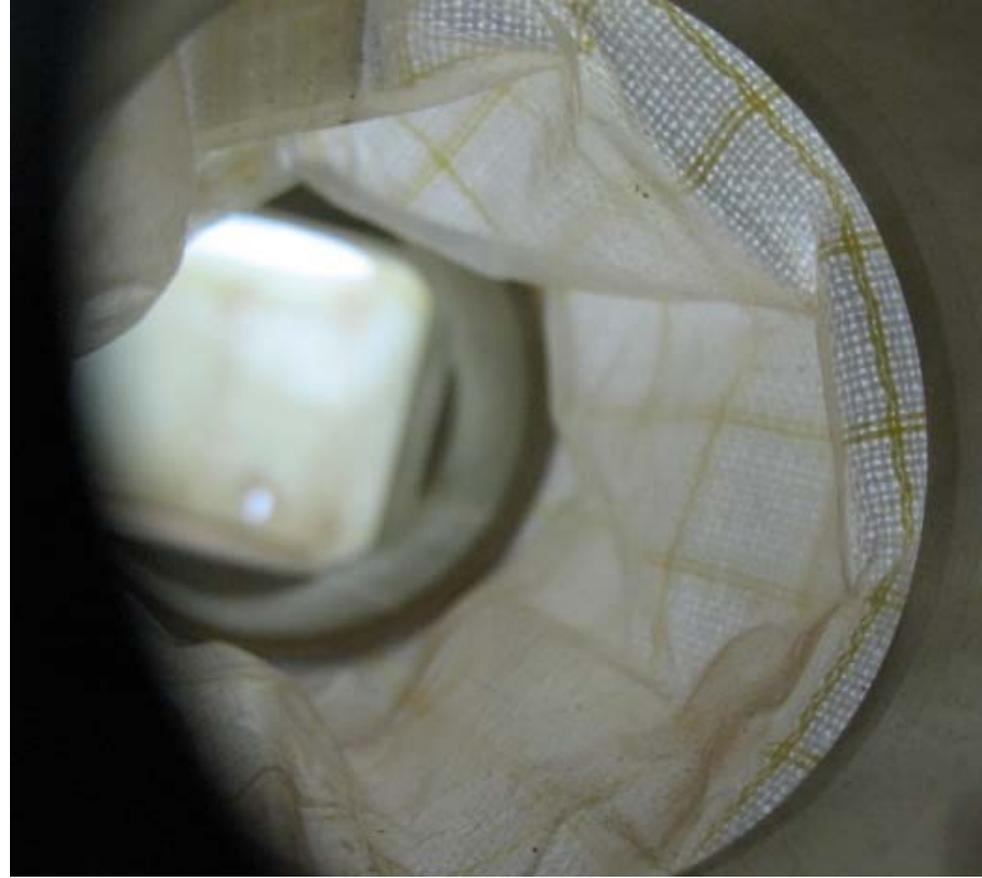
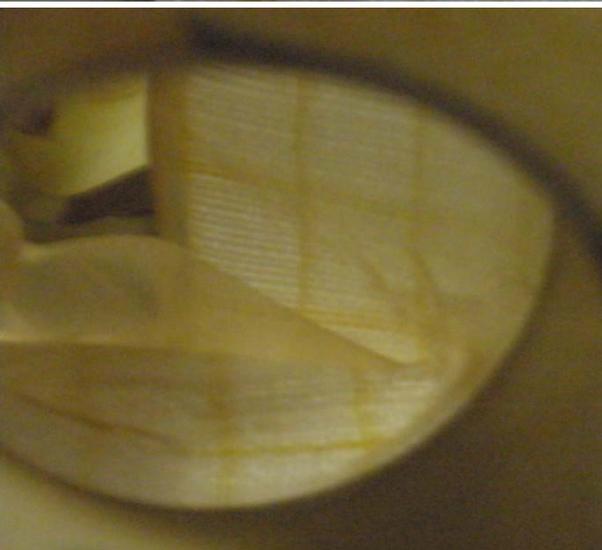
The PTFE liners inside the ortho fabric tubes appear to be intact. These will be reused for test #5.
