National Aeronautics and
Space Administration

November 17, 2009

SUBJECT: AMS Burst Disk Vent Duct Redesign and Certification

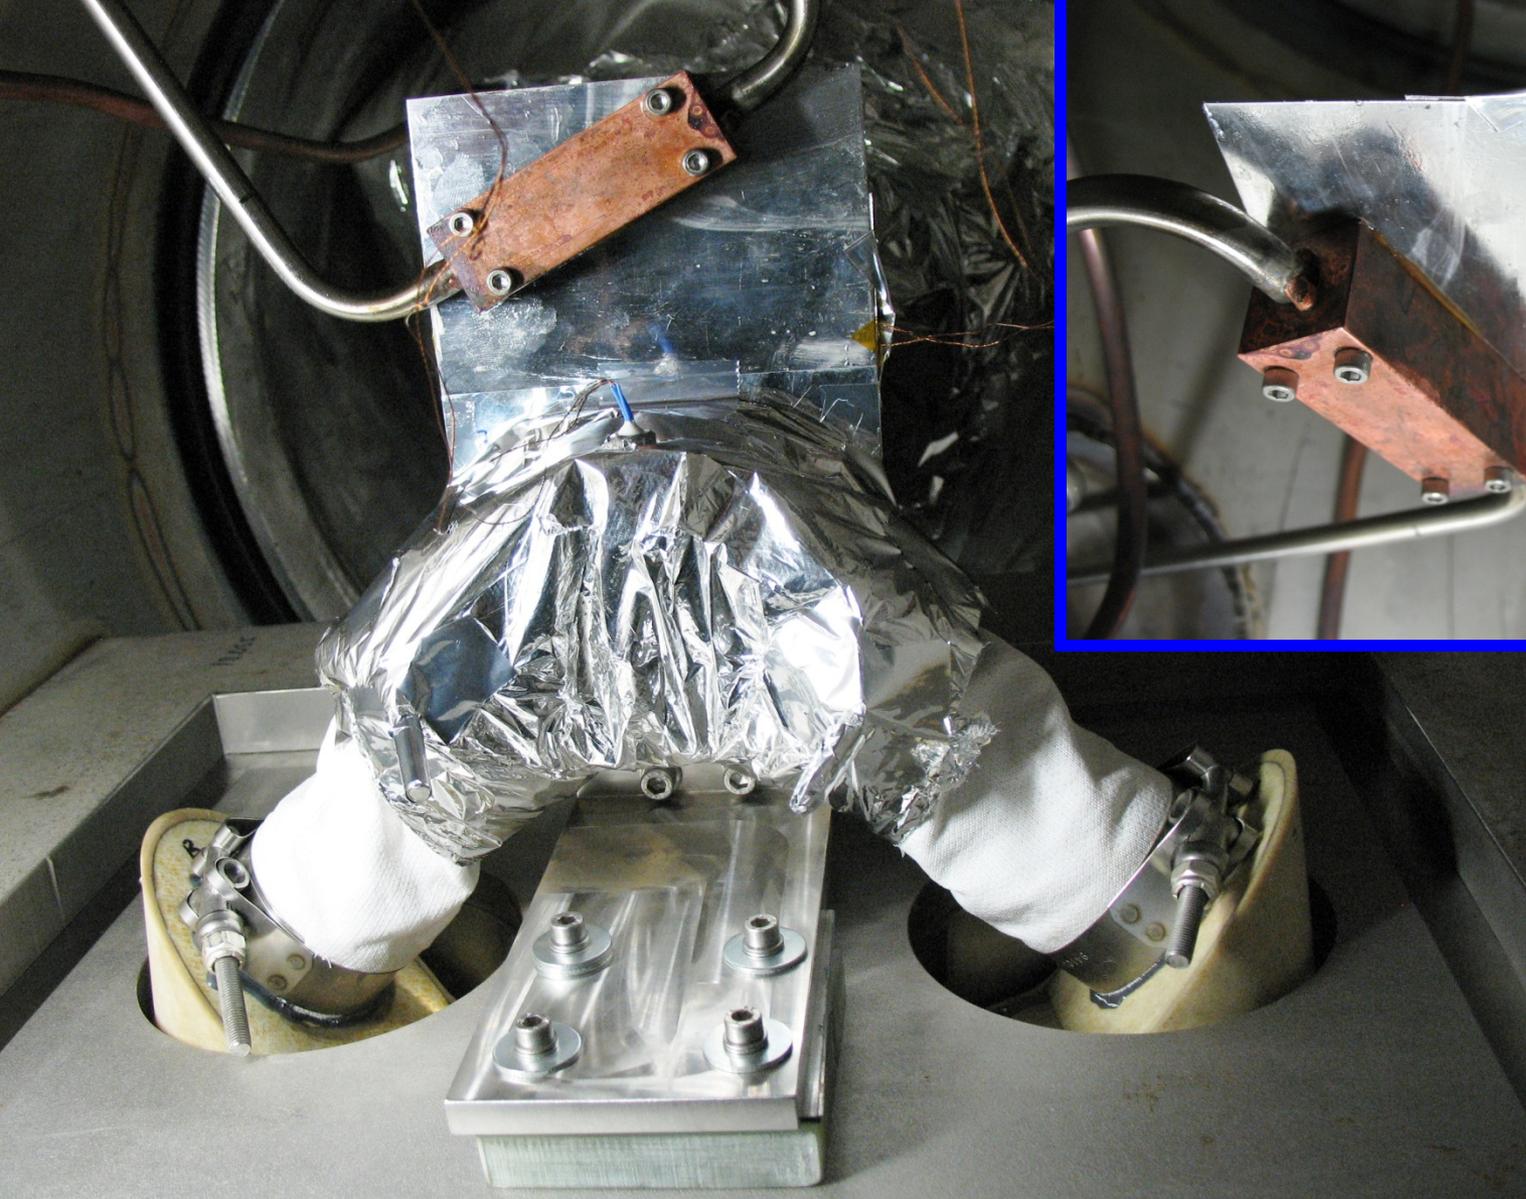
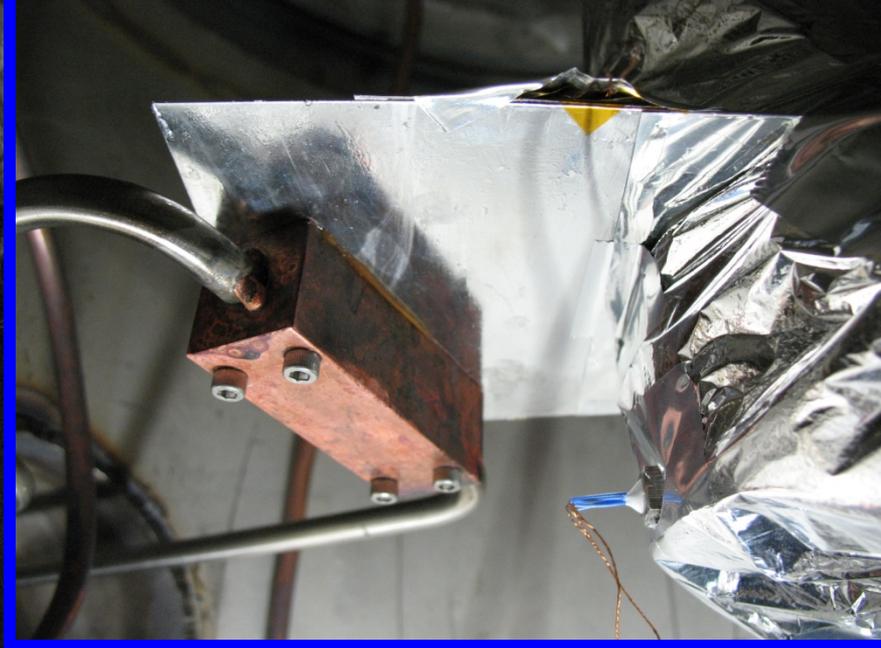
The test article was reassembled with a new set of radiation shields, installed in the test vessel and attached to the LN2 pipework and thermal block with N-grease.

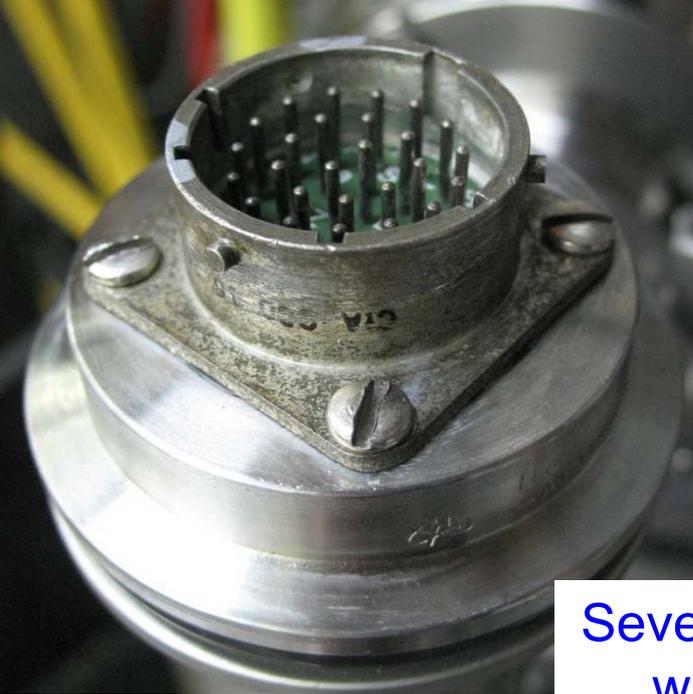
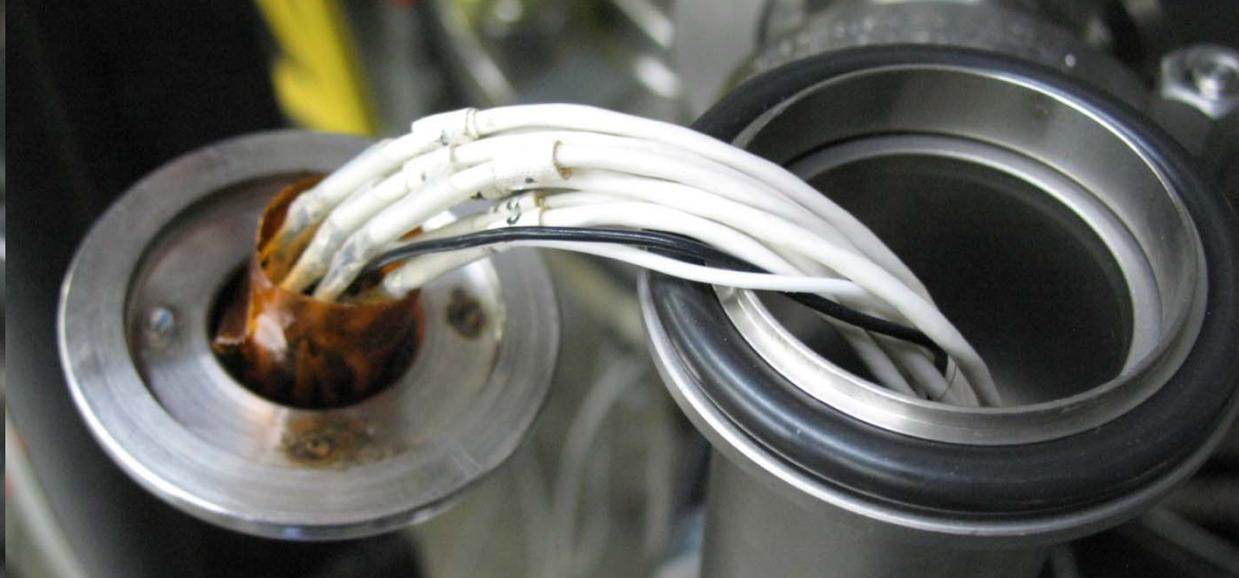
Several attempts were made to repair the leaking fitting with the cracked welds for the electrical connector

We eventually used epoxy to permanently seal the connector to the fitting

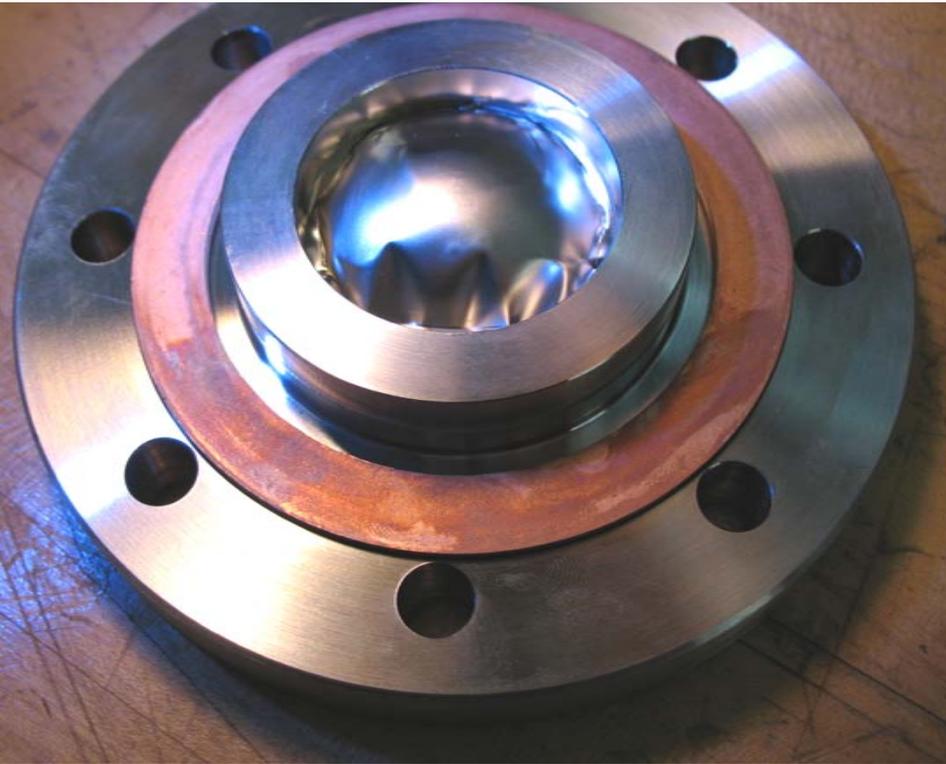
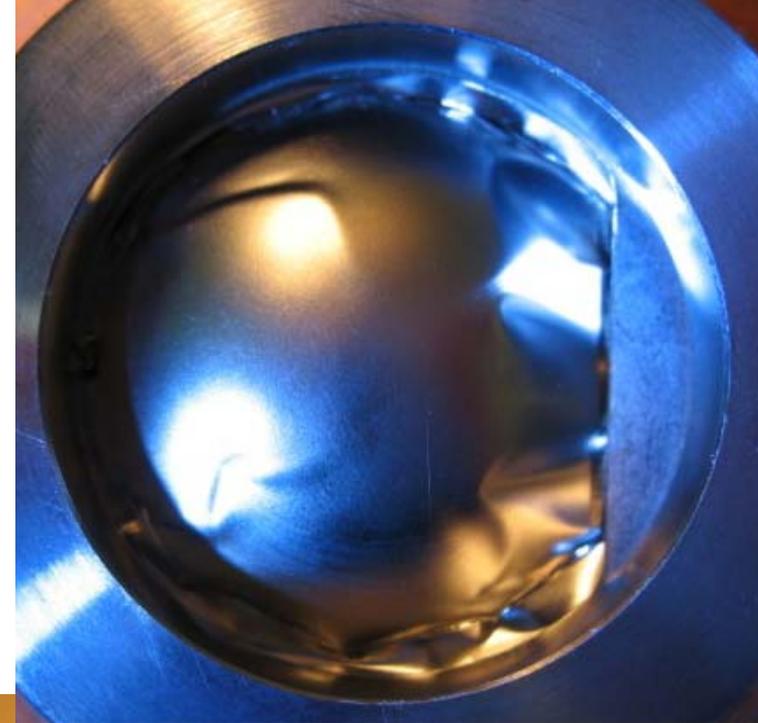
This is the downstream or low pressure side.

Note the direction of the flow arrow on the side indicating the burst disc was properly oriented.

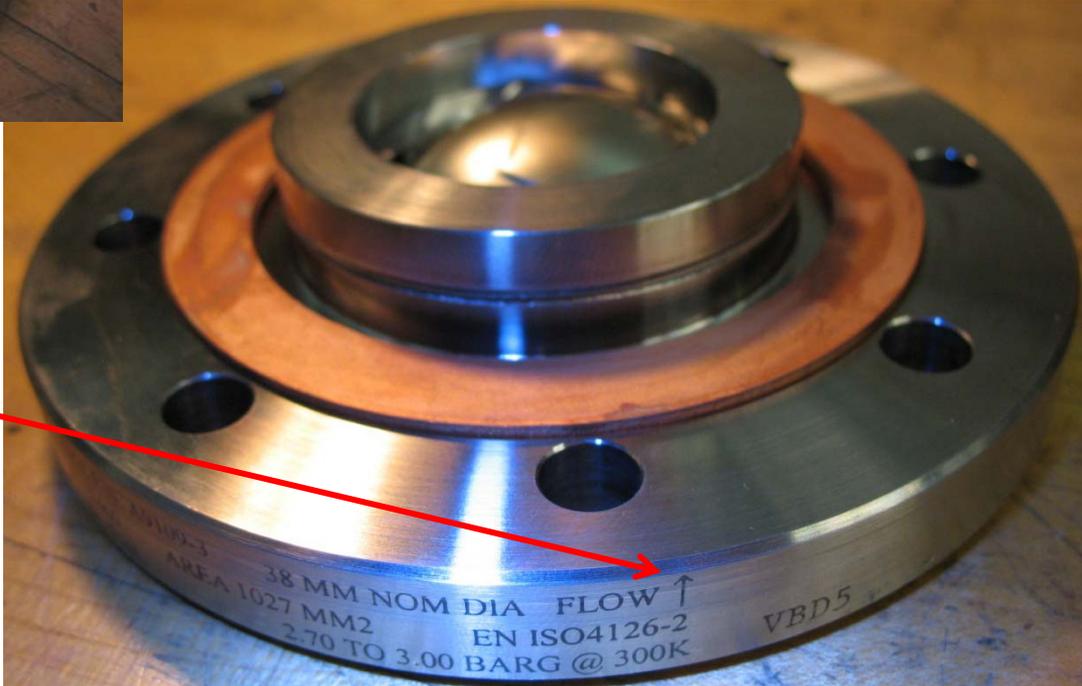
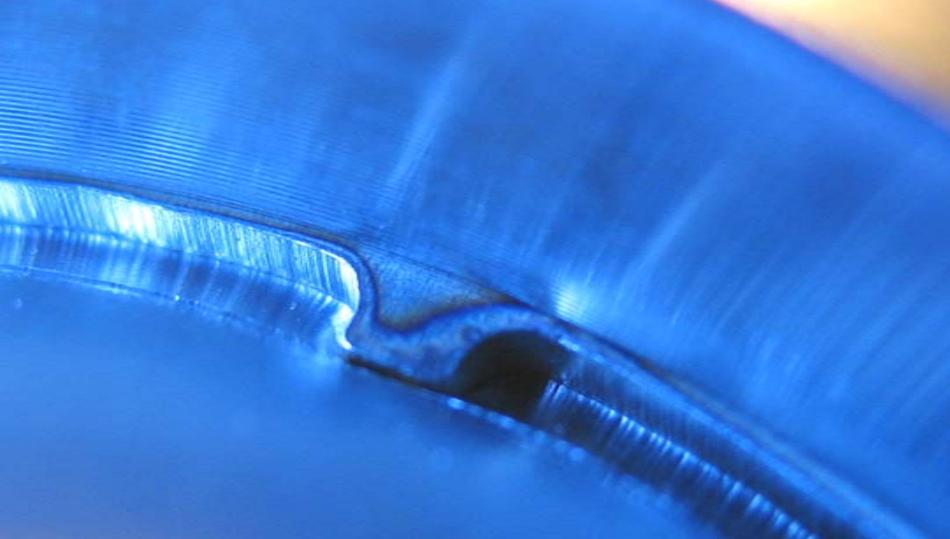
Closeups of the tooth on the downstream side.

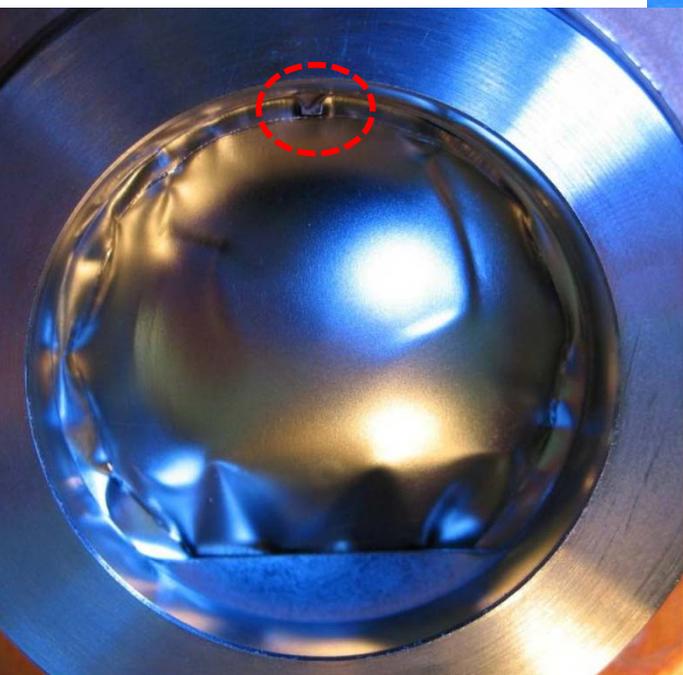
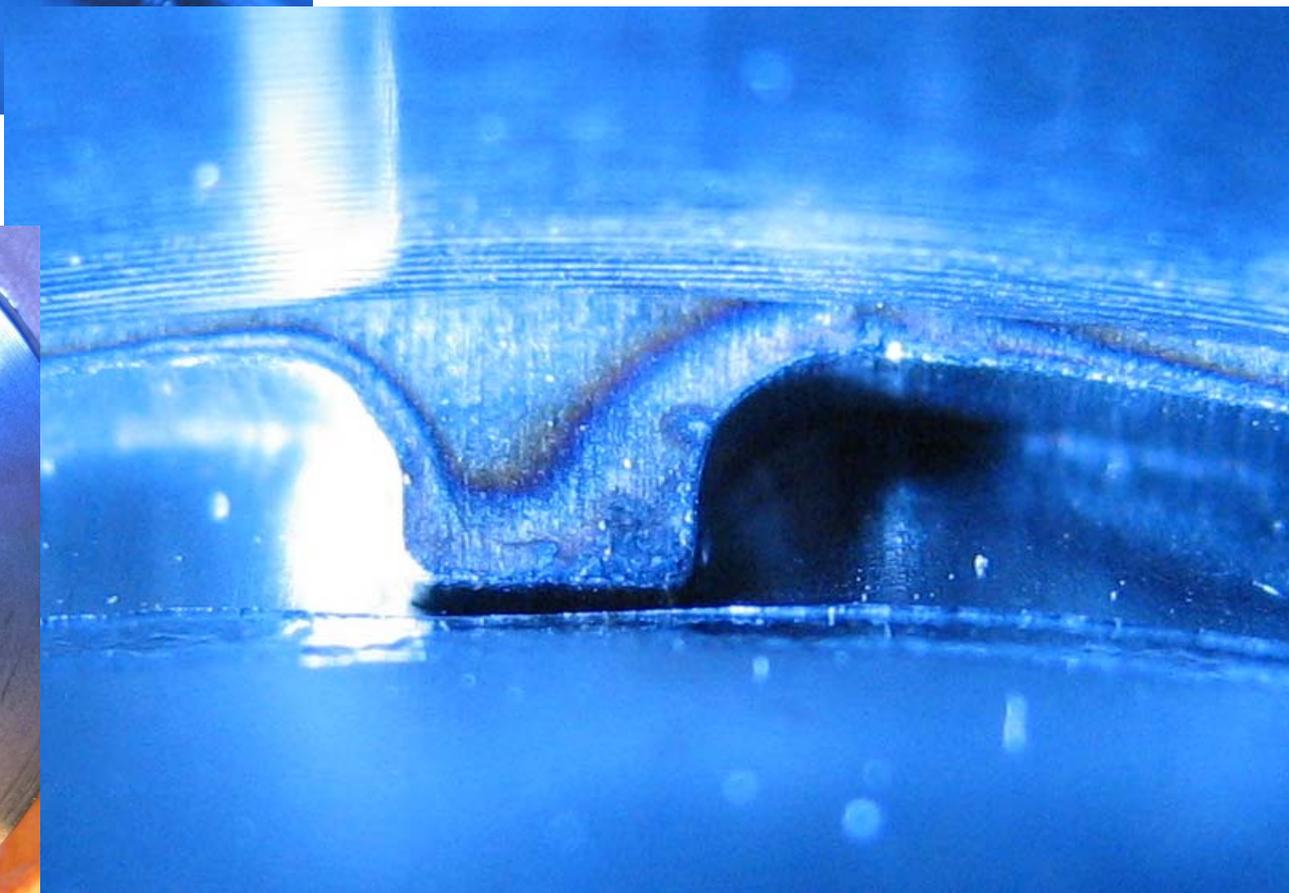
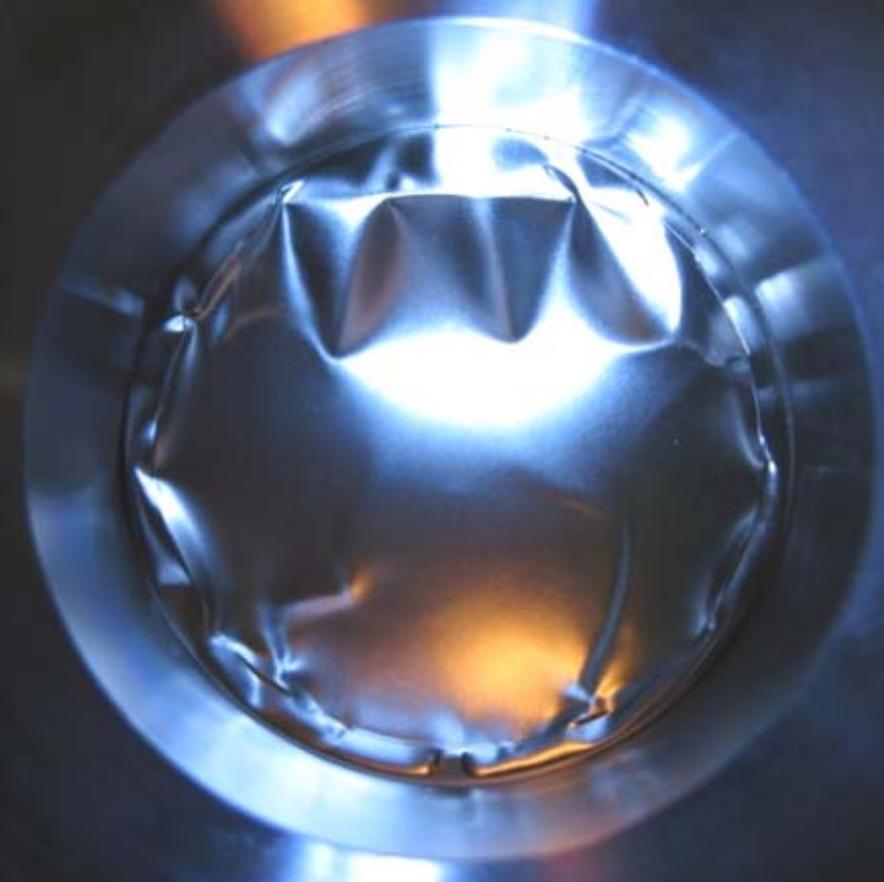
This is the upstream or high pressure side.

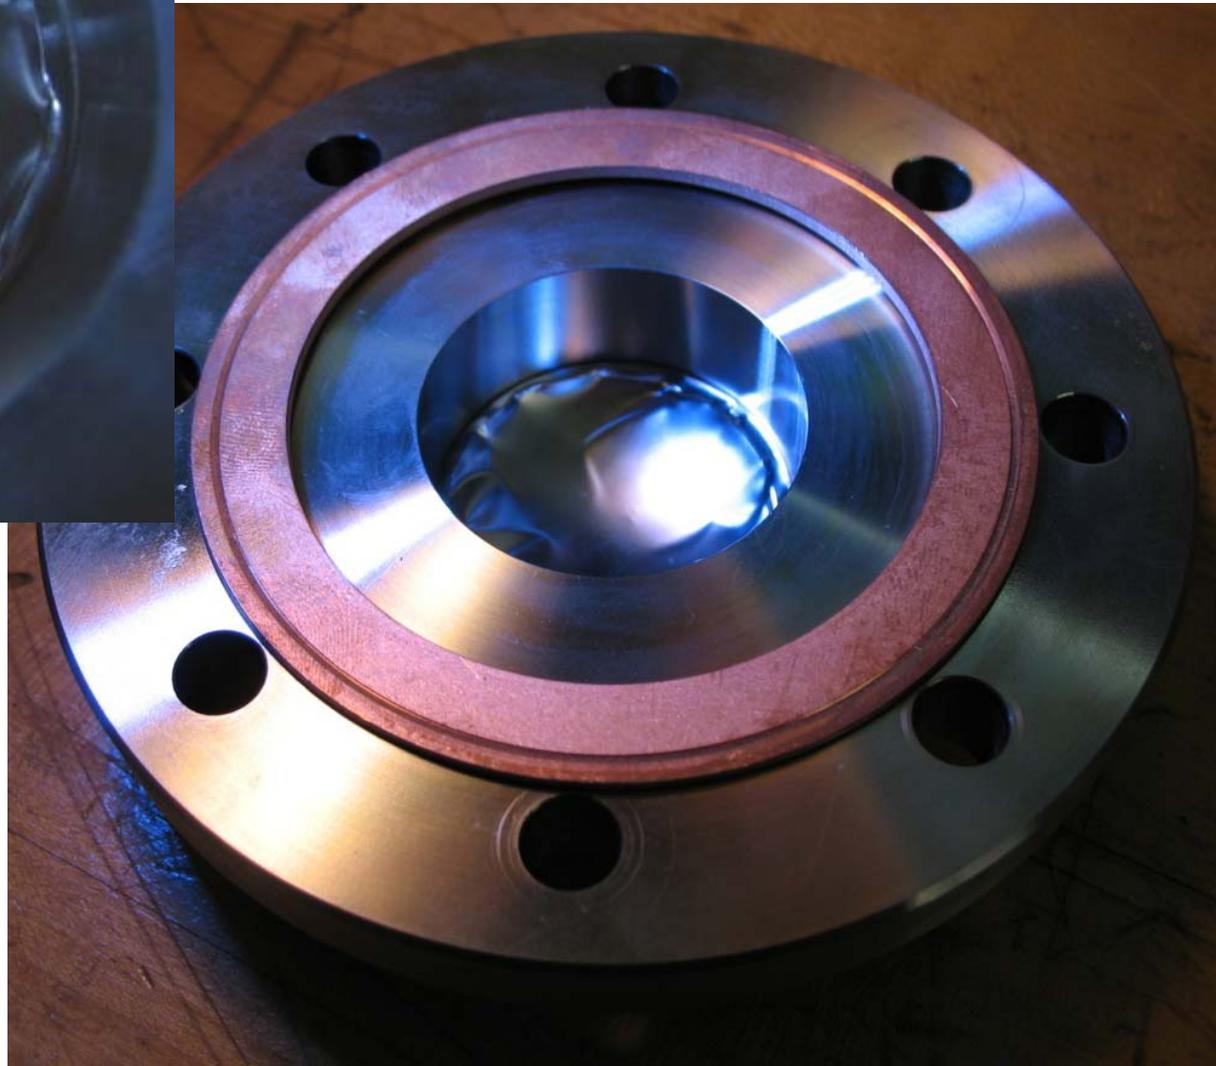
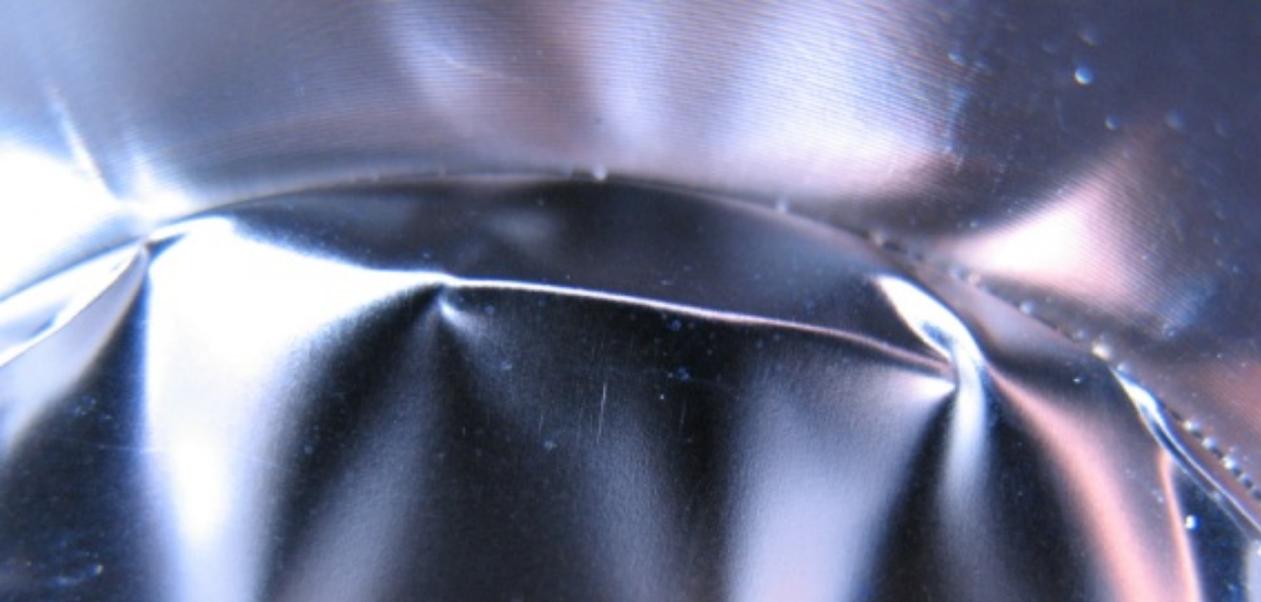
Closeups of the hinge
line under different
lighting conditions.

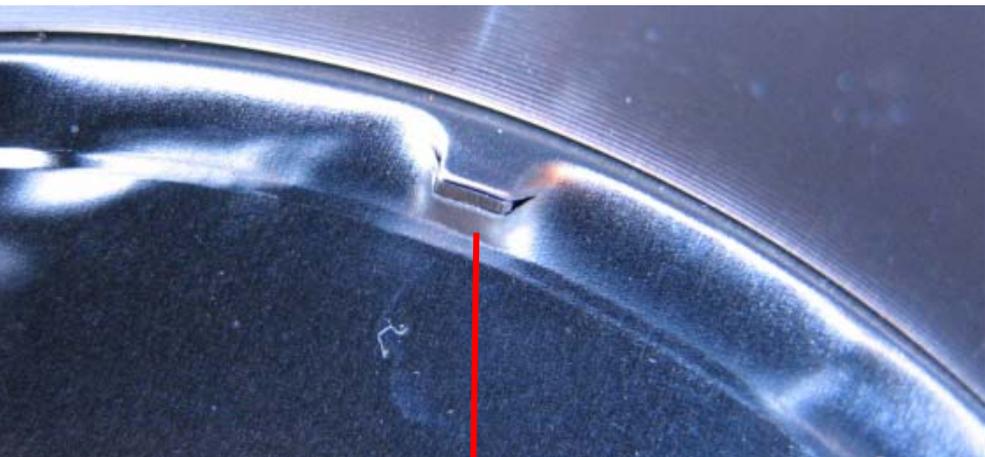
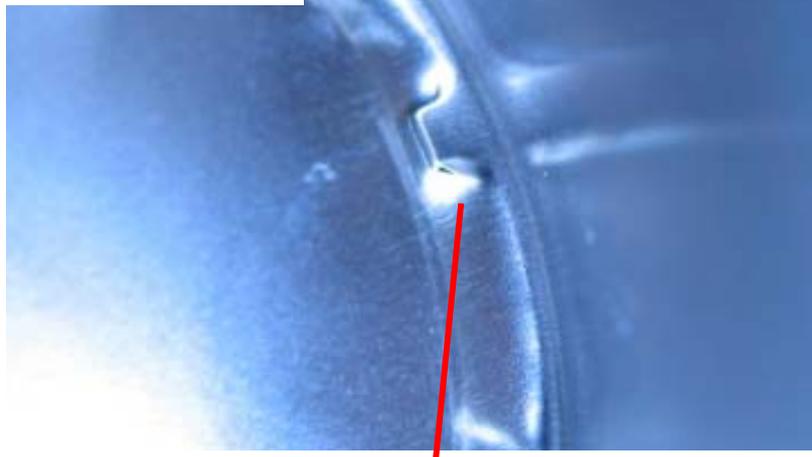
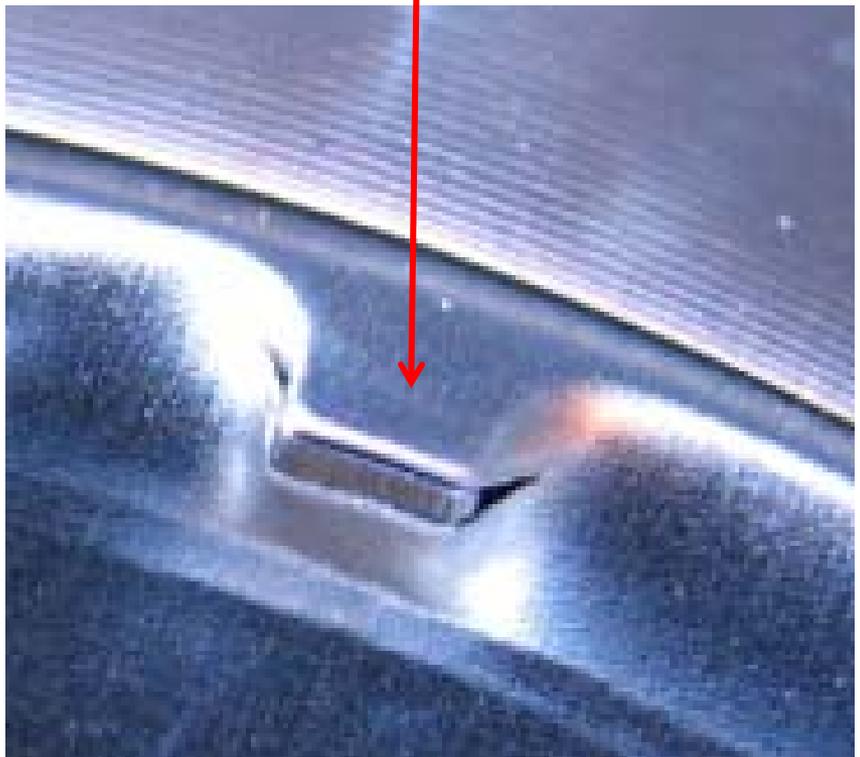
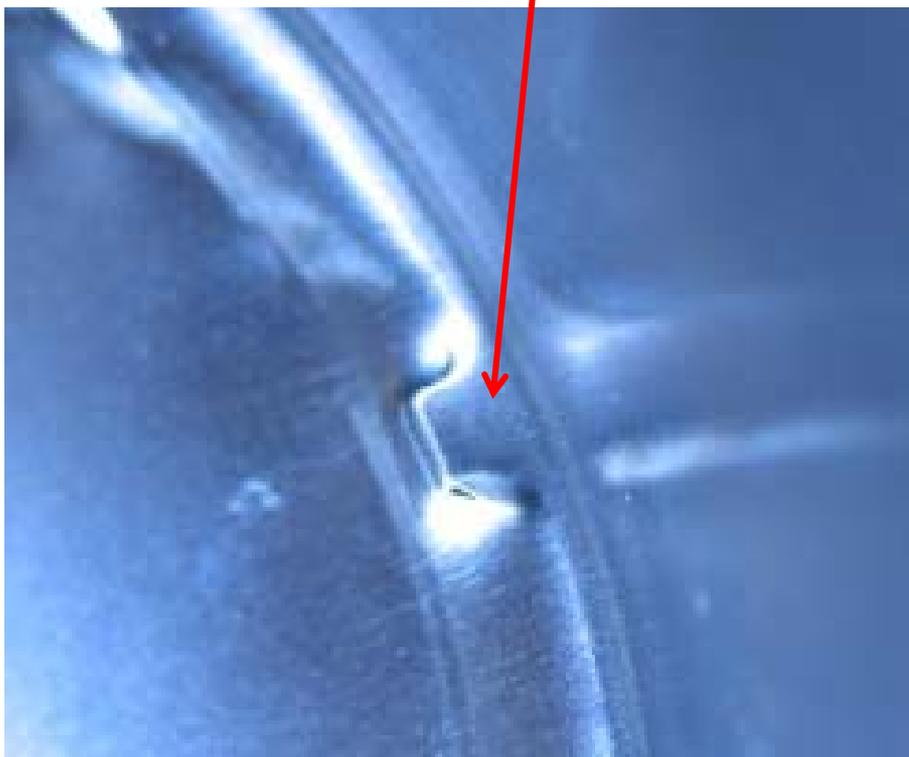
Closeups of tooth penetration of the burst disc membrane on the upstream side. This is where helium leaked into the vacuum space after the membrane reversed.

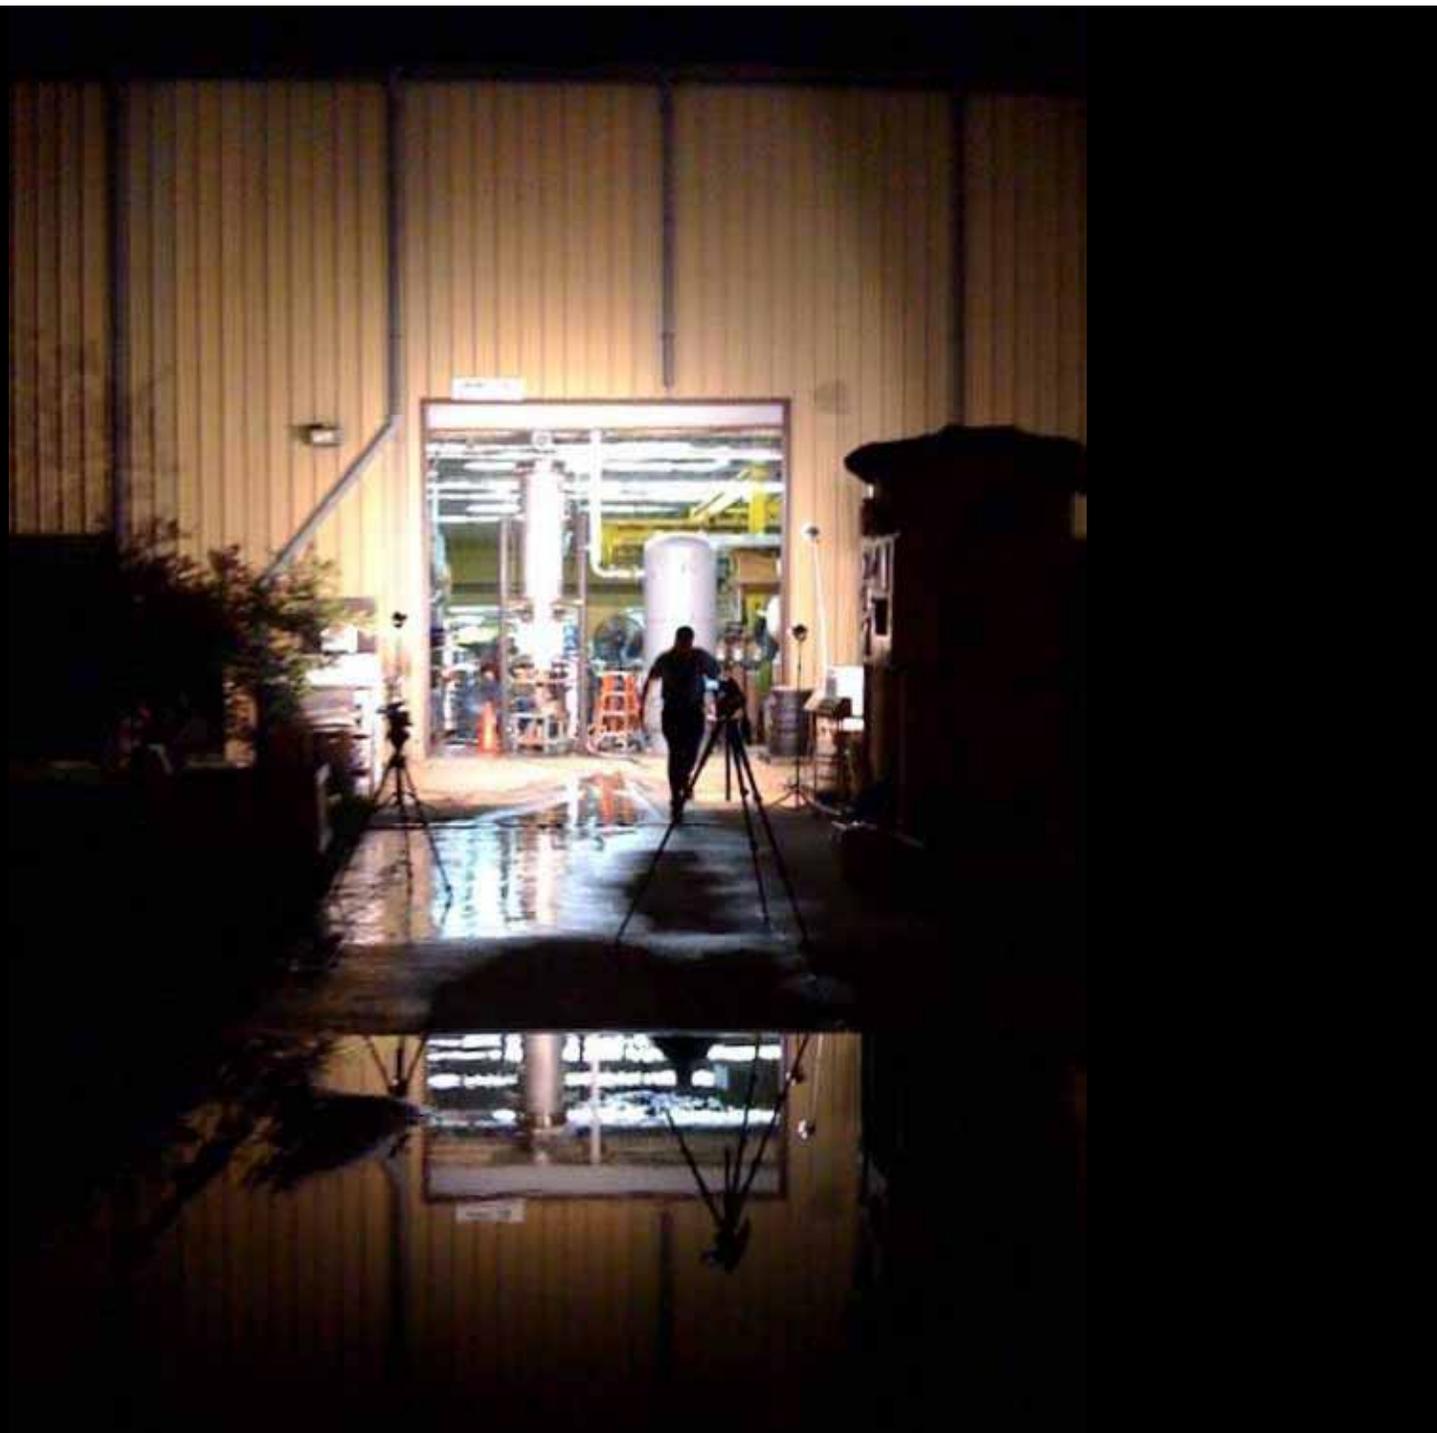
An instant
after rupture

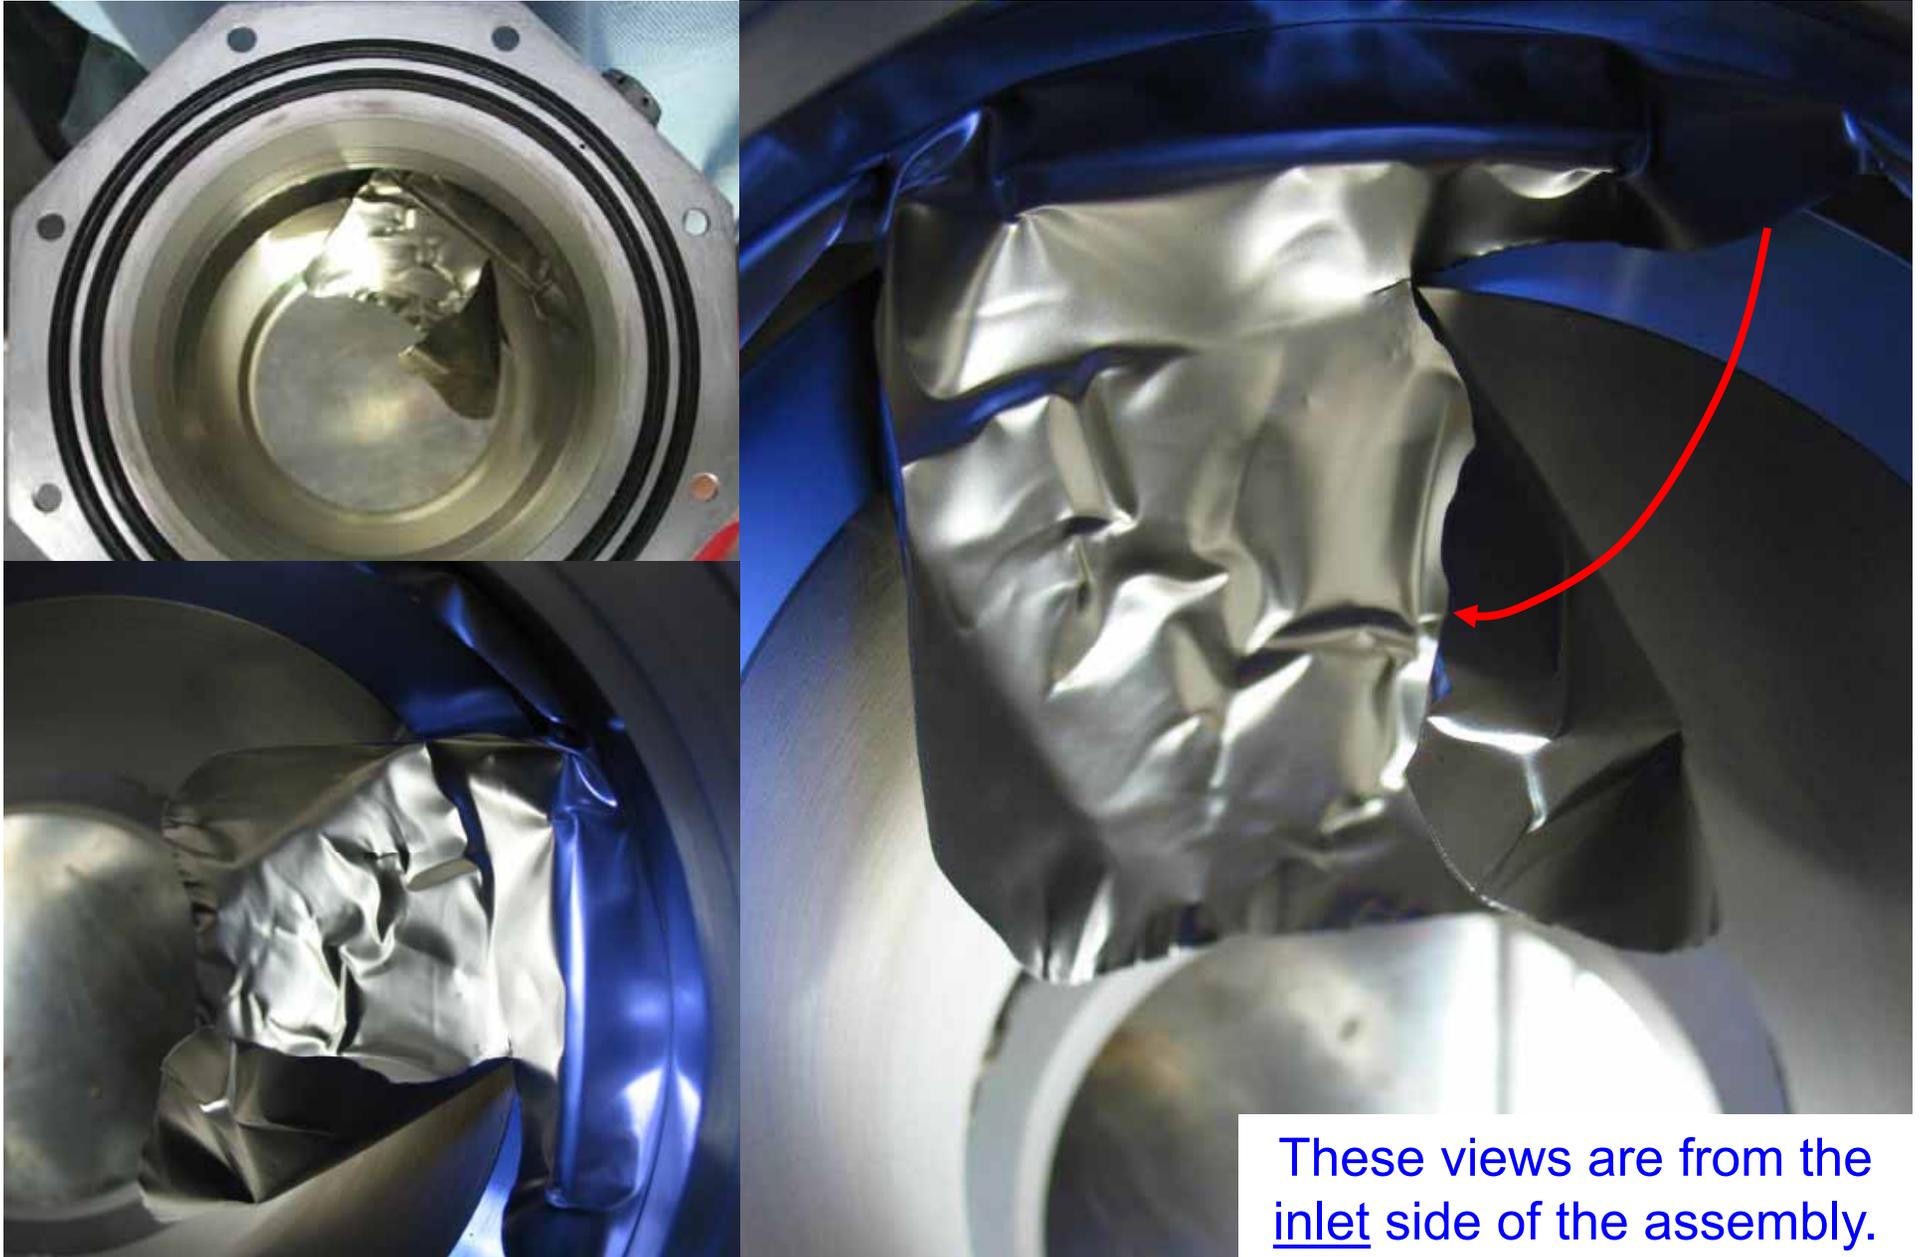
BD06A (from a flight BD07A/B) performed well. The membrane was still in the housing though it had torn along a significant portion of the hinge line.

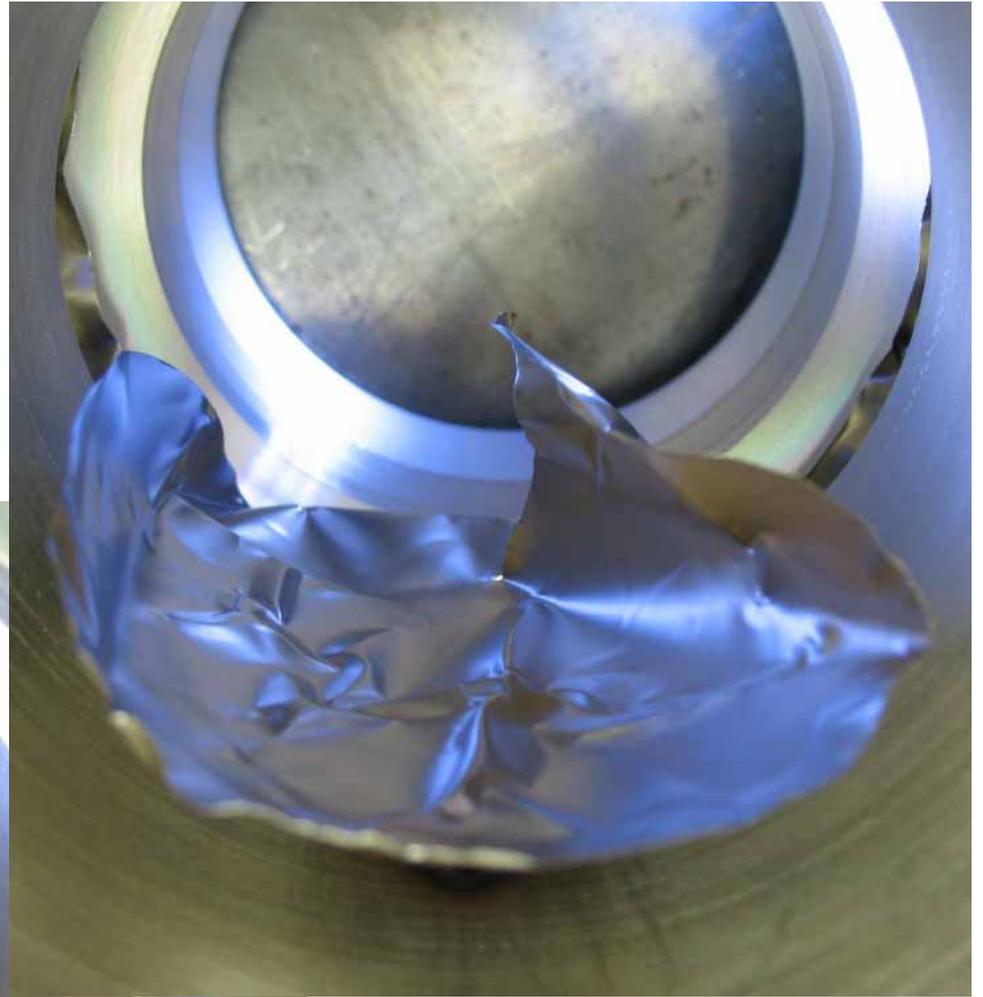
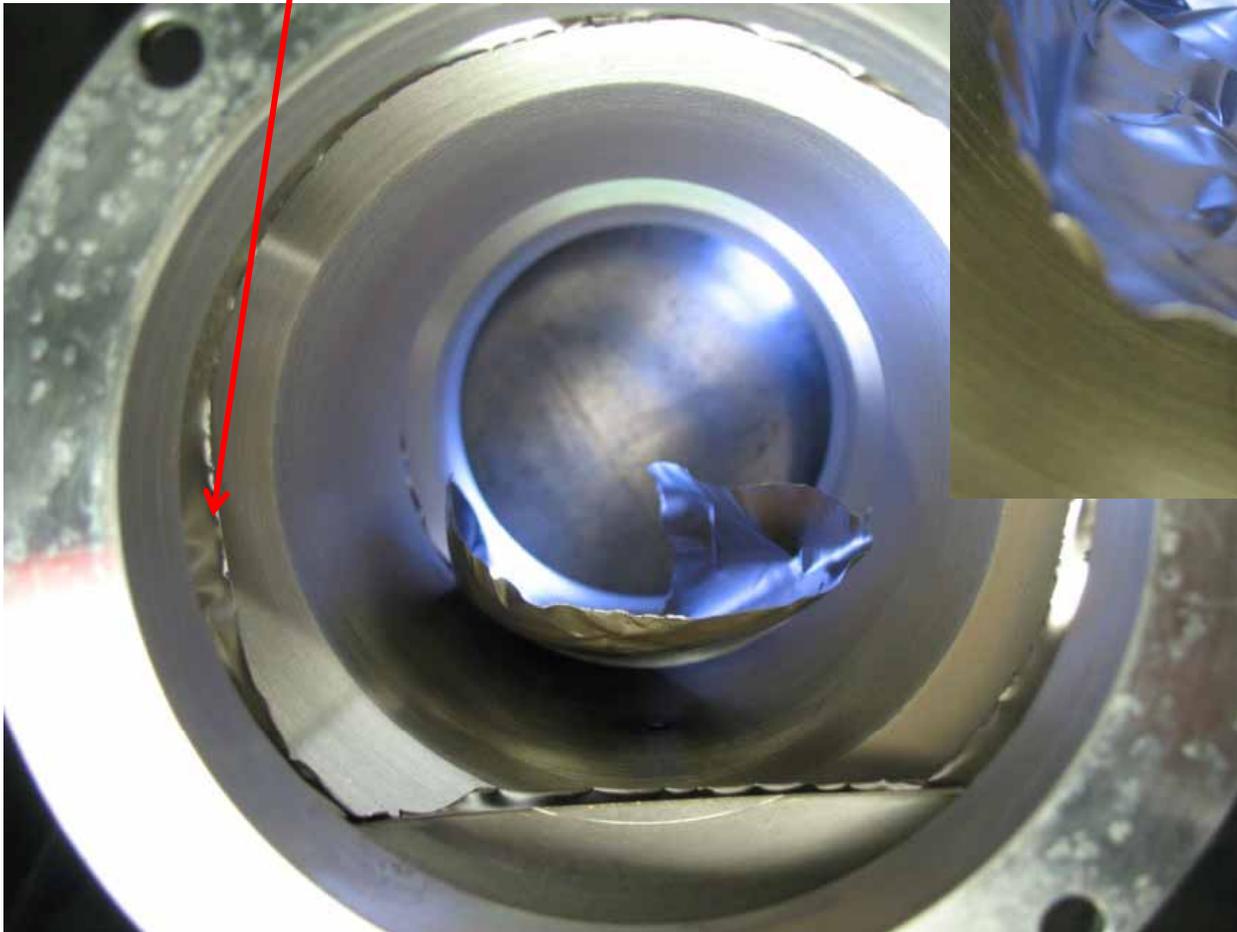
These views are from the inlet side of the assembly.

This is the BD07B disc that was cut out with an X-acto knife prior to installation.

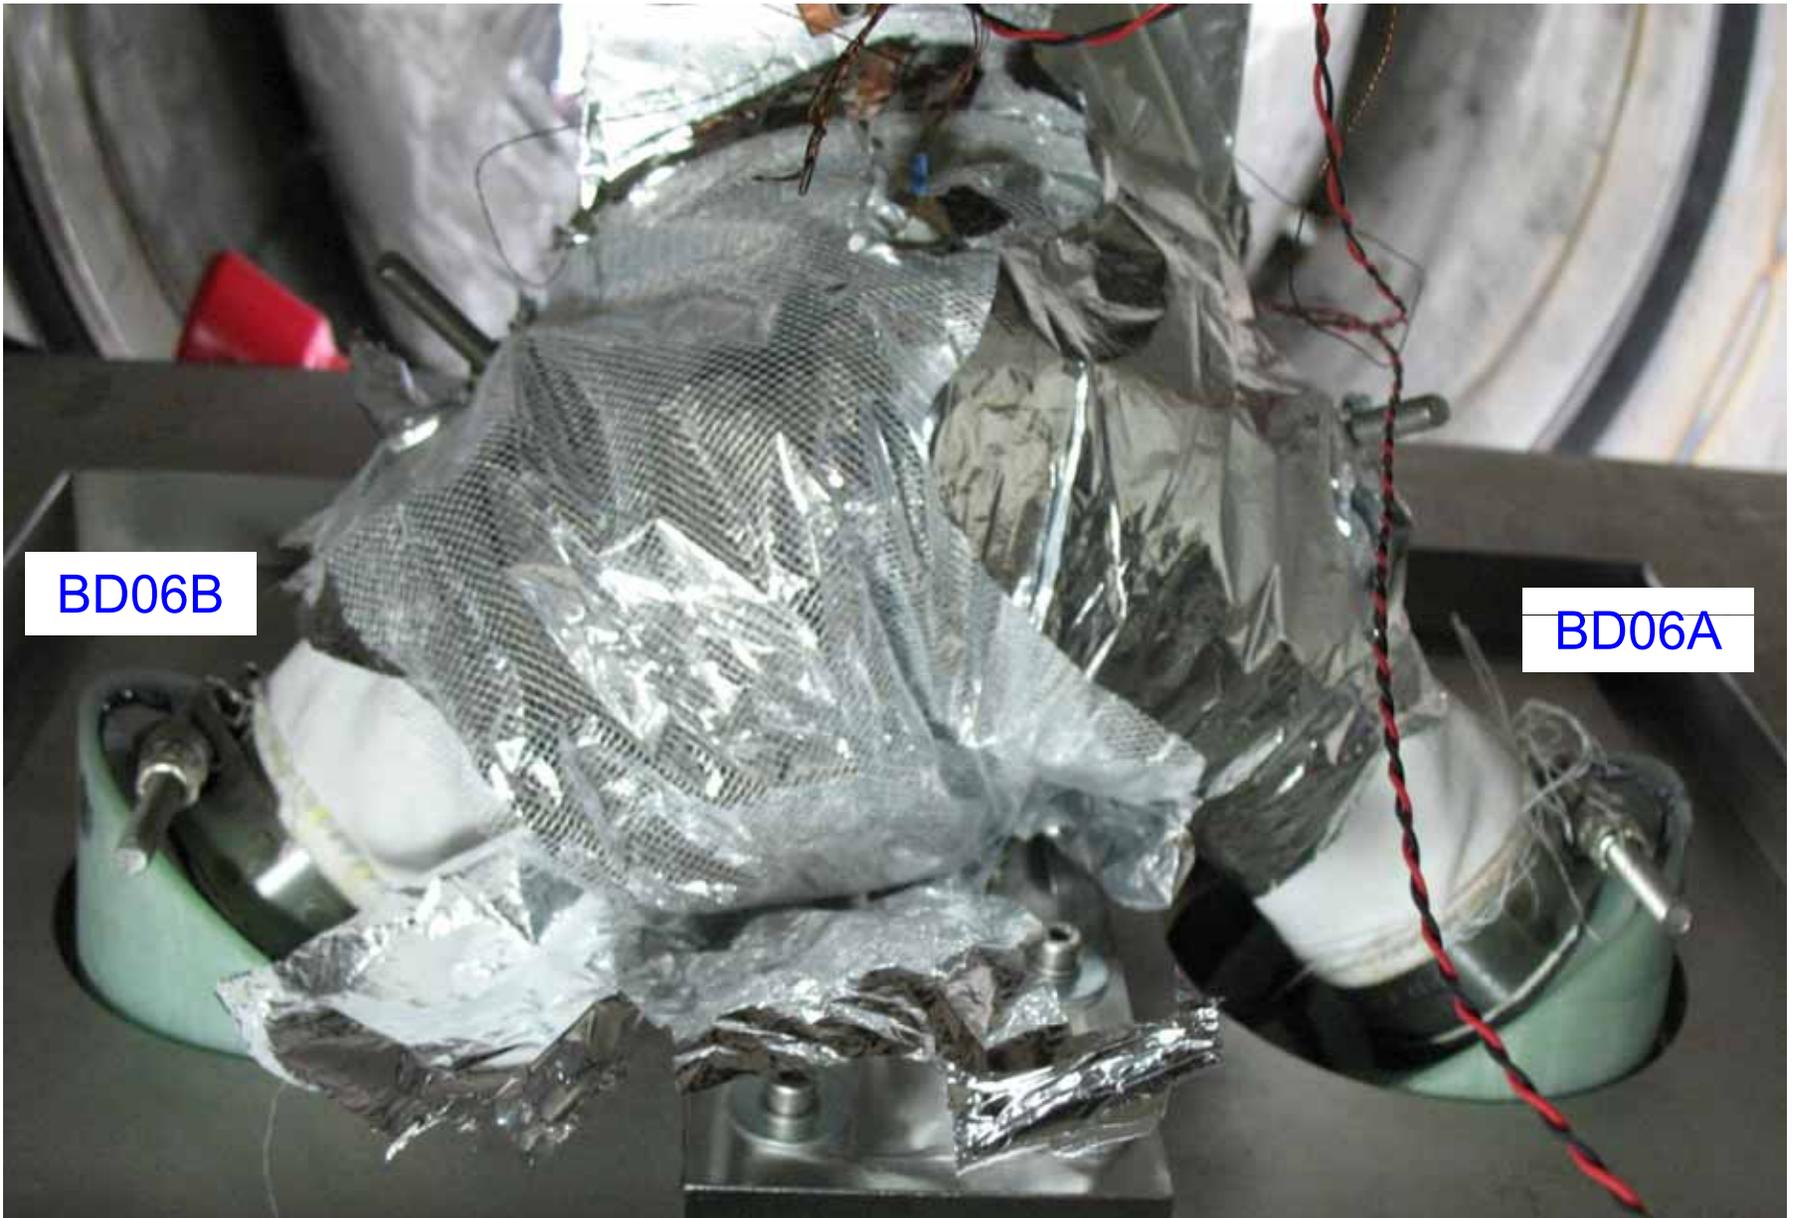
These views are from the outlet side of the BD06A assembly.

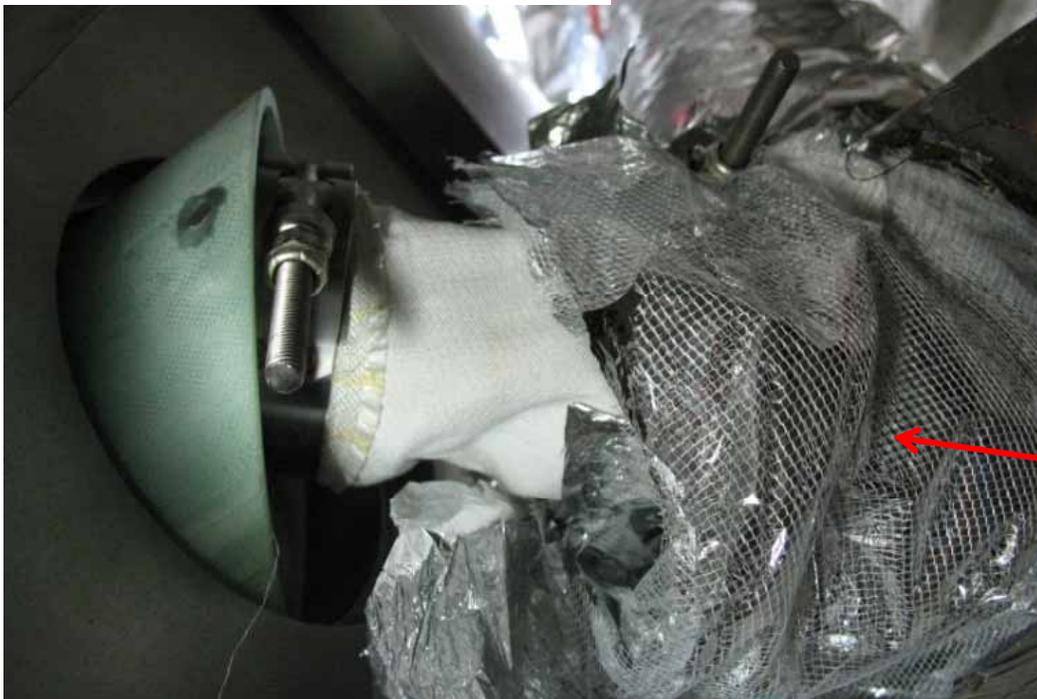
The cryostat was allowed to warm up over night with warm air blowing through the vacuum space. Part of one layer of MLI on the B side of the ductwork was damaged. The A side appeared relatively intact

MLI damage on B side

One layer of superinsulation was missing in this area.
