National Aeronautics and
Space Administration

November 17, 2009

SUBJECT: AMS Burst Disk Vent Duct Redesign and Certification

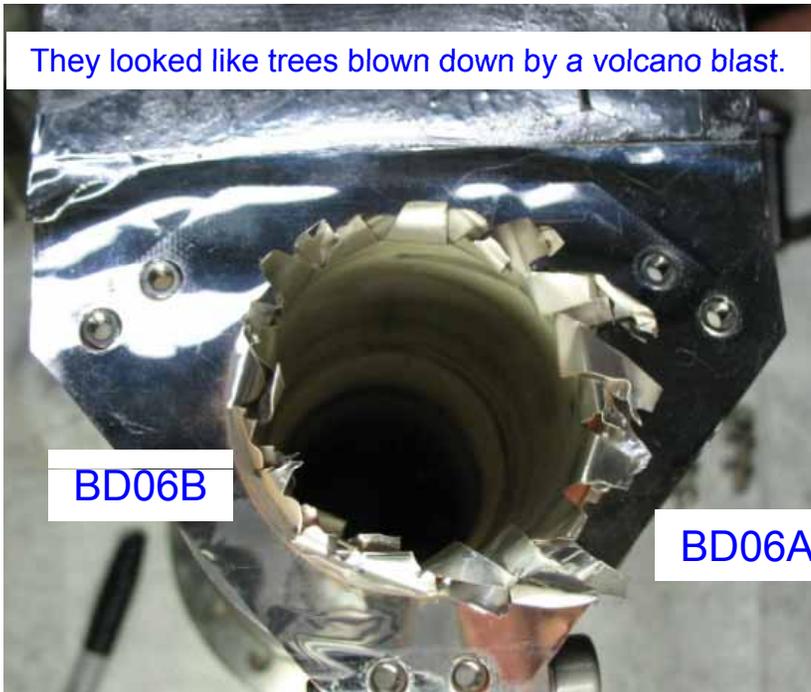
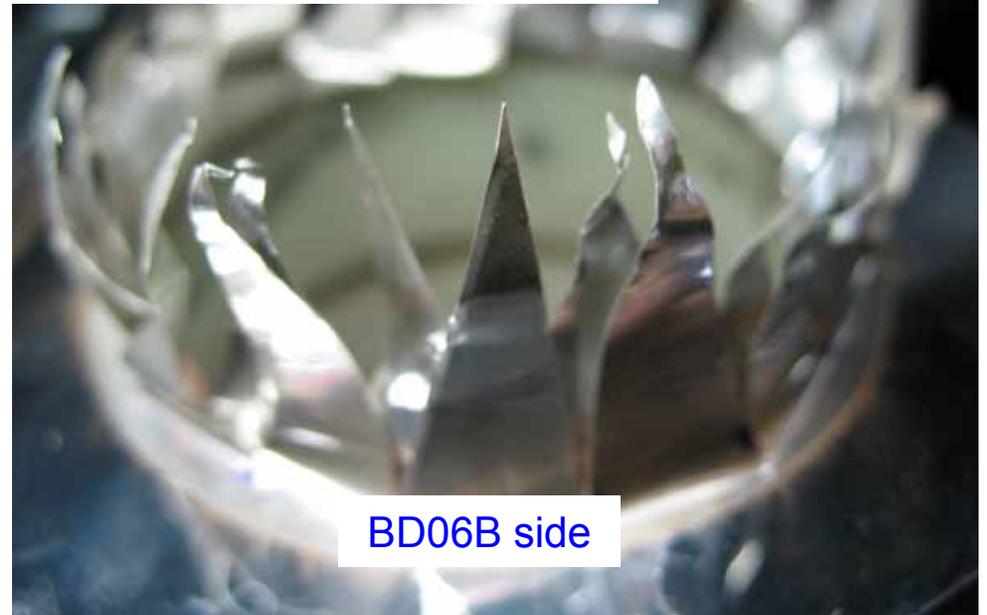
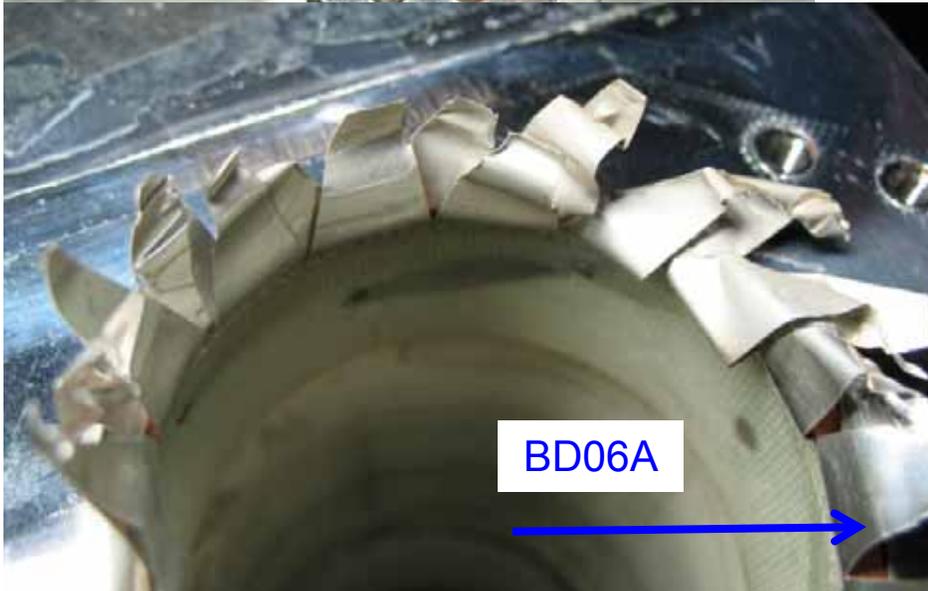
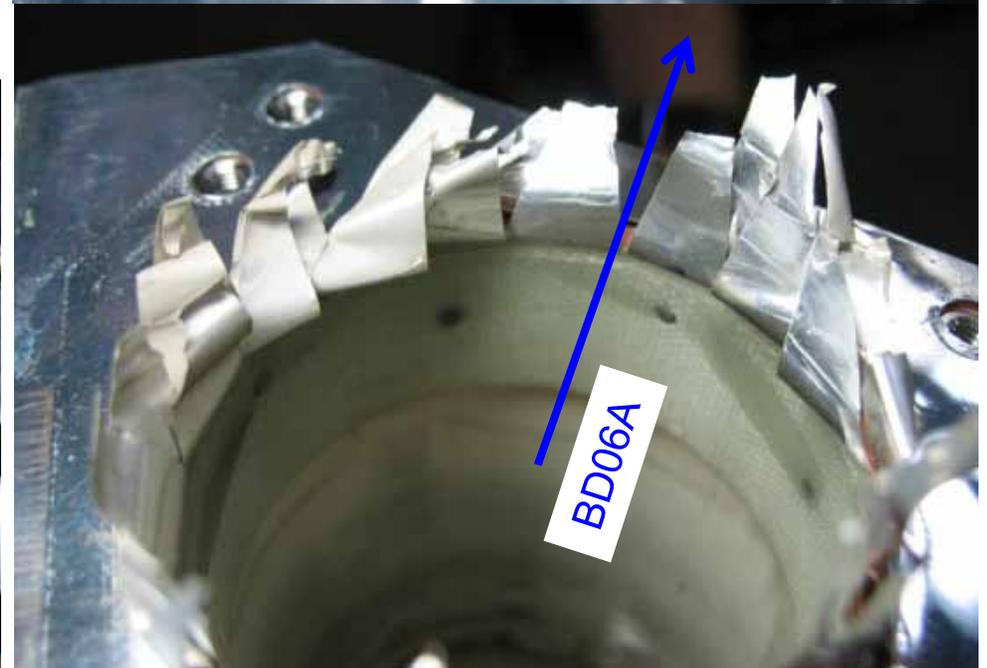
Some tips of the radiation shield near the BD06A exit were sheared off while most of the others around the circle were intact.

They looked like trees blown down by a volcano blast.

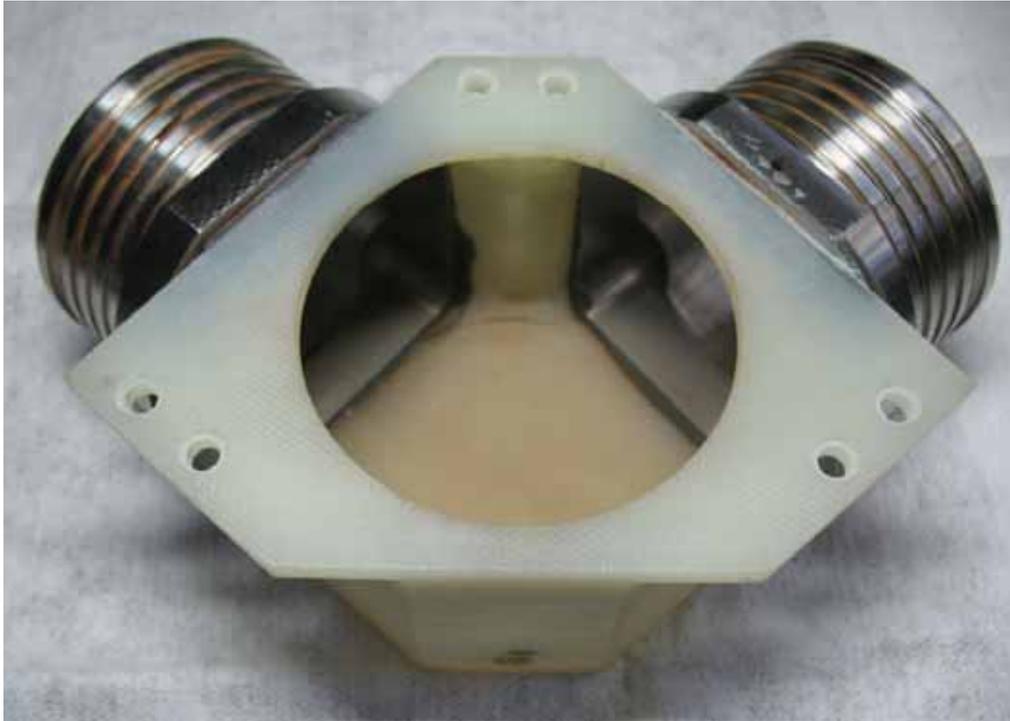
The Tee Box
appeared unaffected.

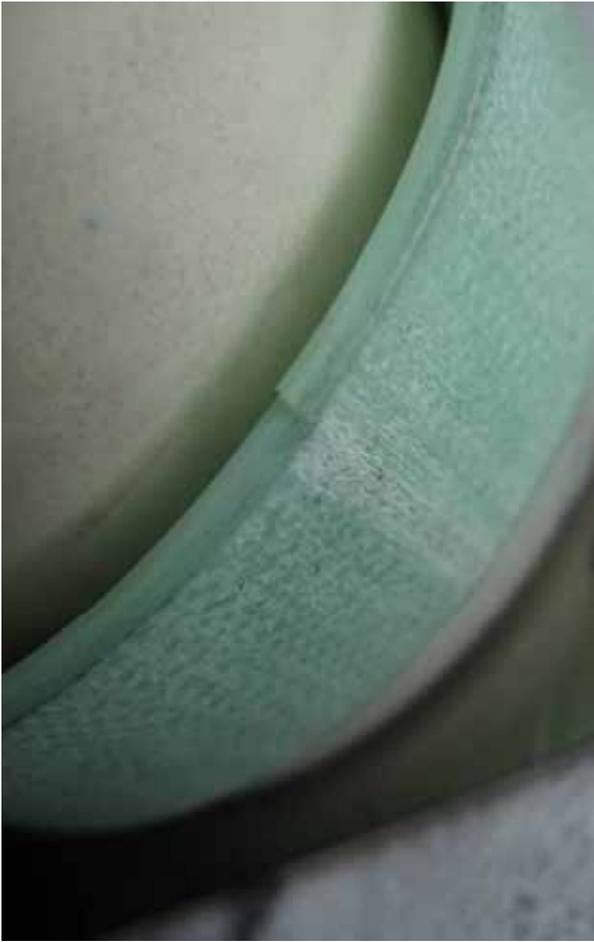
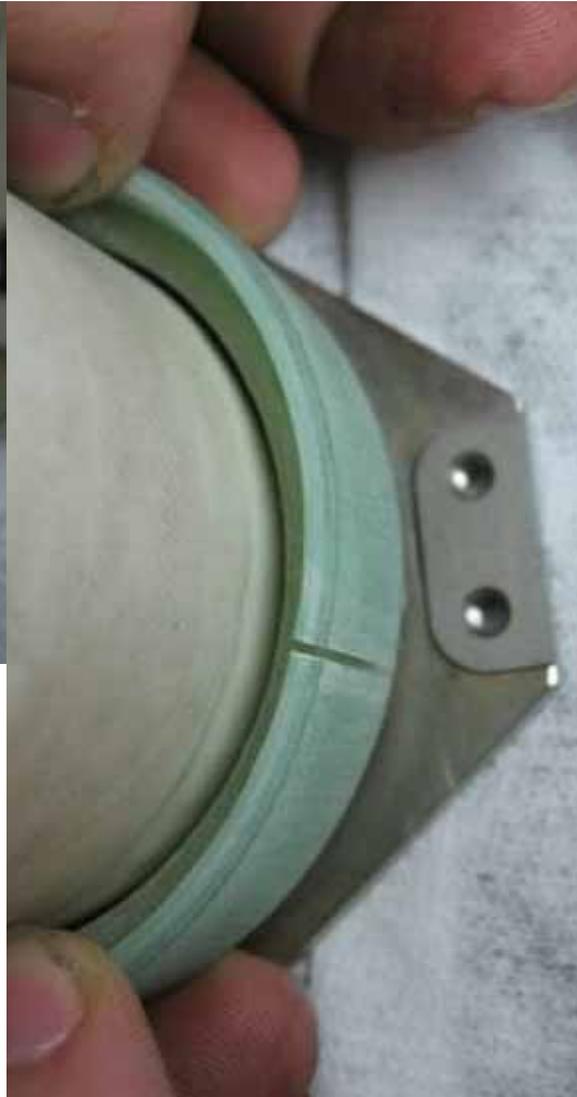
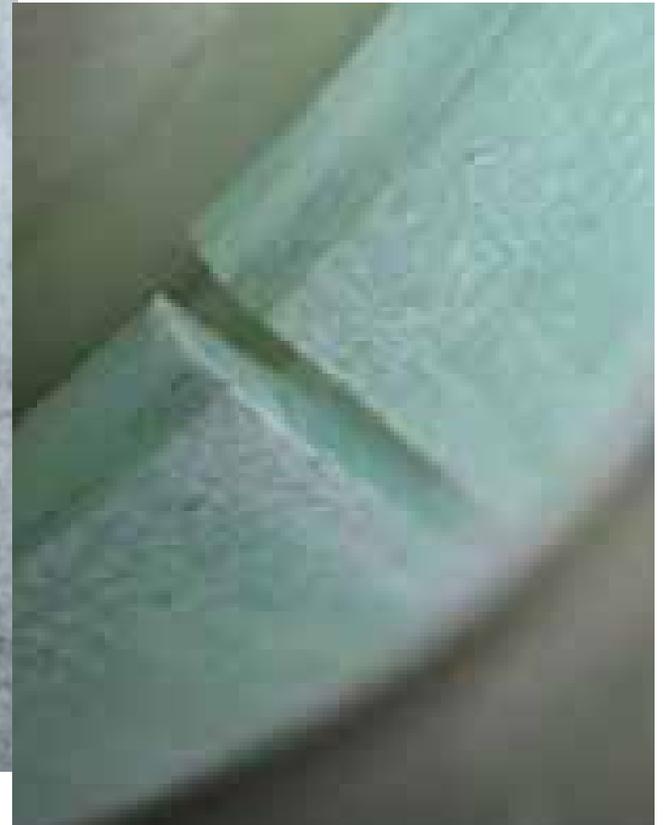
The BD06A Flexible Tube ortho-fabric looked fine. However, the PTFE had a significant tear and a large hole was apparent. This is where the majority of the helium went from the helium vessel to the vacuum space.

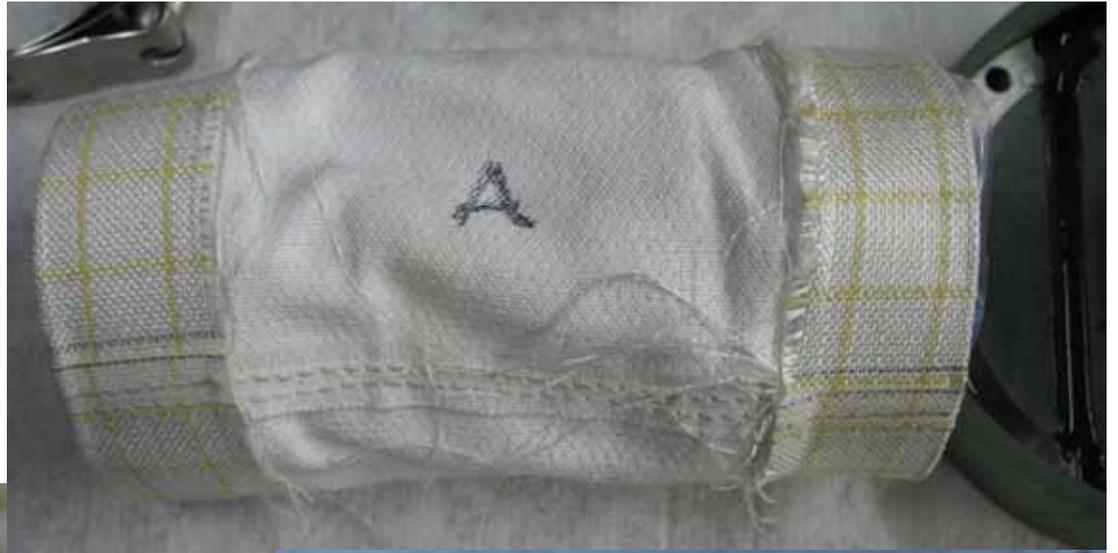
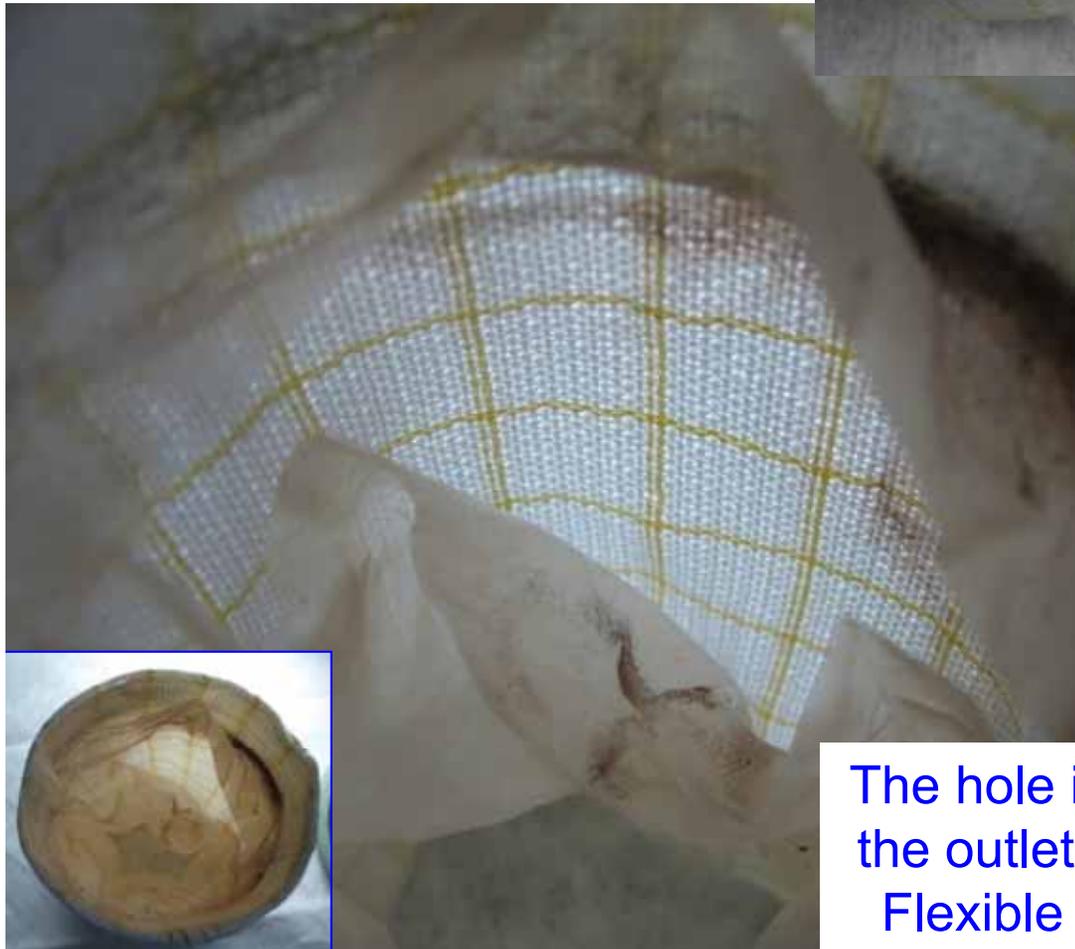
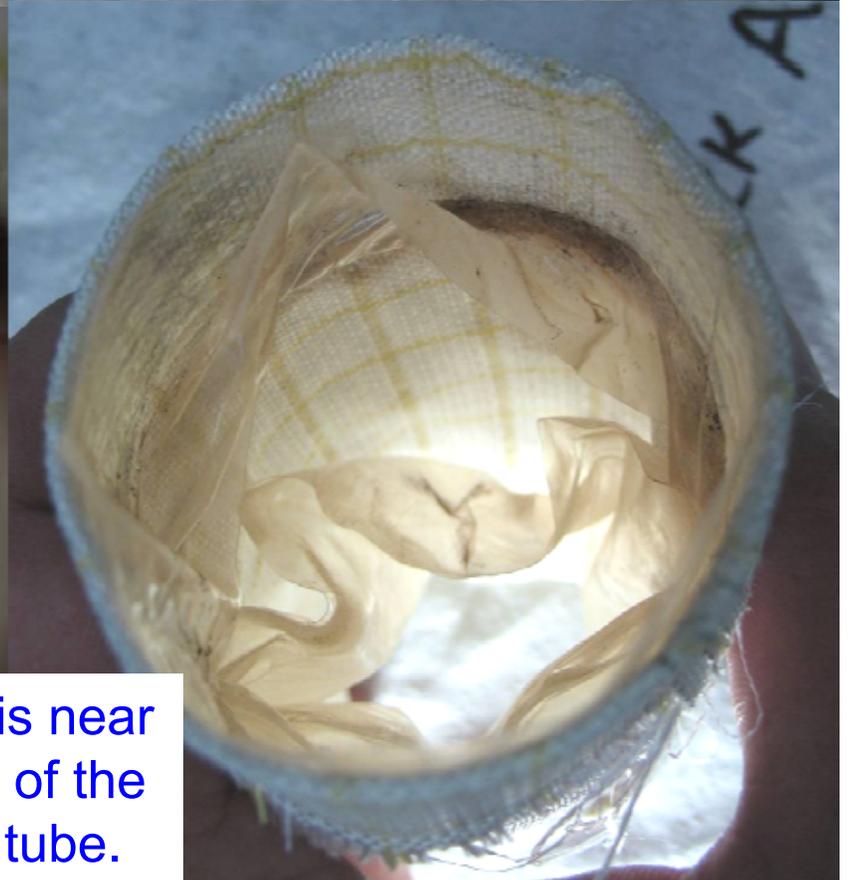
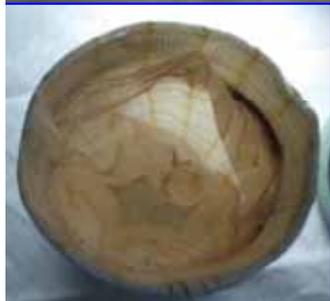
The hole is near the outlet of the Flexible tube.

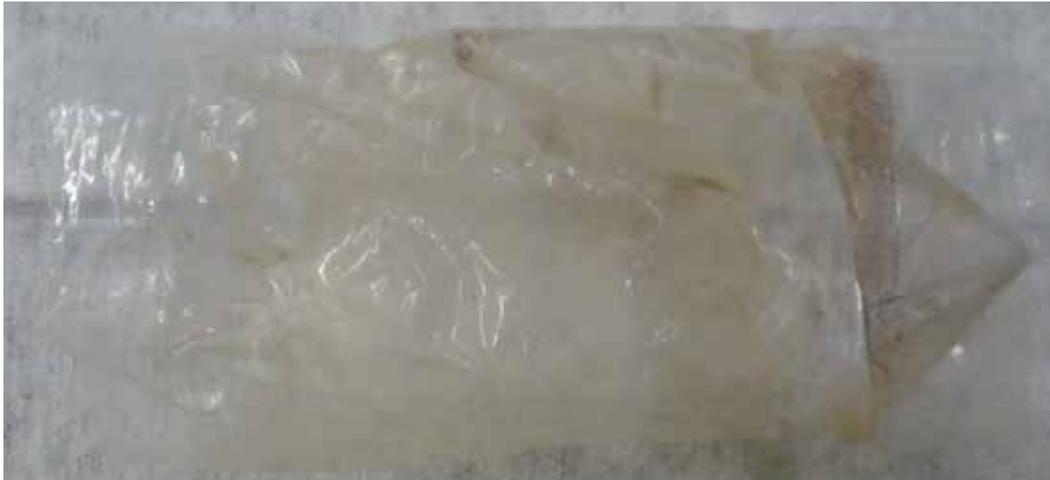
PTFE liner removed from the ortho-fabric flexible tube on side A

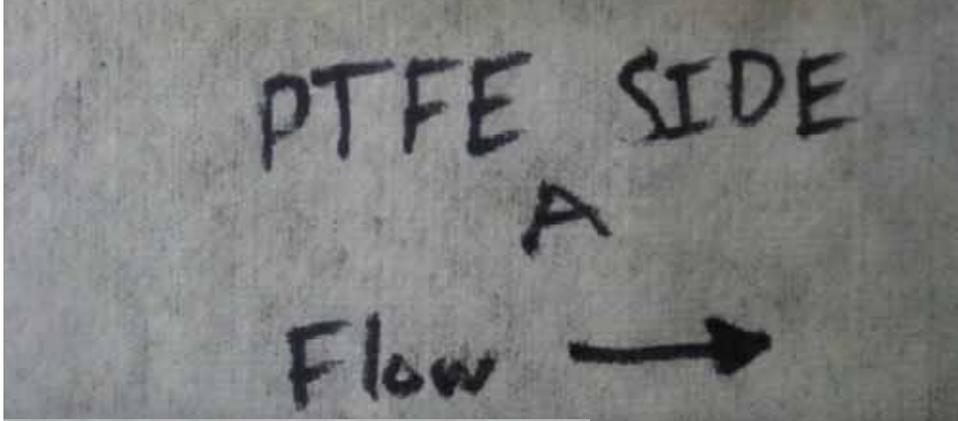
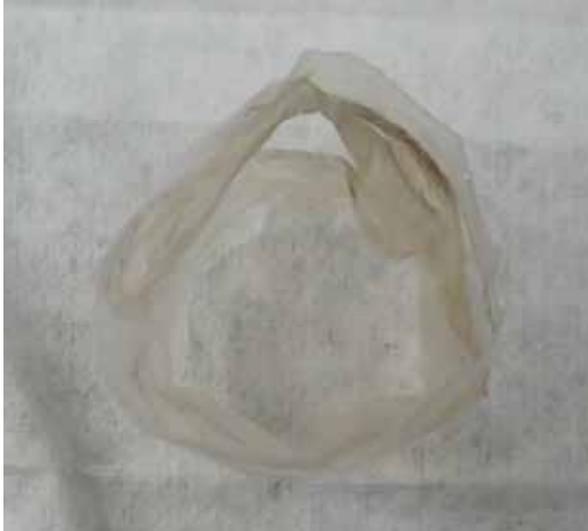
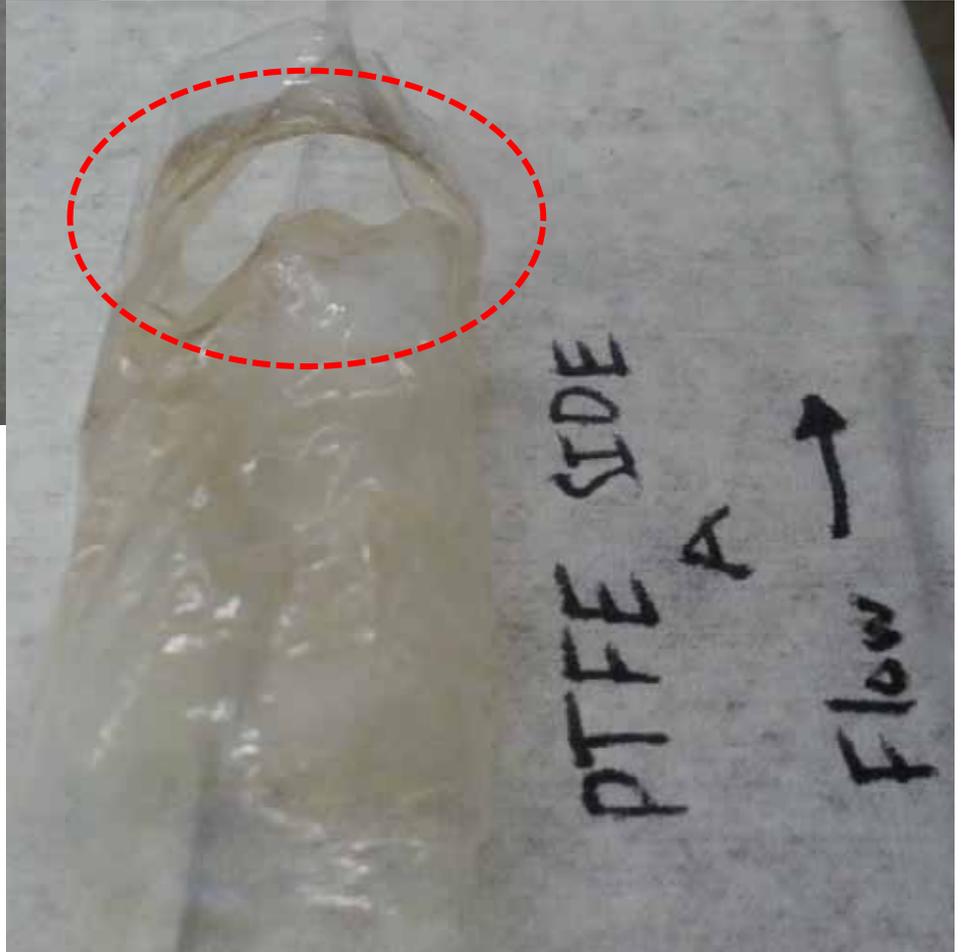
The BD06B Flexible Tube ortho-fabric also looked fine and the PTFE liner was intact.

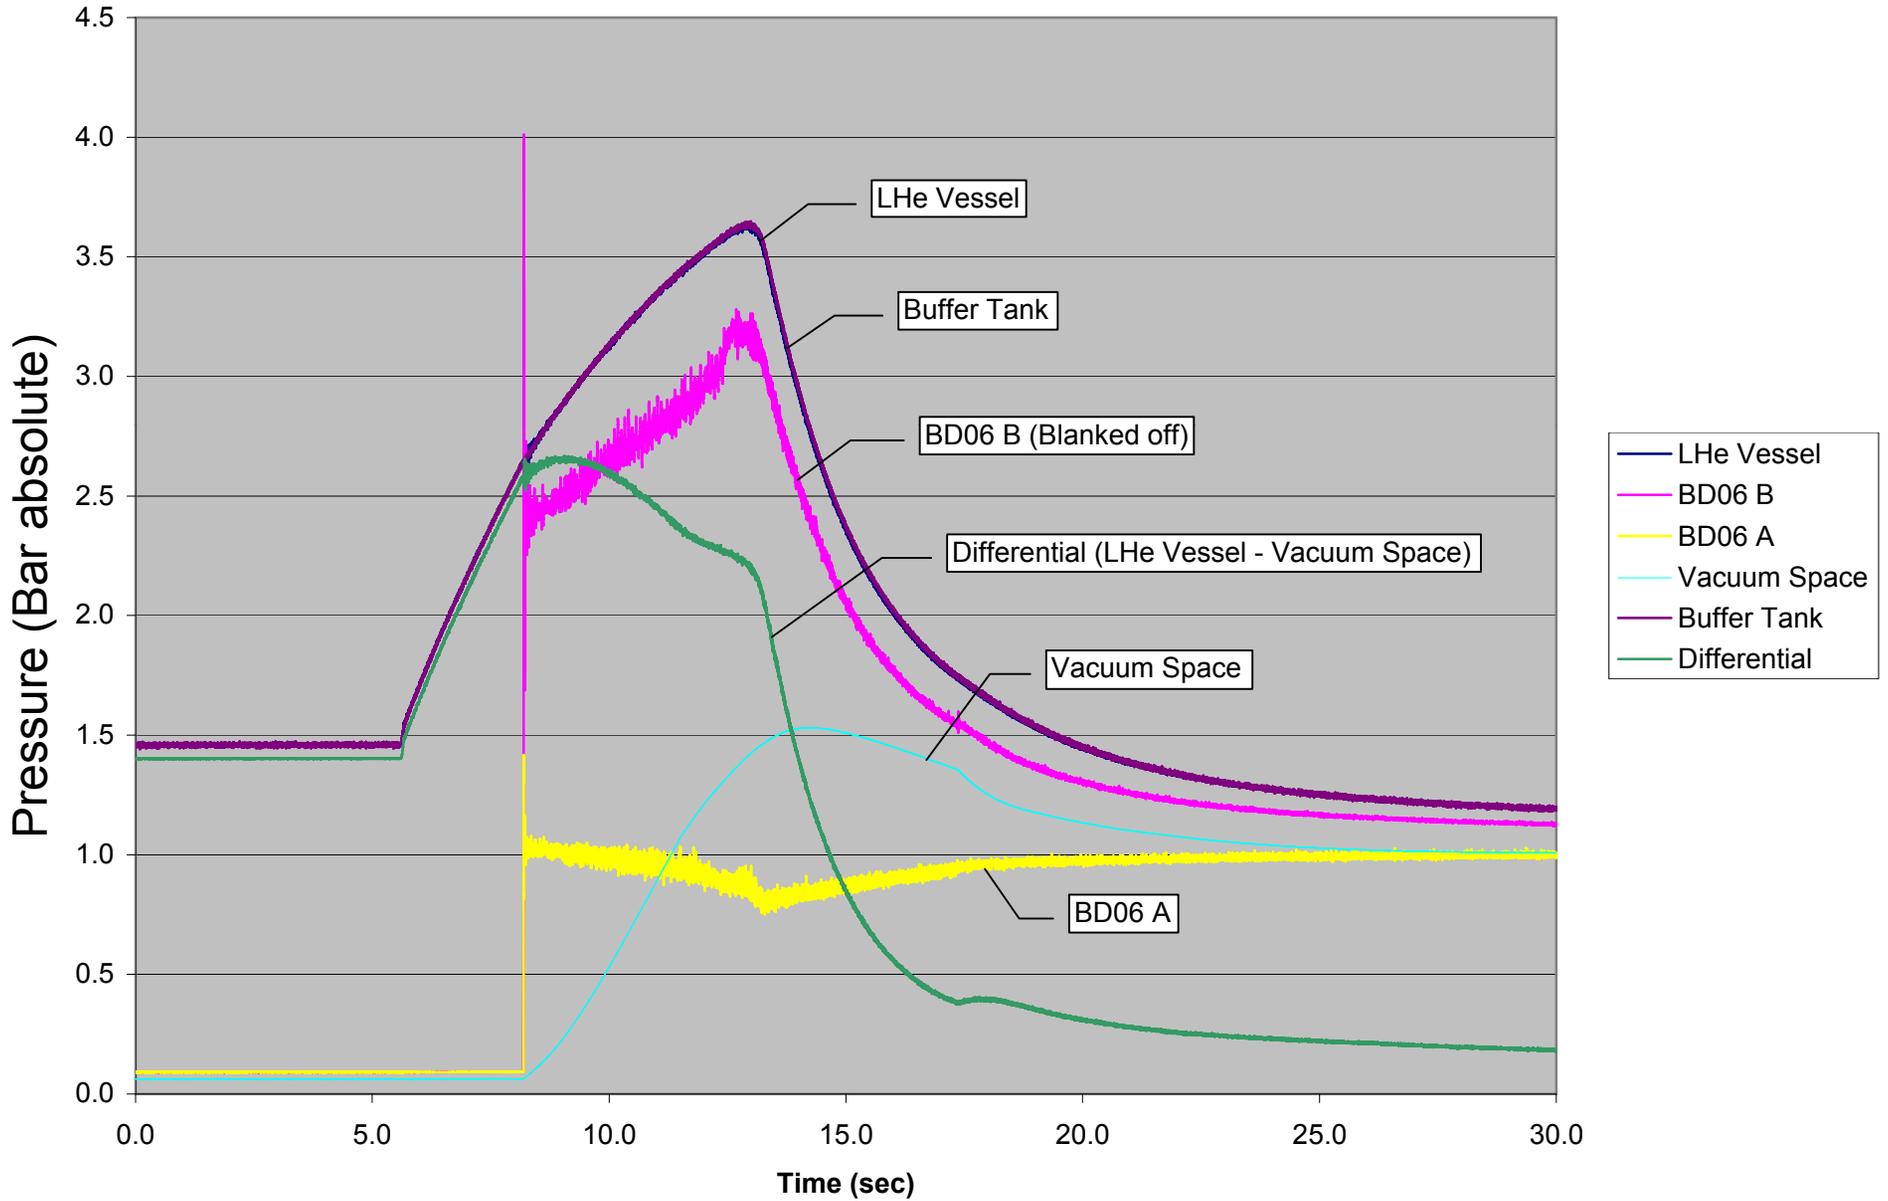
Burst Disc Test #6 Preliminary data

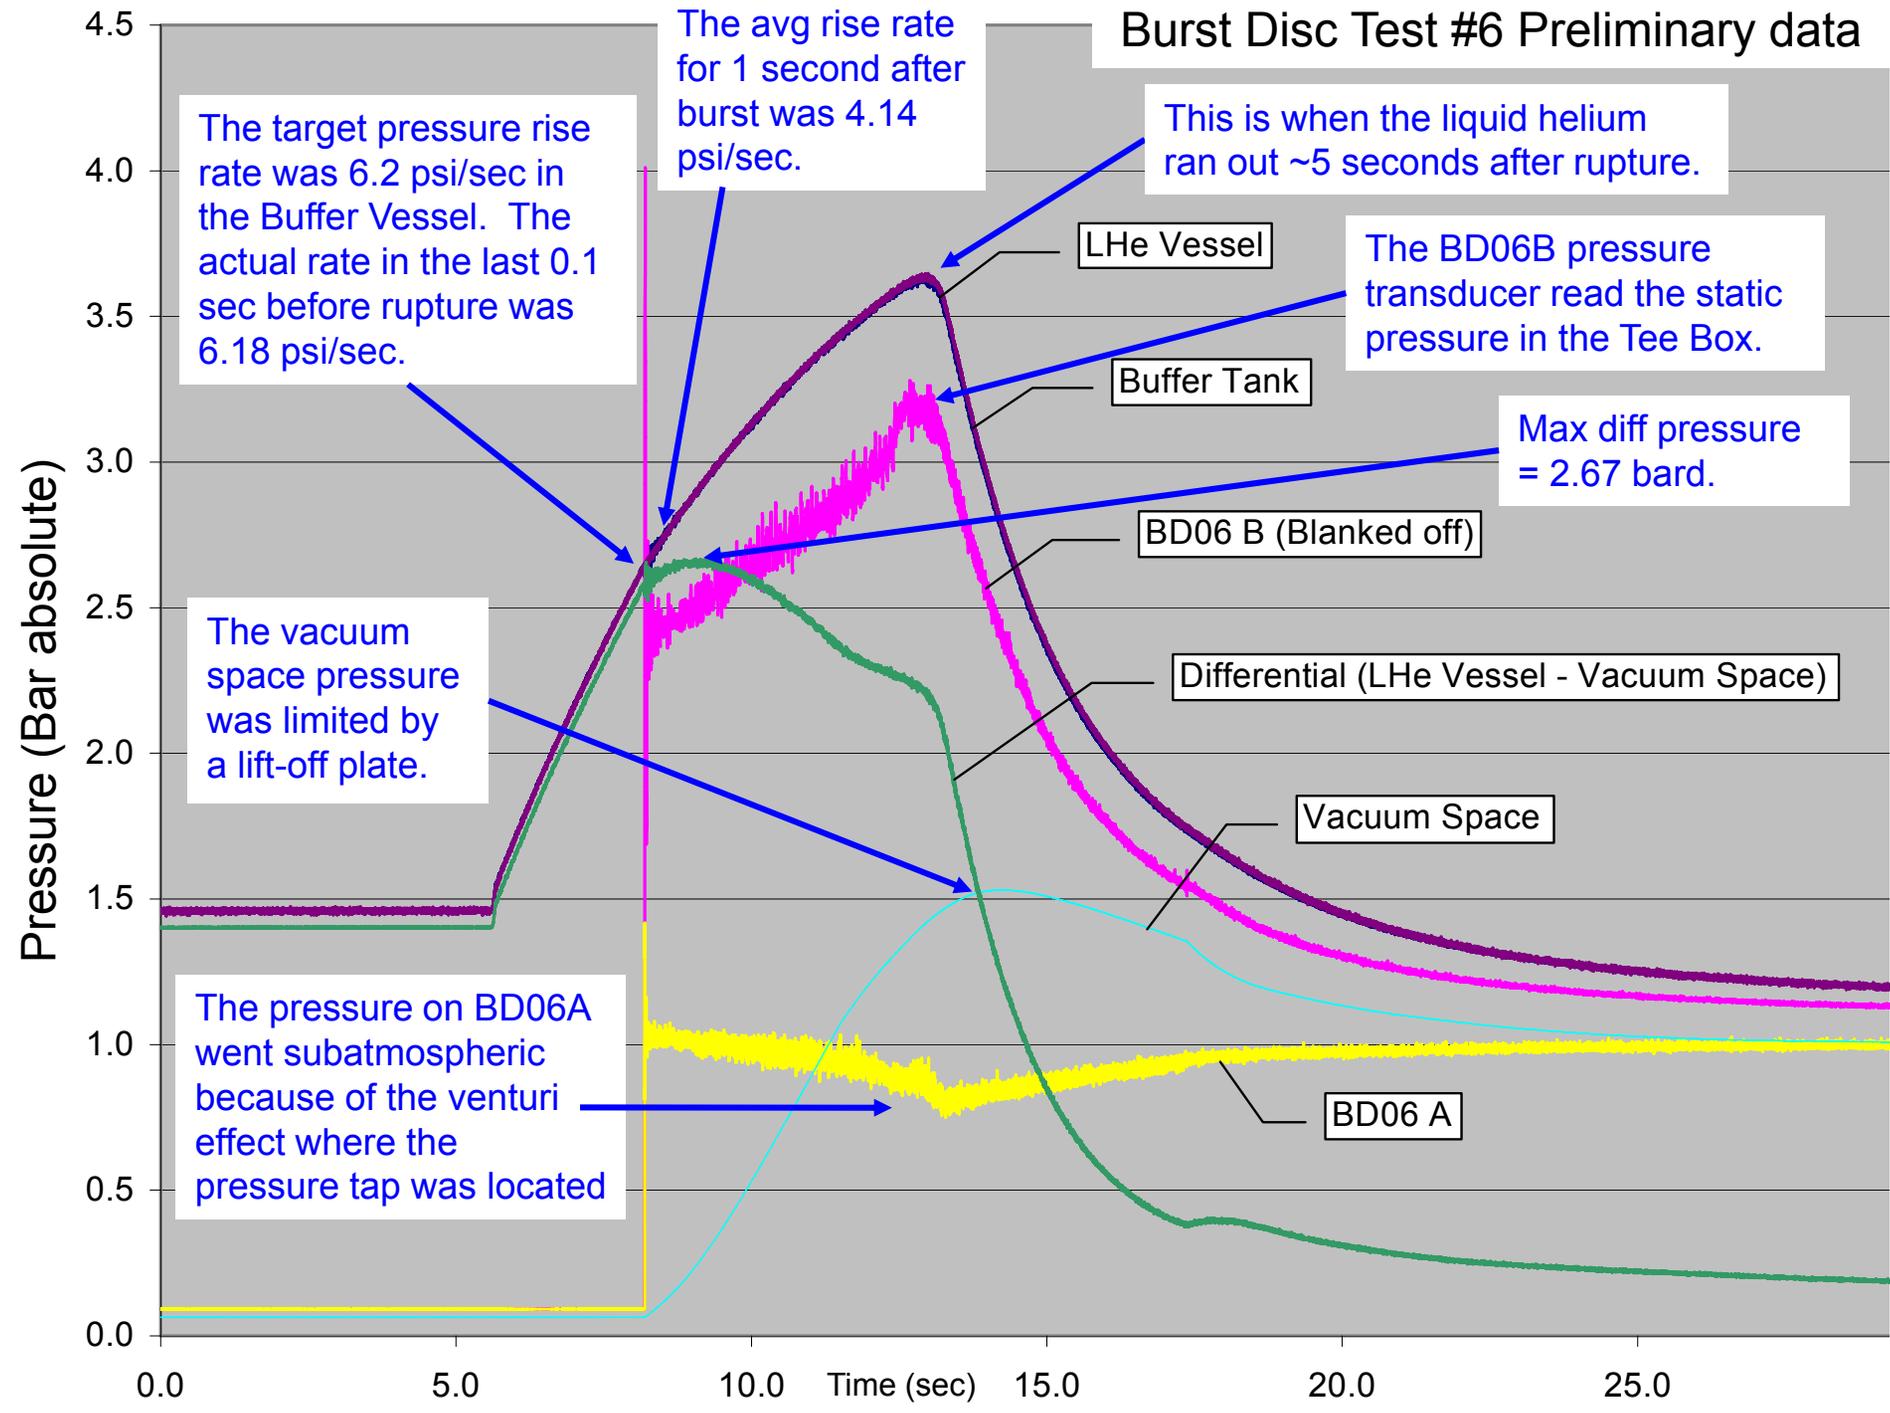
Burst Disc Test #6 Preliminary data

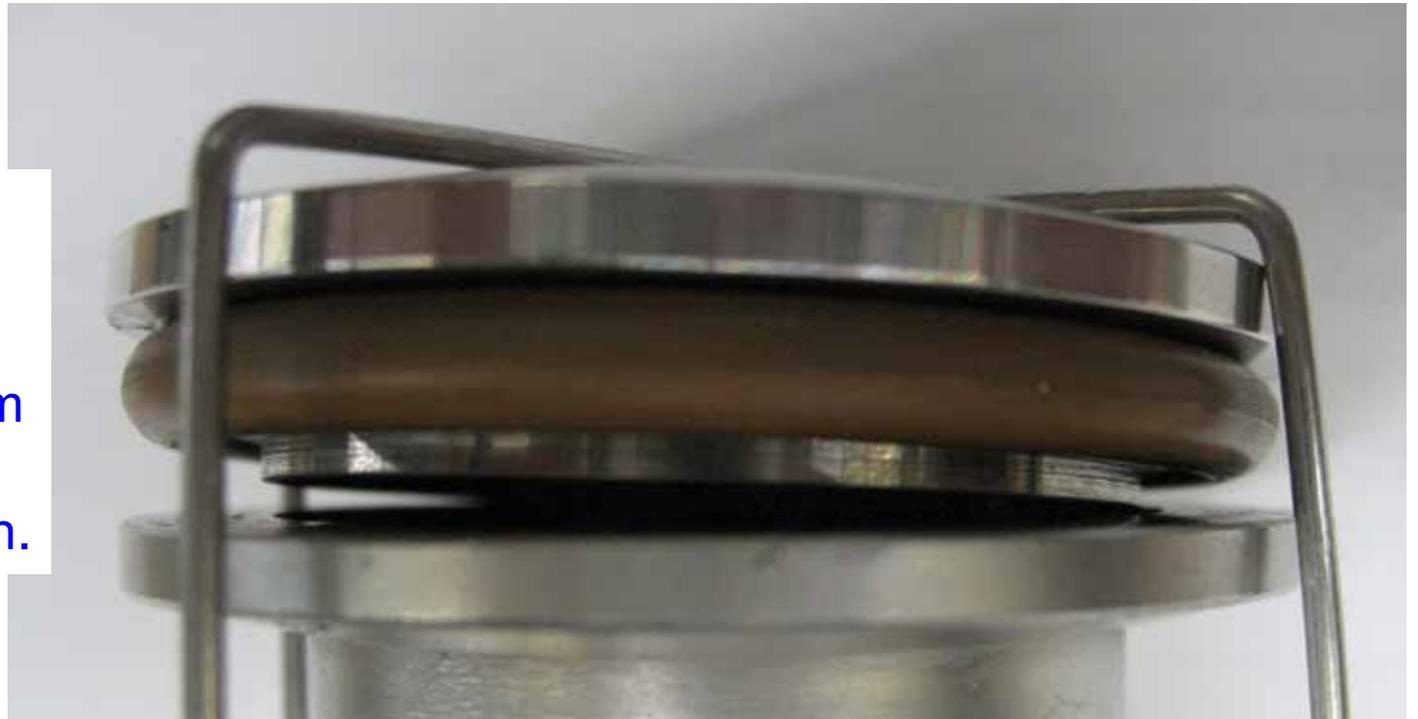
The lift-off plate installed on the vacuum space limited the maximum pressure it would have otherwise seen.

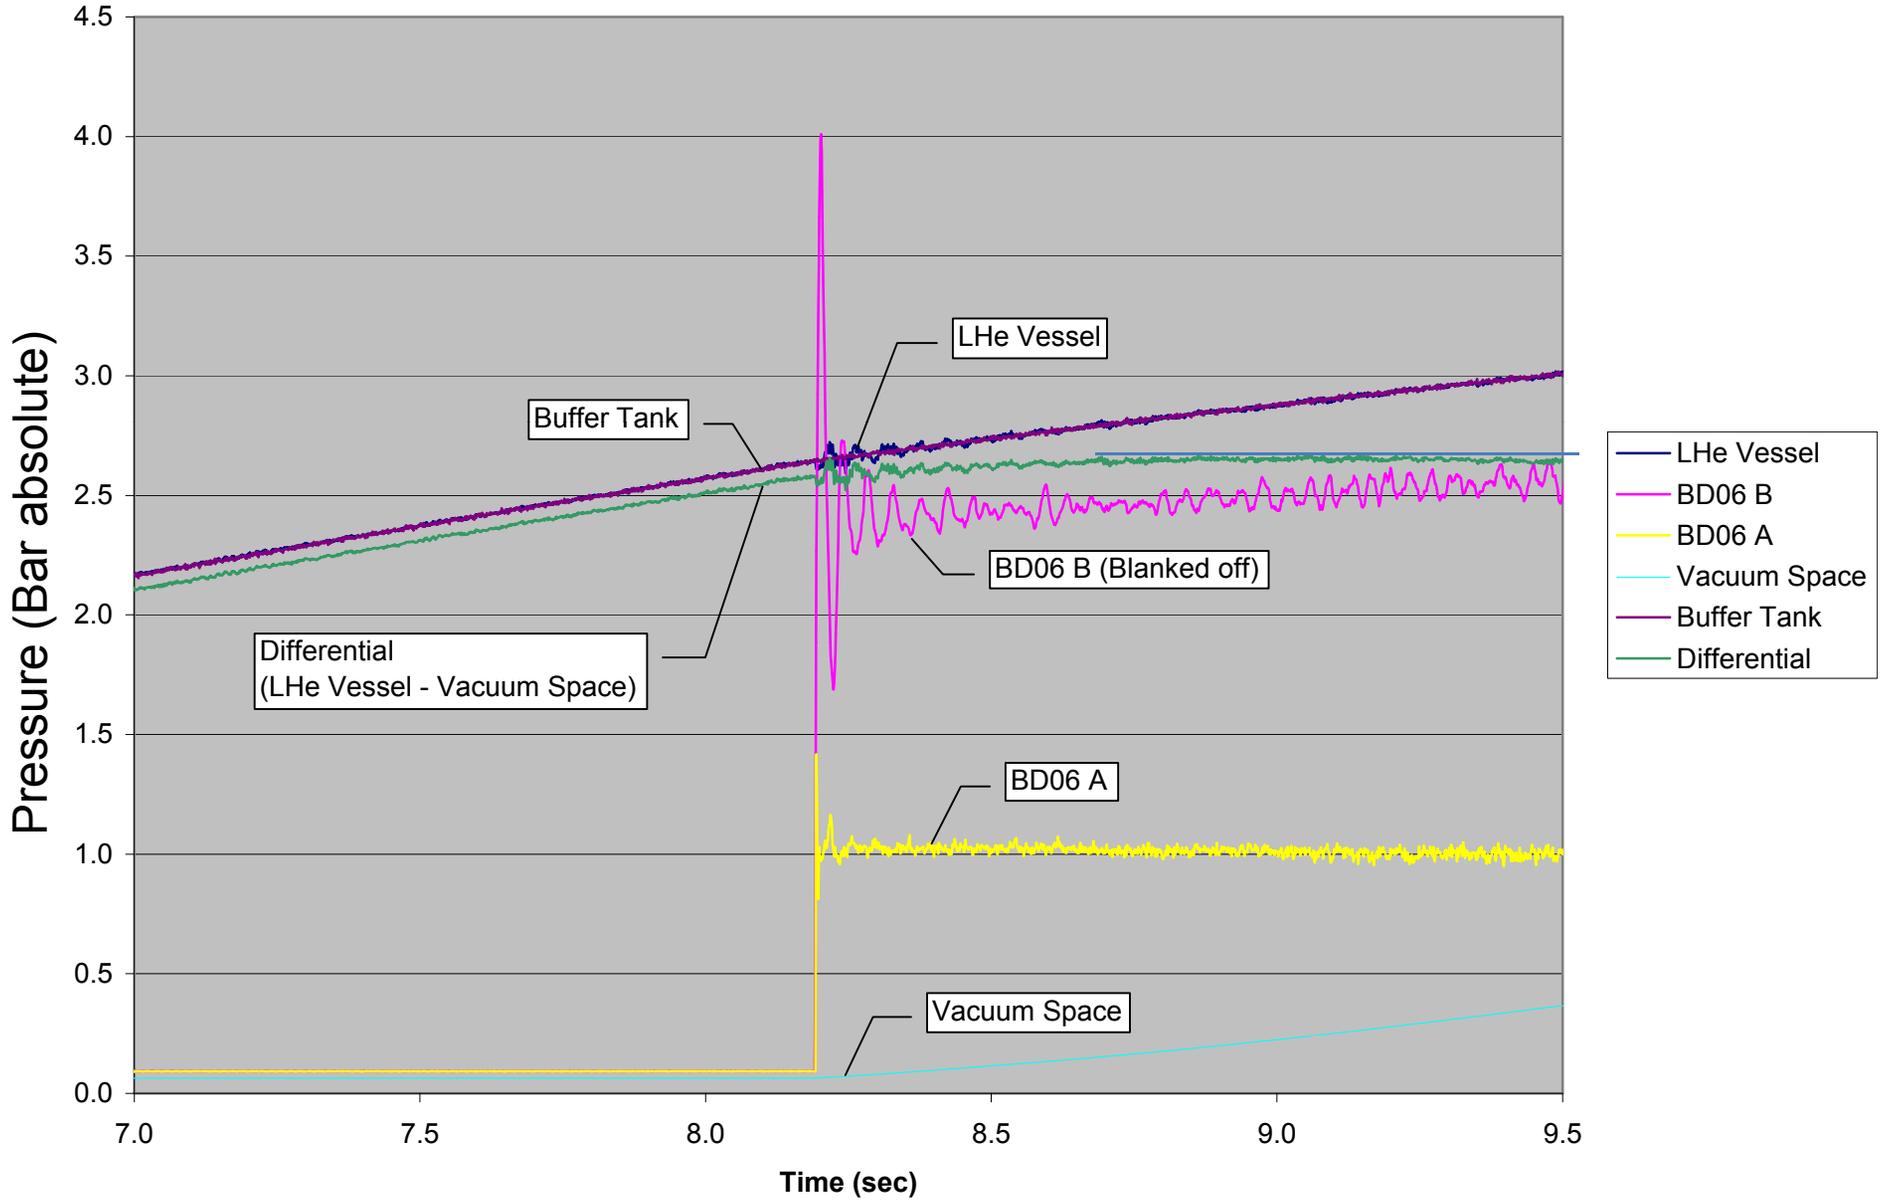
Burst Disc Test #6 Preliminary data

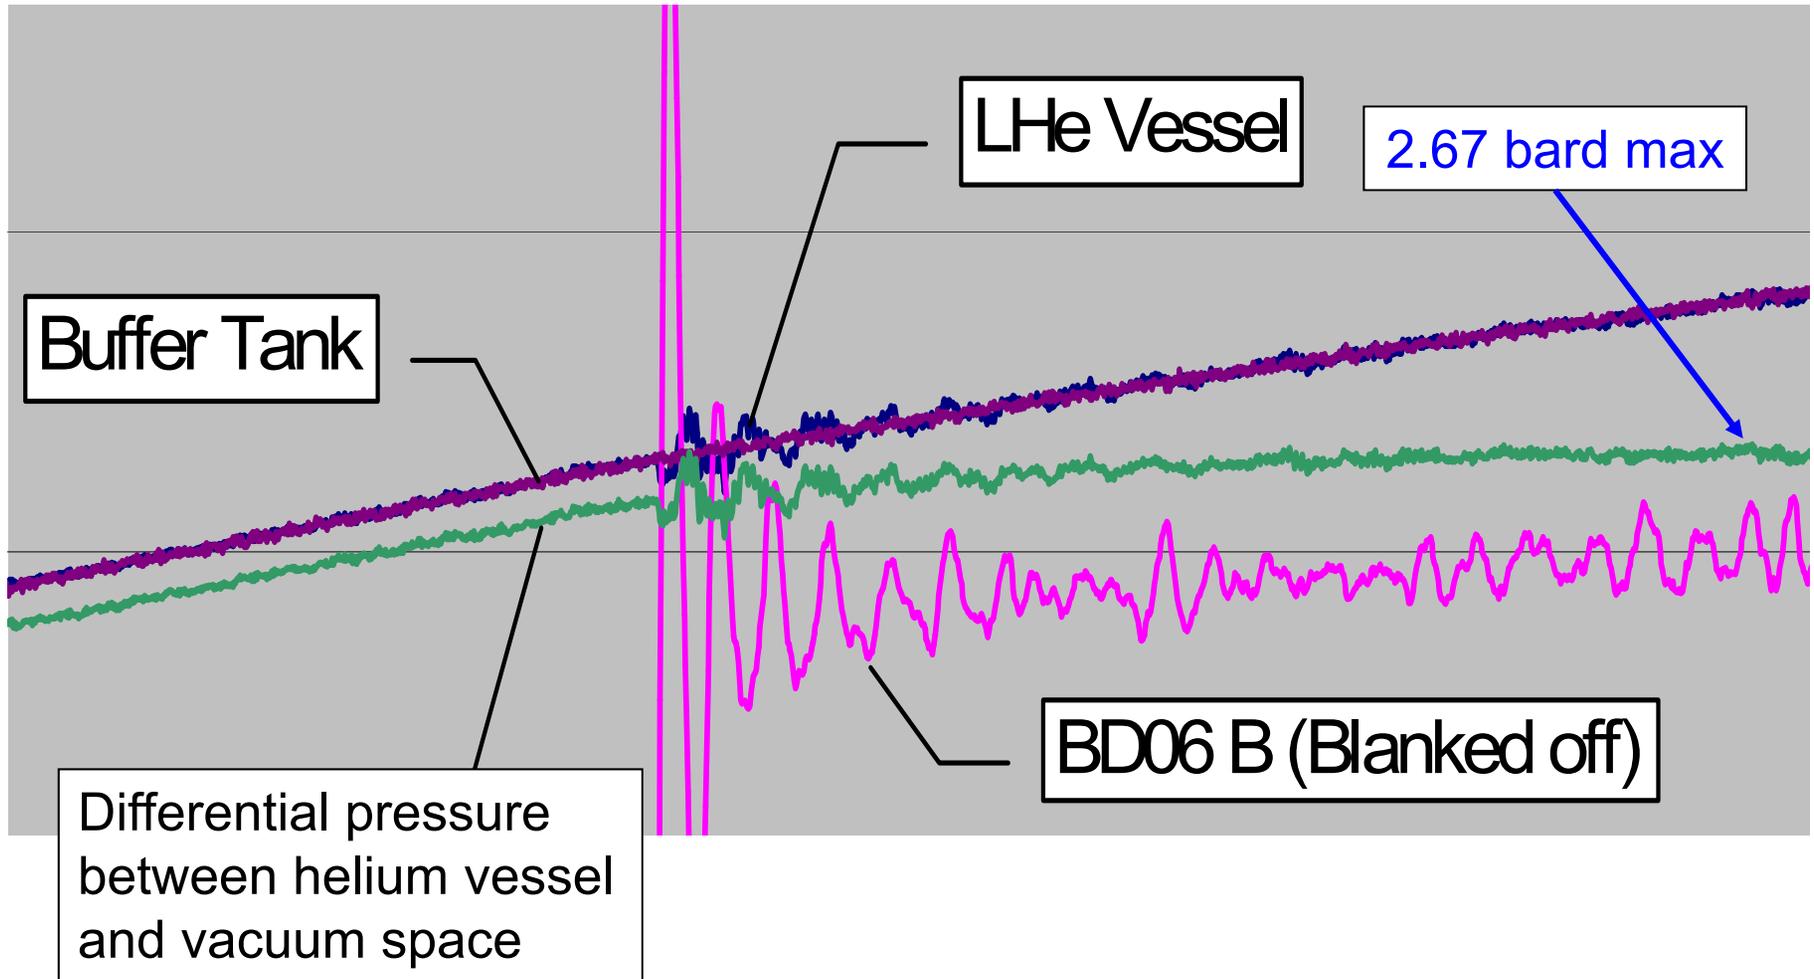
Burst Disc Test #6 Preliminary data – close up

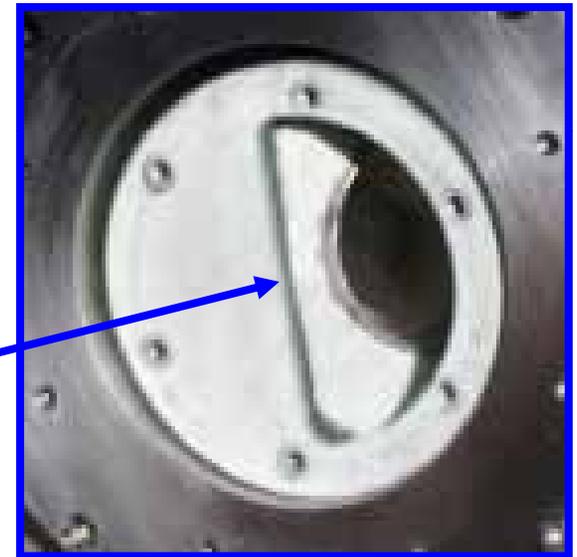
- In addition, this test only used one BD06A disc because of the limited number of flight-like discs available and also because we wanted to see the effect of having only one disc operational. Thus, the flow through this tube was doubled.
 - An unexpected benefit of doing this test with only one BD06 was to provide the actual static pressure in the Tee Box via the dead-end connection to pressure transducer BD06B. This pressure followed the helium tank closely which indicates the “choke” in the system is not at the BD03 burst disc or in the Tee Box. It was likely in the semi-circular exit of the angled adapter where it connects to the BD06A disc. This is warmest section with the smallest relative flow area.

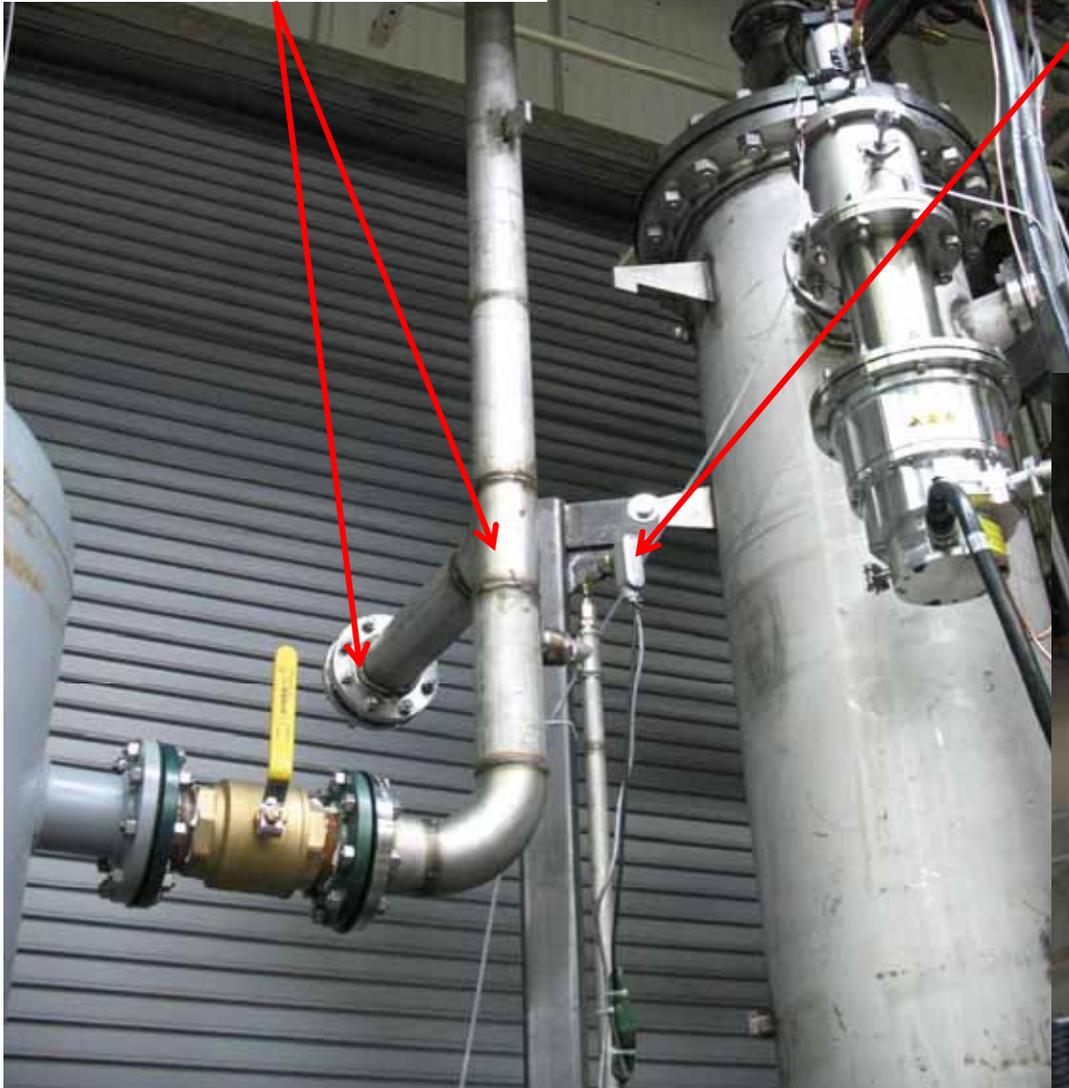
Another 4" Tee and 4" 100 psig burst disc were added to the inlet line of the helium vessel.

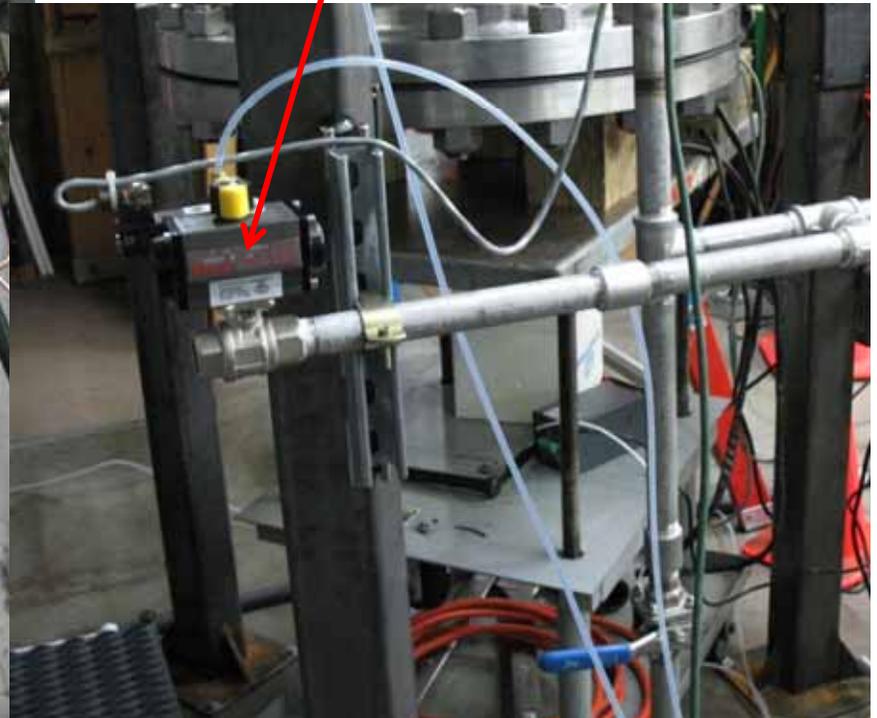
The 1" actuated ball valve and pressure switch from the large gray buffer vessel were moved to the supply line. This would open before the 4" burst disc in the event of another anomaly as seen in test #5.
