National Aeronautics and
Space Administration

November 17, 2009

SUBJECT: AMS Burst Disk Vent Duct Redesign and Certification

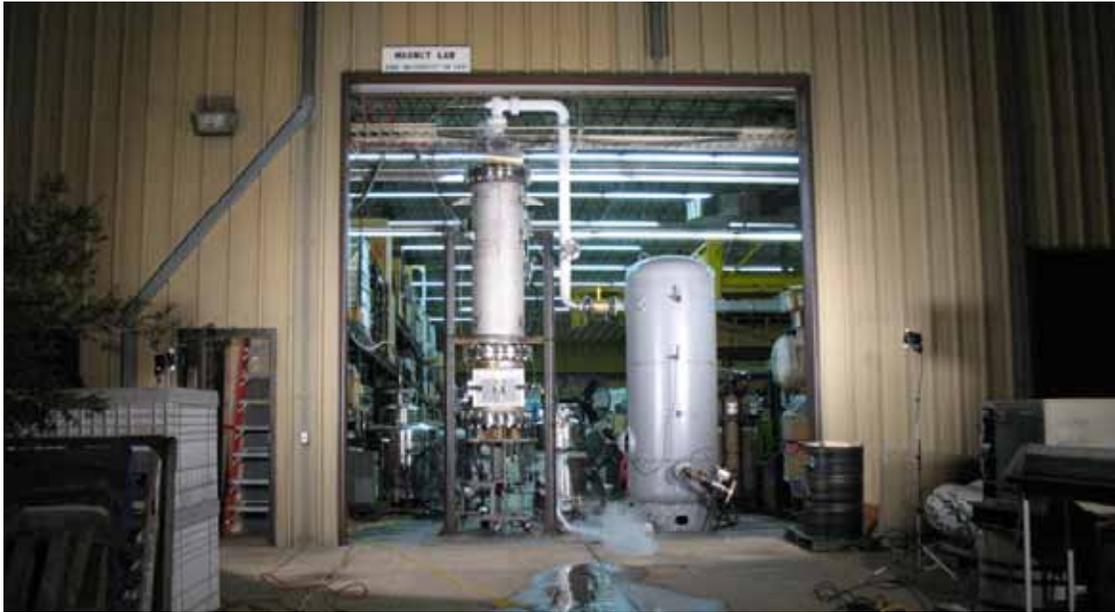
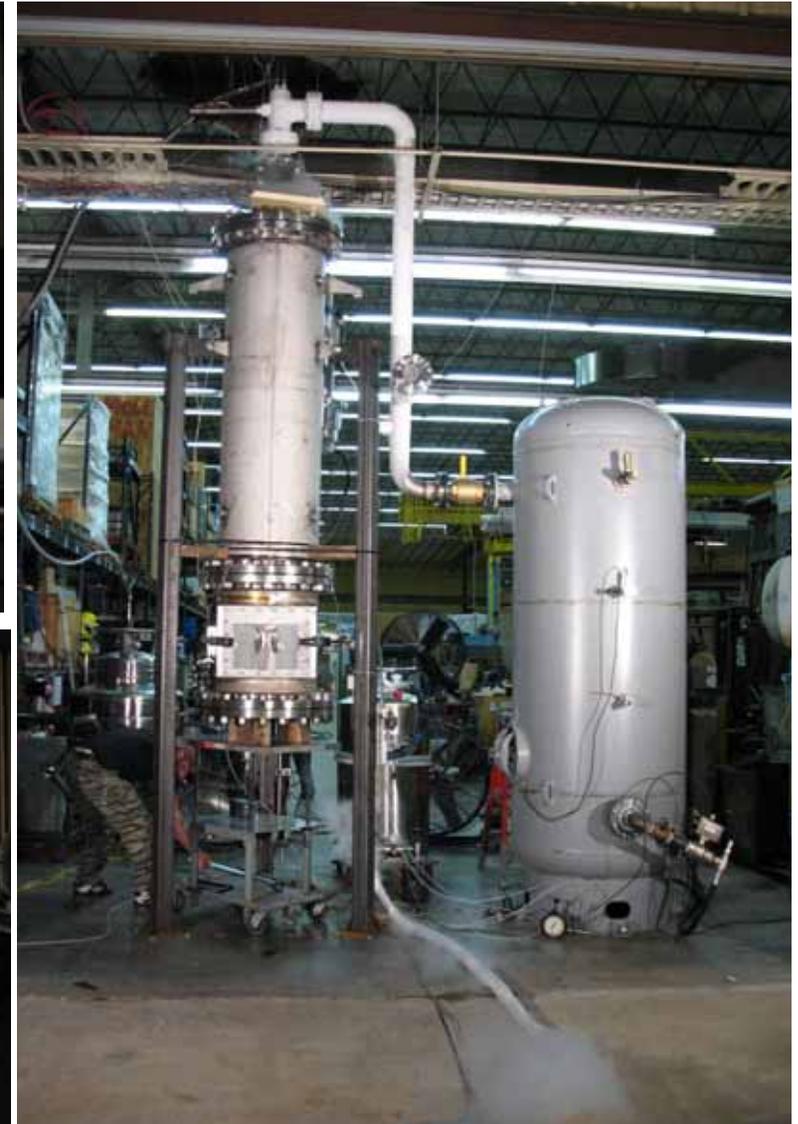
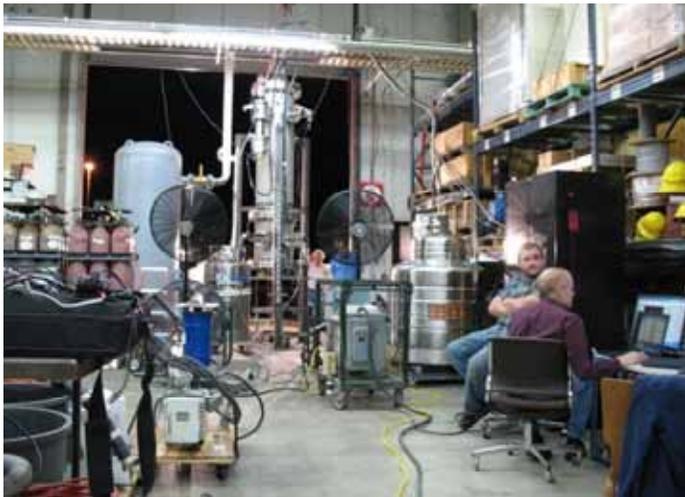
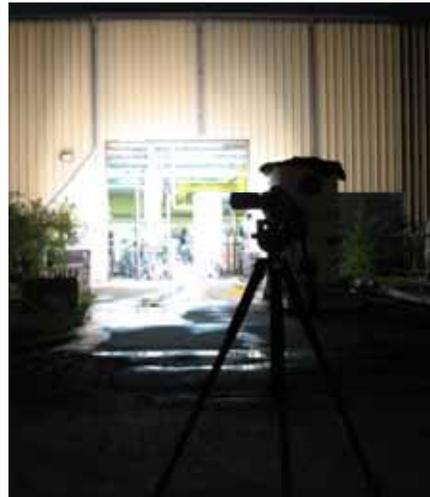
The system was cooled down with LN₂ beginning on 23 September. However, an operator error resulted in significant amounts of air being ingested into the vacuum space on 24 September. The entire system had to be warmed up, re-pumped & purged, and re-cooled. Another unapproved modification to the warm-up system resulted in even more moisture in the vacuum space.

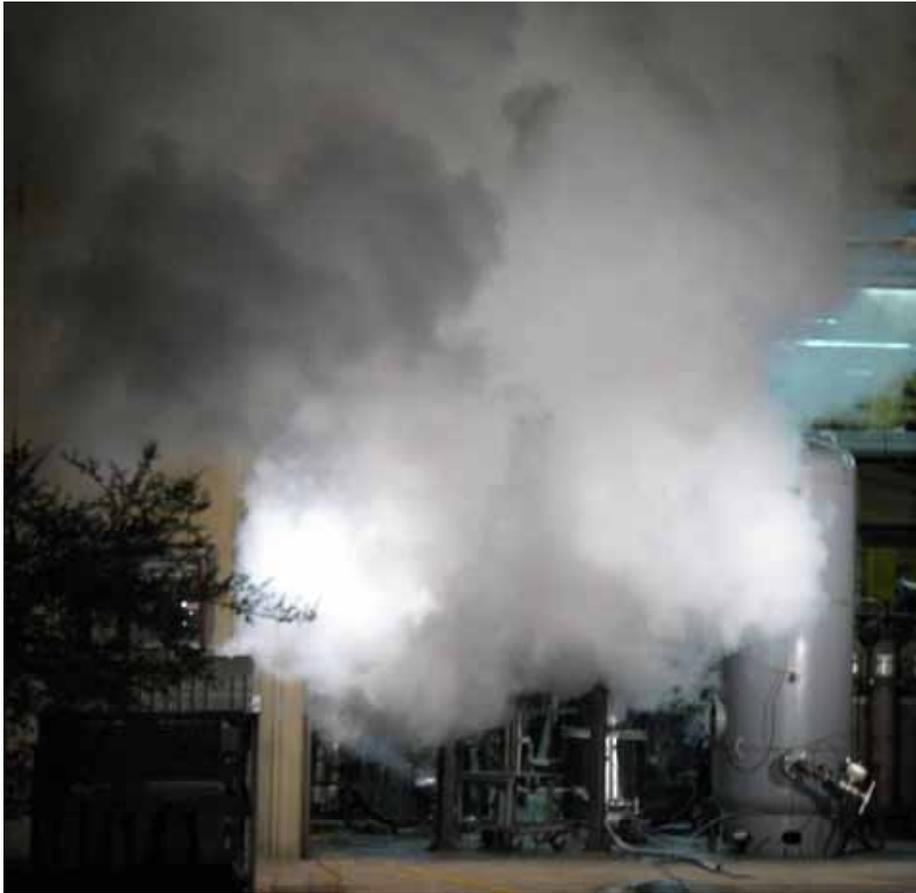
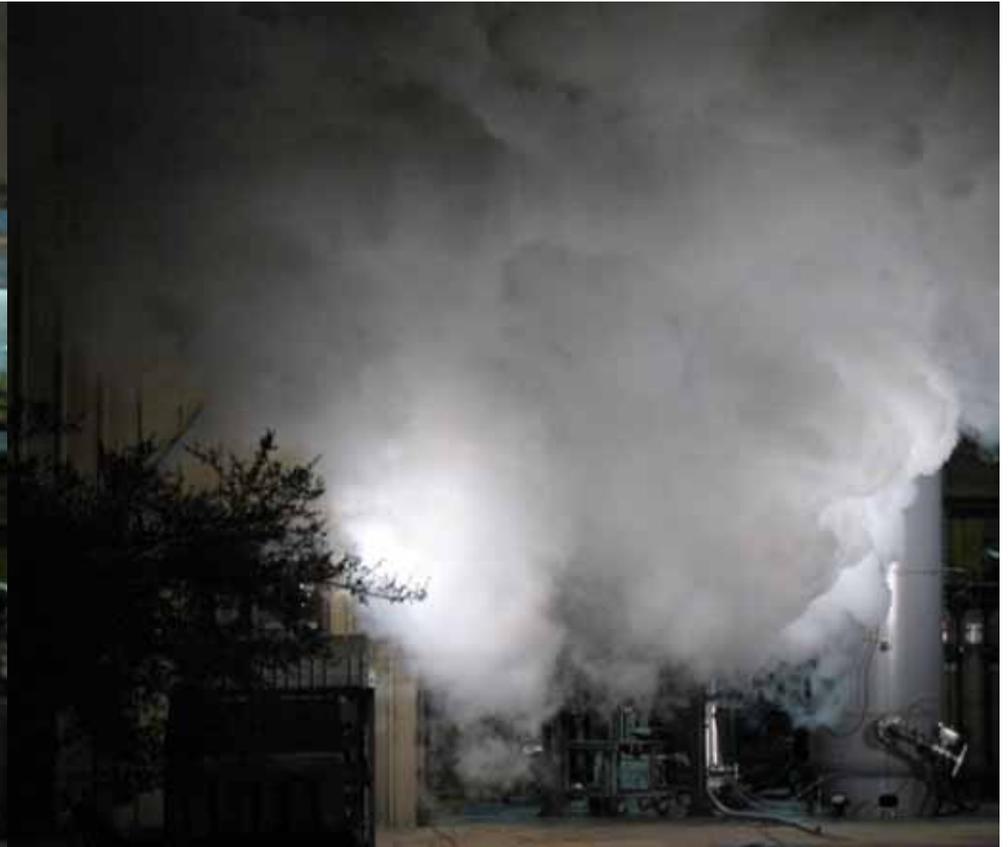
The vacuum space was opened to air through a 0.5" (12.7 mm) diameter orifice. The pressure in the helium vessel began to increase noticeably within ~1.4 seconds and ~18.6 seconds later, BD03 ruptured. BD06A & B ruptured almost simultaneously within 0.12 seconds later.

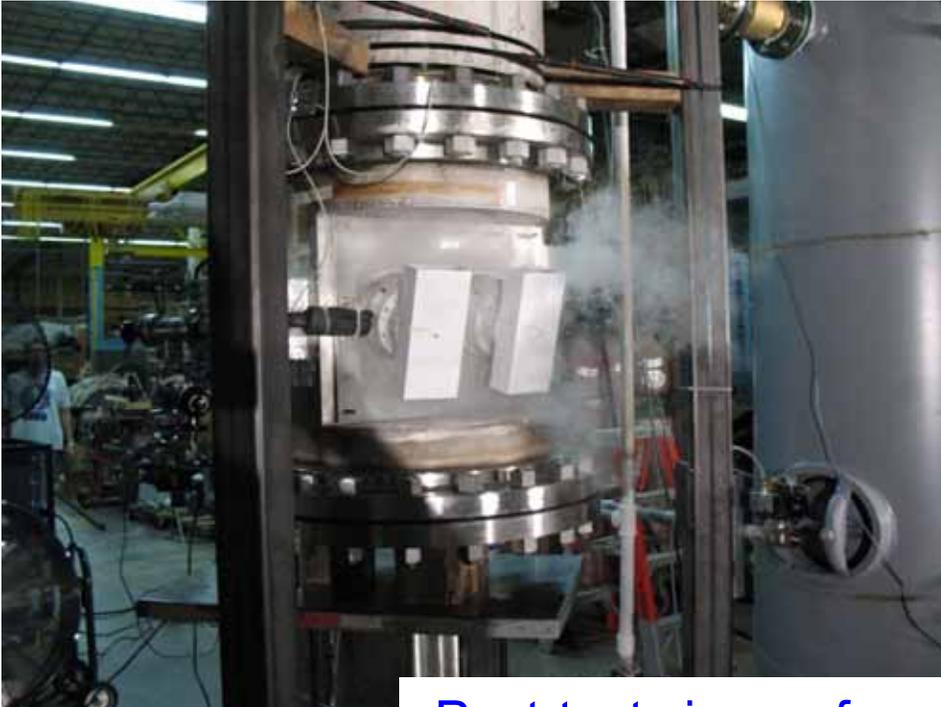
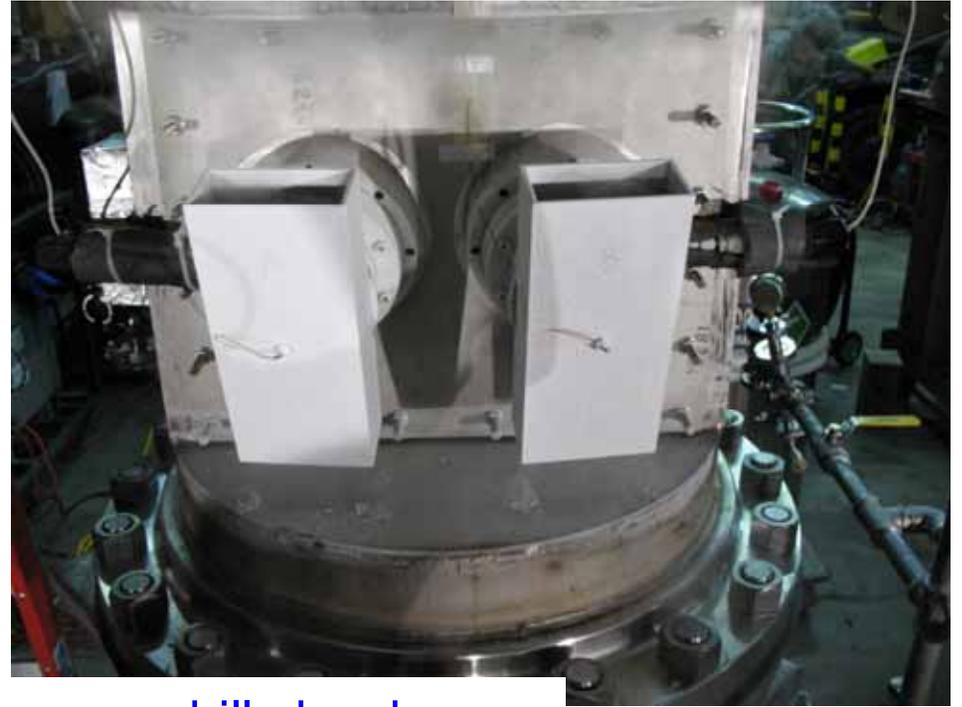
Post-test views of some very chilly hardware.

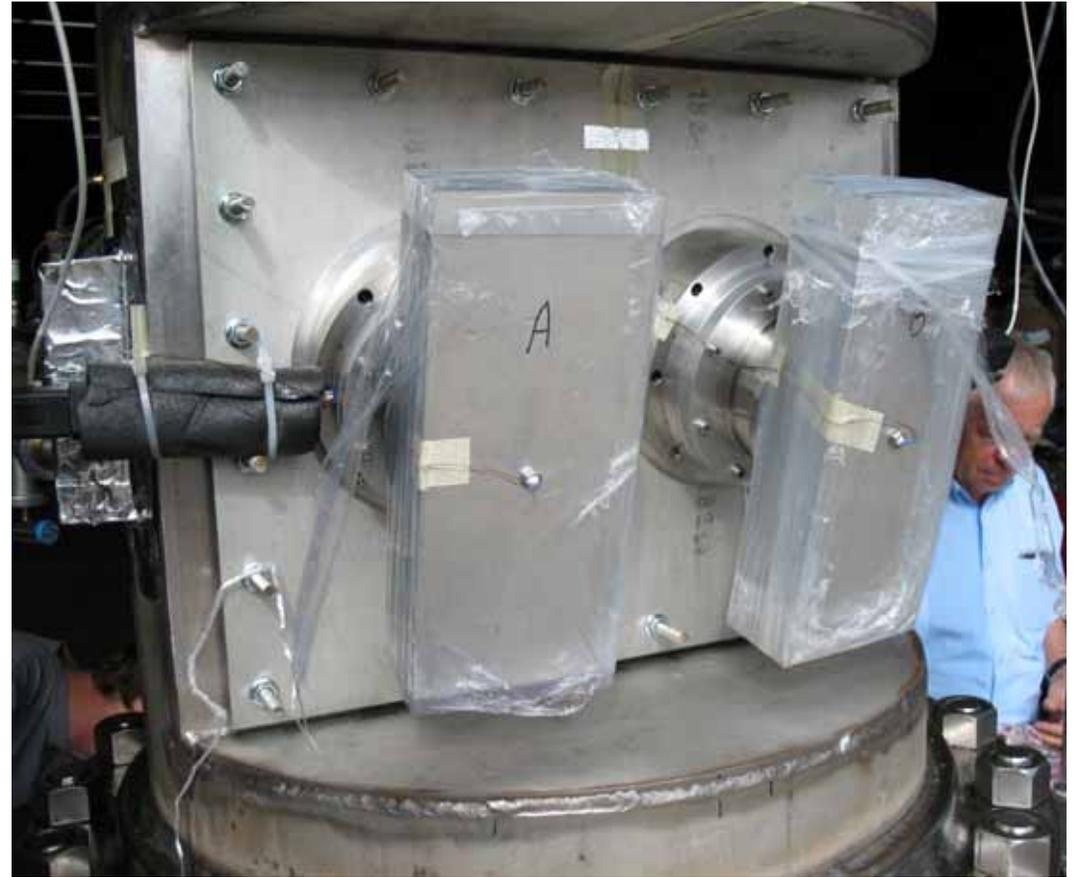
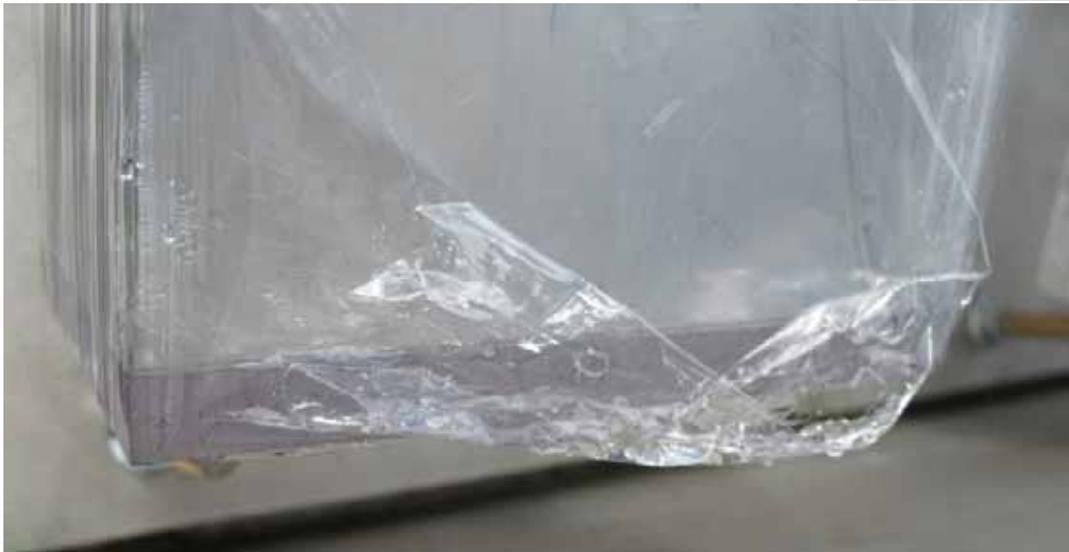
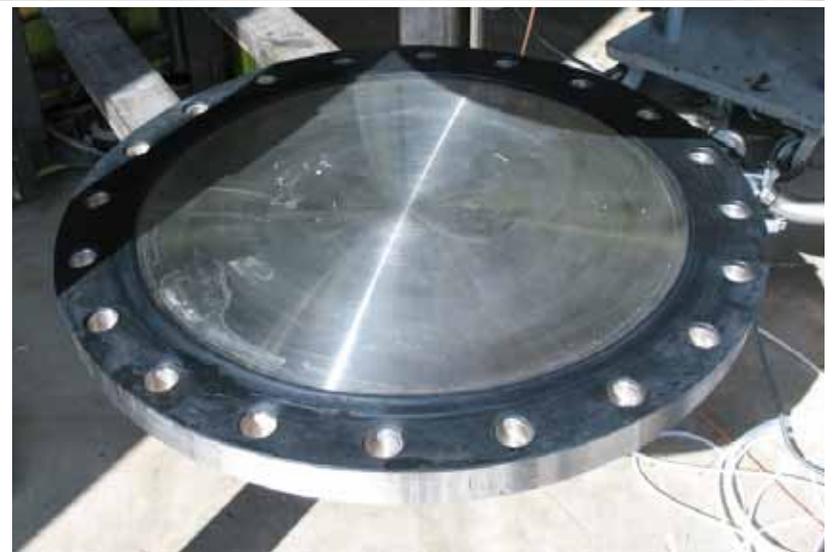
The exhaust ports were wrapped in plastic to reduce the moist air from entering the vacuum space while a heater and blower were used to dry out the hardware. The next day, considerable water was observed inside the vessel. The majority of this entered after the discs were ruptured. The same thing would happen to the AMS cryostat if the BD06A, B, or BD07 discs were to ever fail.

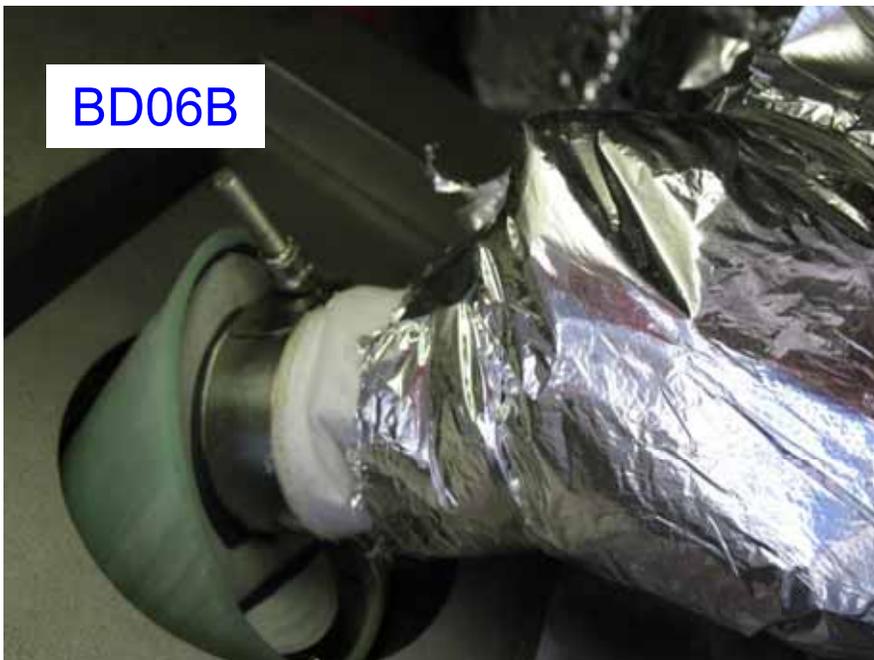
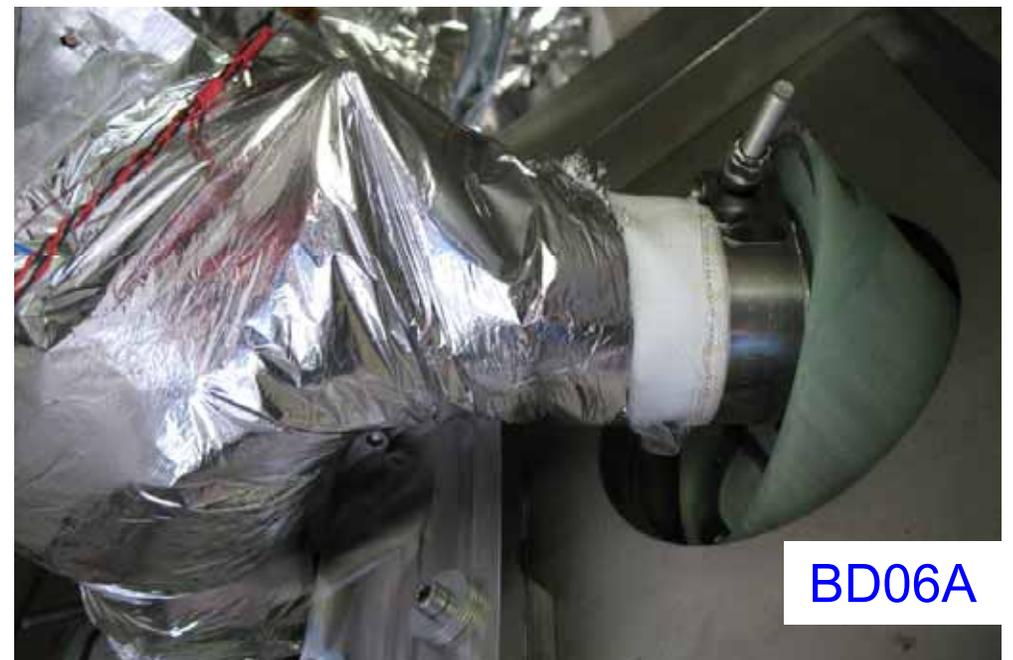
Post-test inspection of the hardware revealed it was still intact.

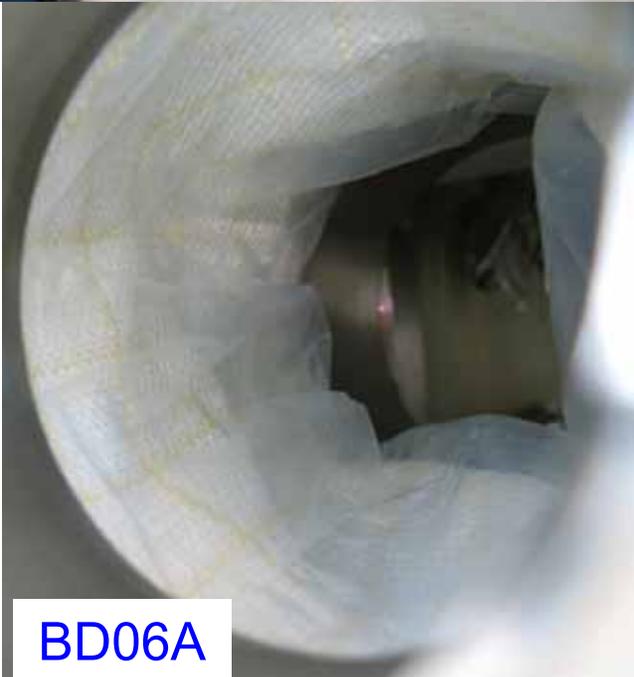
BD06A

The first look at the flexible tubes and the PTFE liners were encouraging.

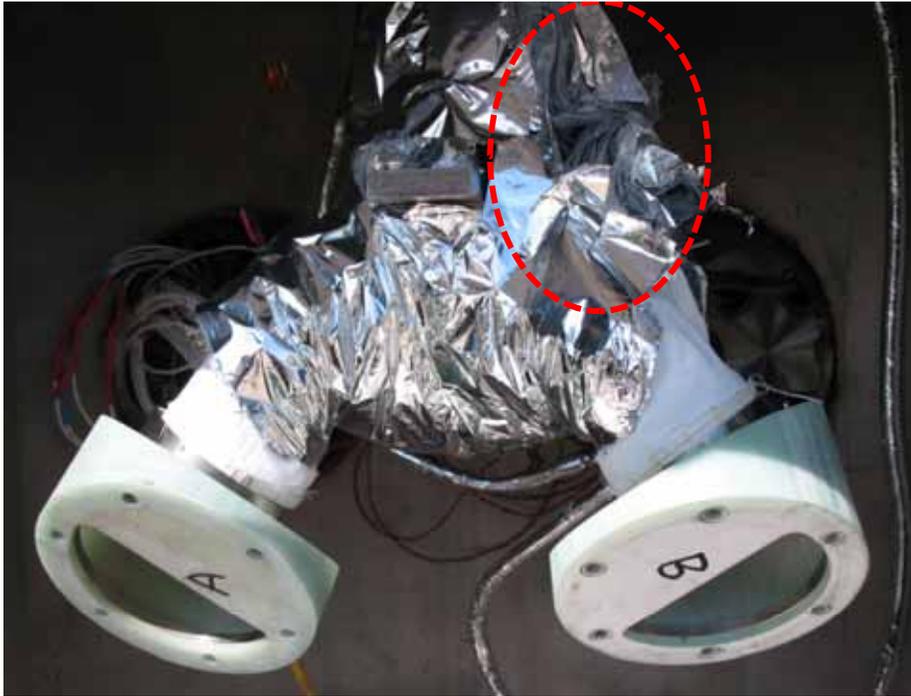
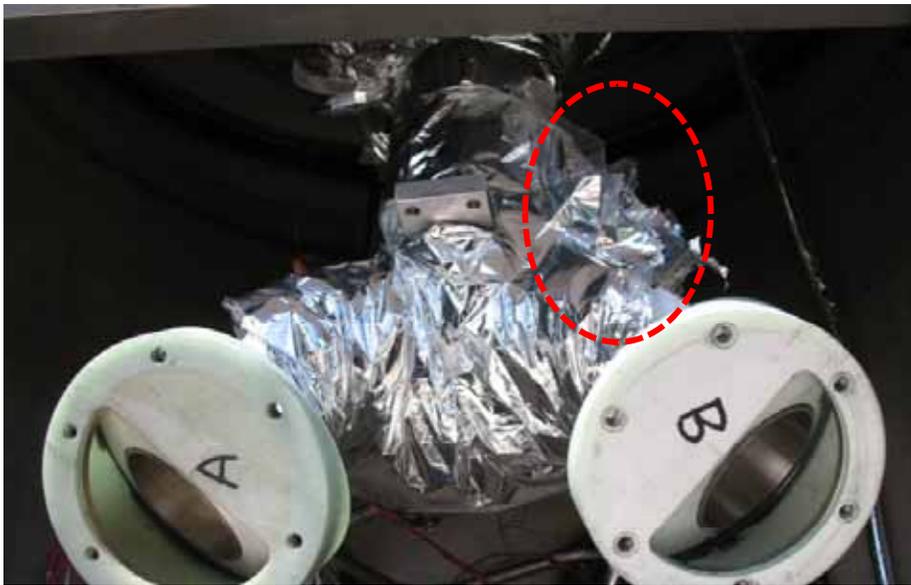
The only noticeable damage was to layers of MLI on the flexible tube for BD06B.

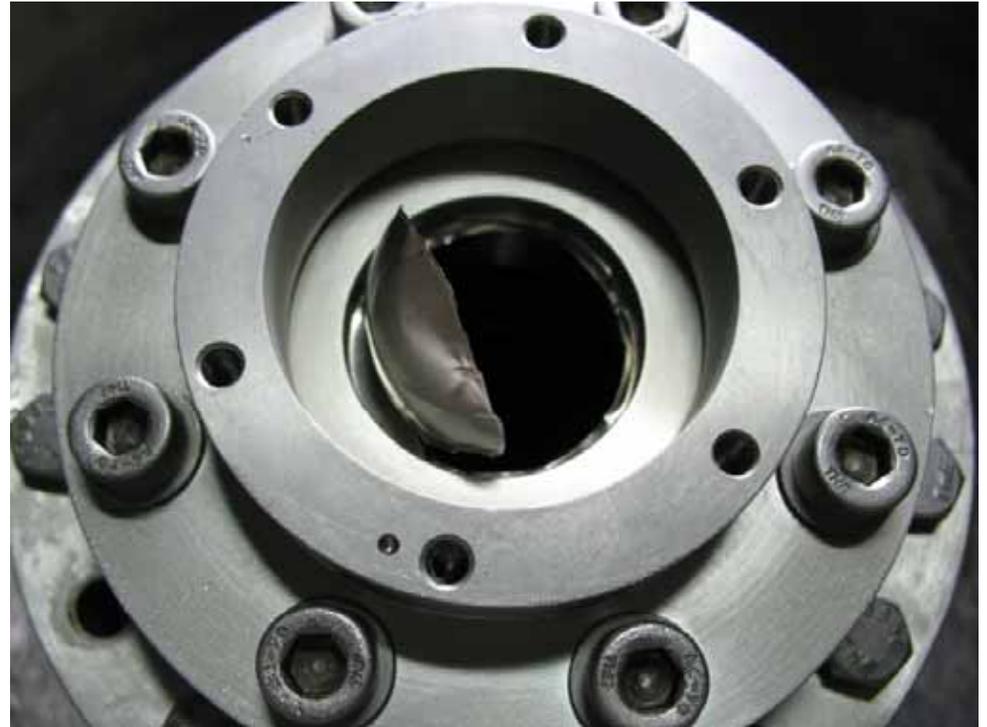
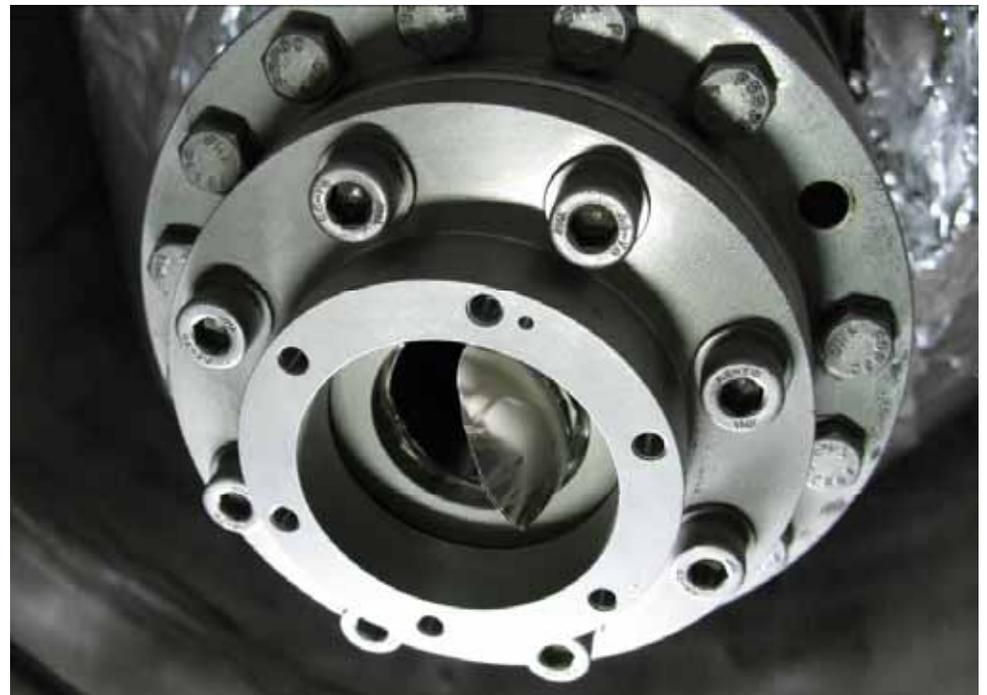
The BD03 disc was still cold, frosty, and intact after removal of the Telescoping Tube. The helium vessel MLI was unaffected.

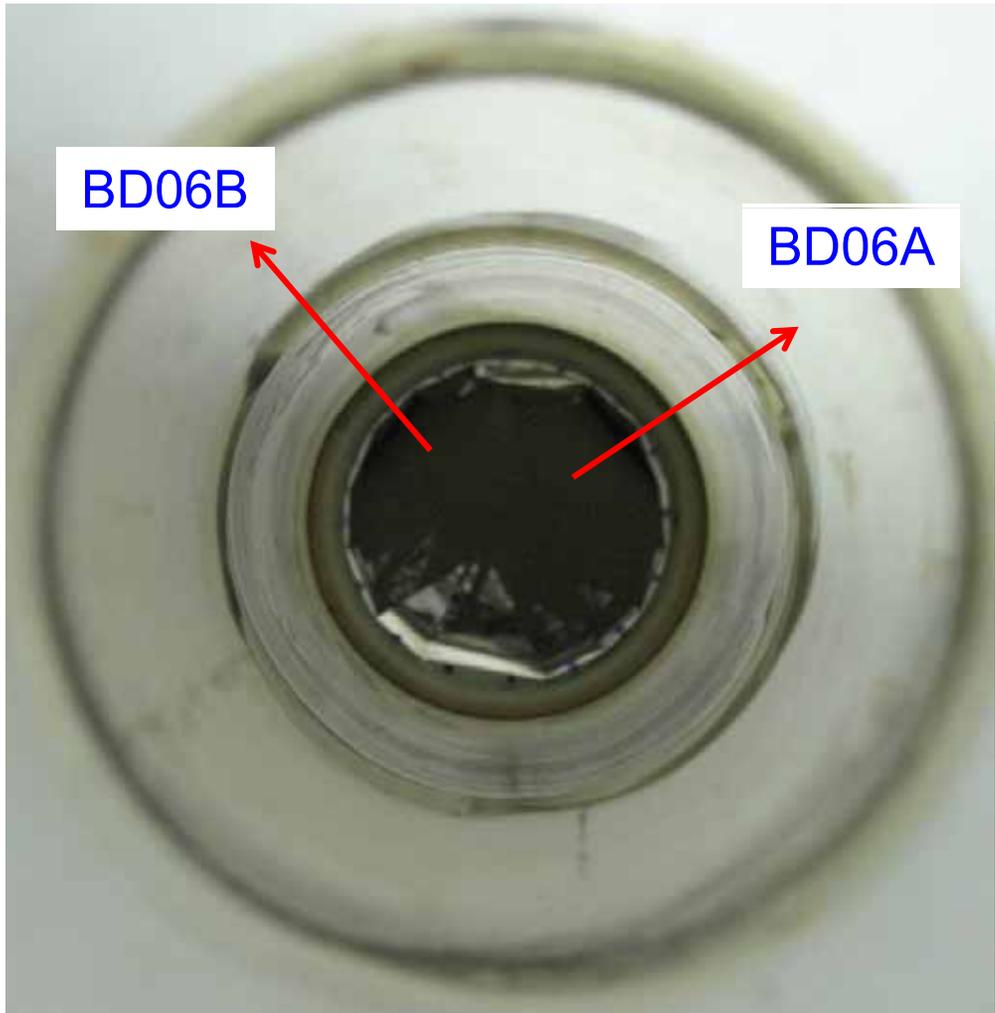
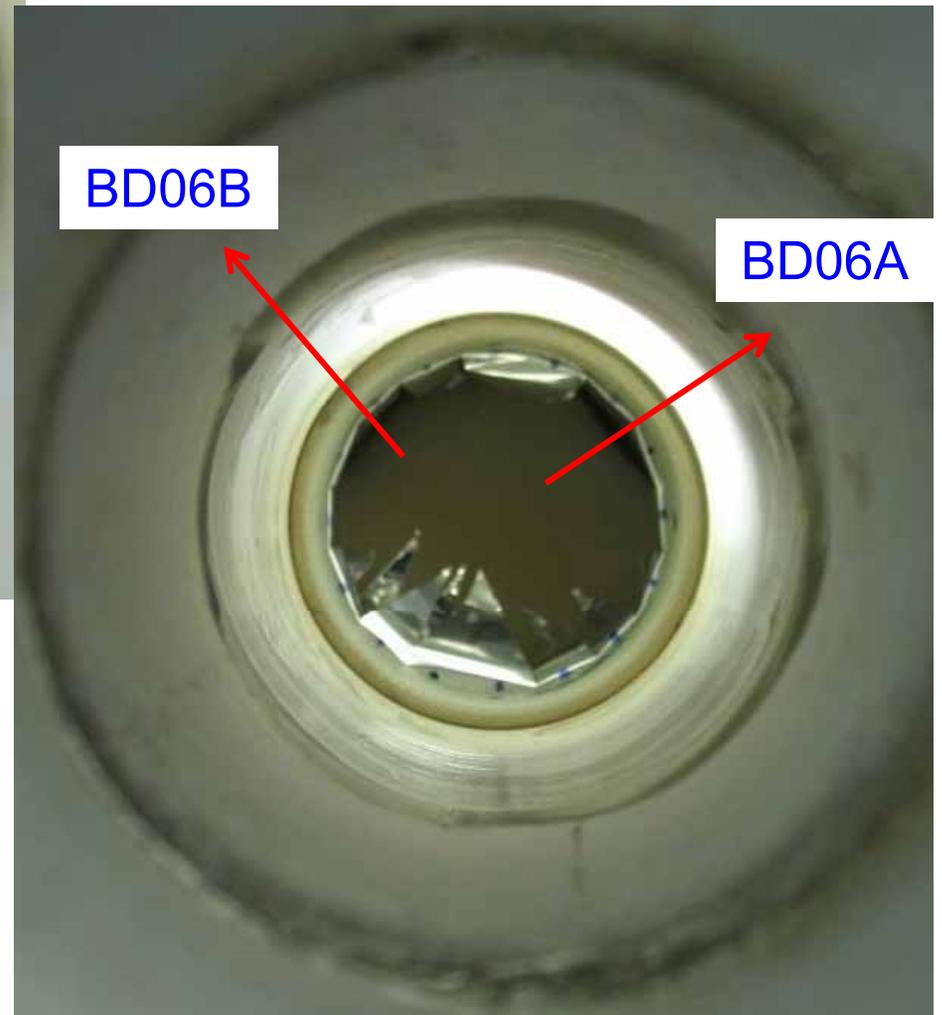
The BD Radiation Shield opened nicely. The only section that wasn't fully bent back was the back side of the Tee Box which is no problem.

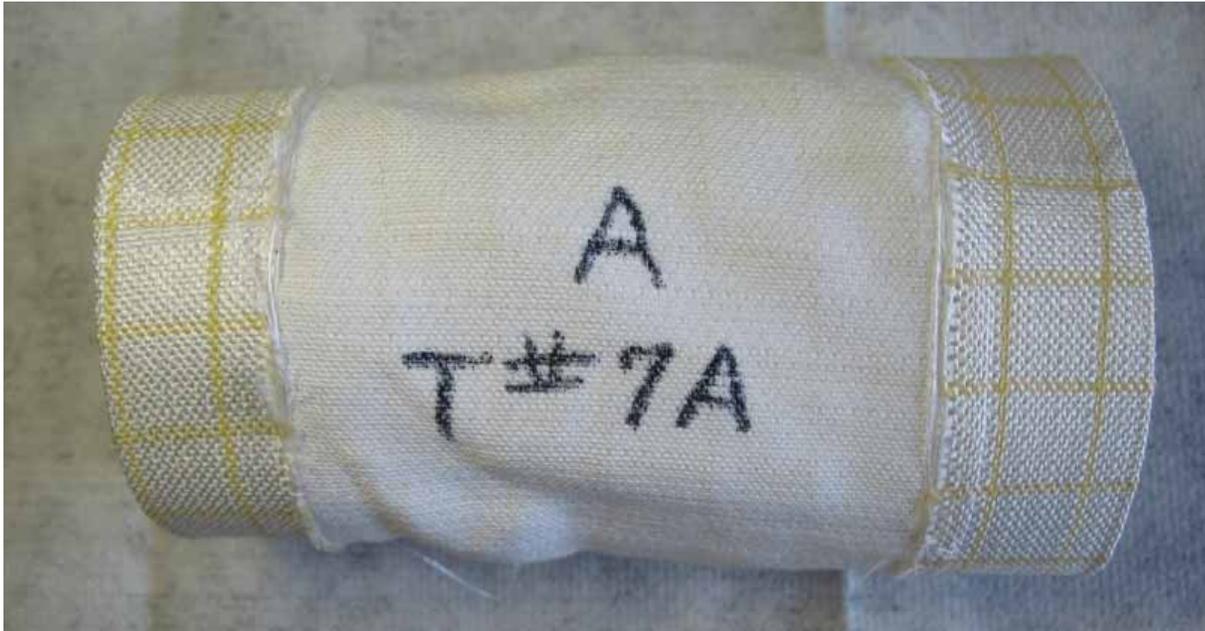
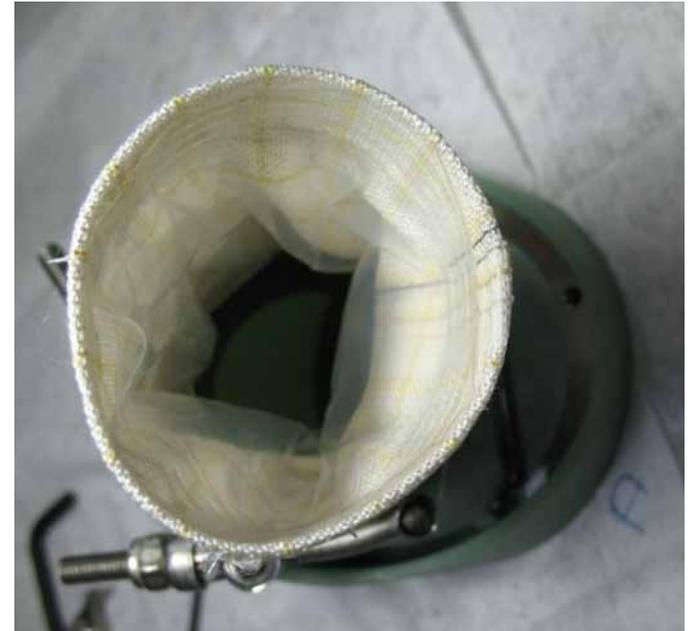
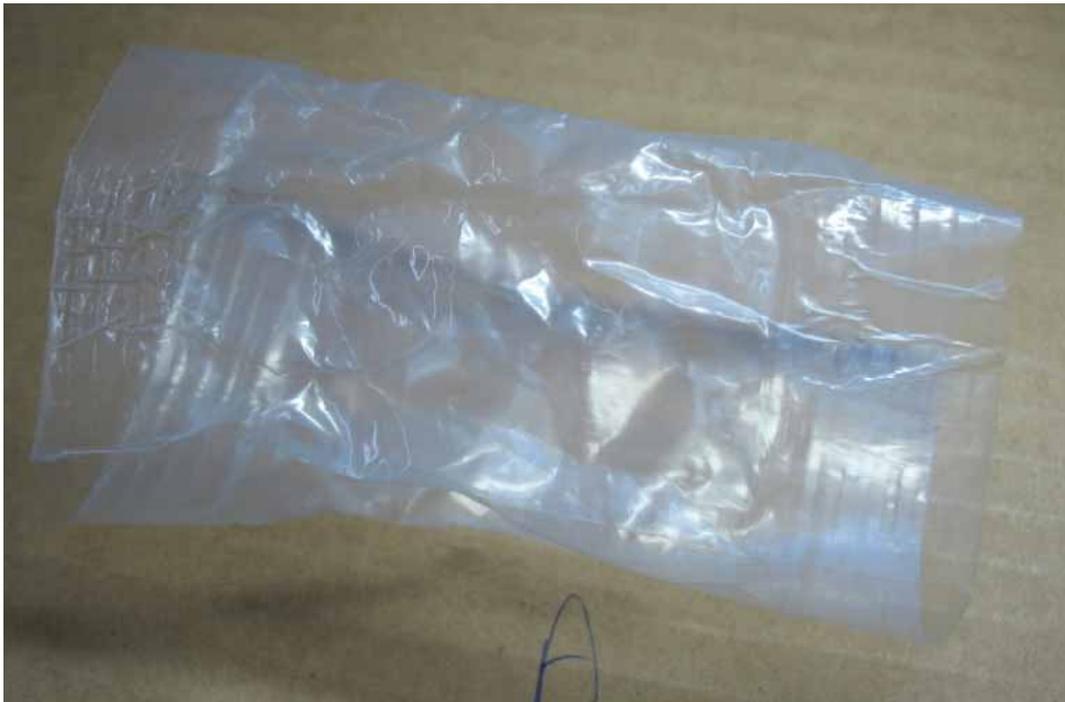
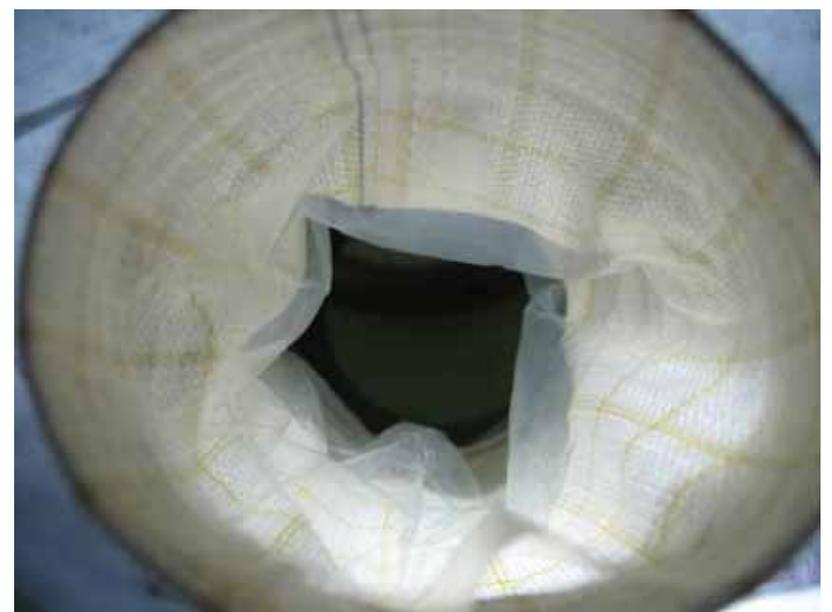
A side: The ortho-fabric flexible tube and the PTFE liner looked good.

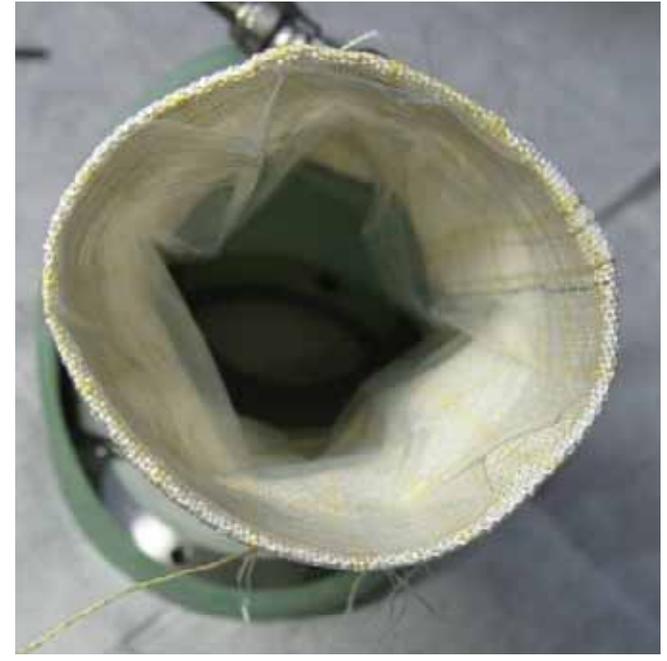
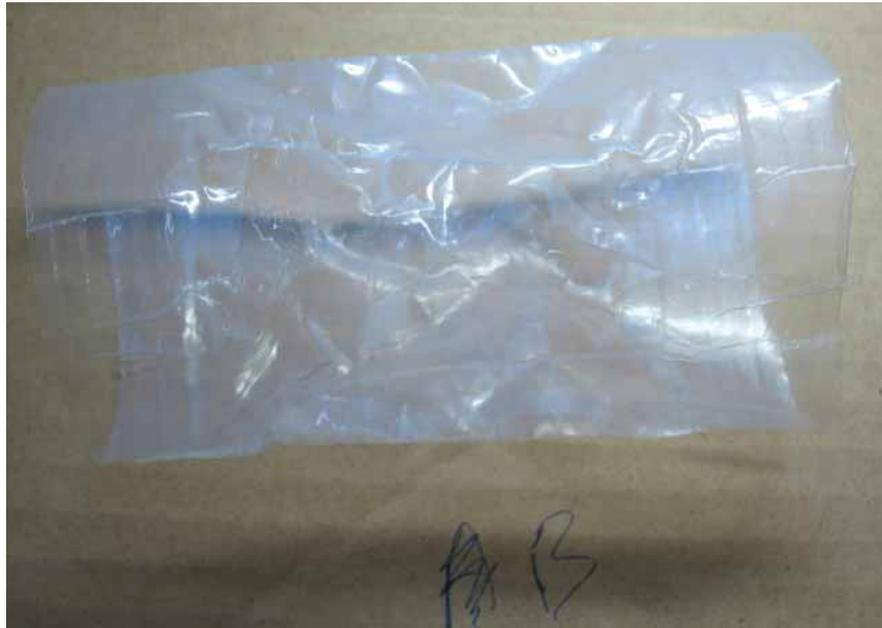
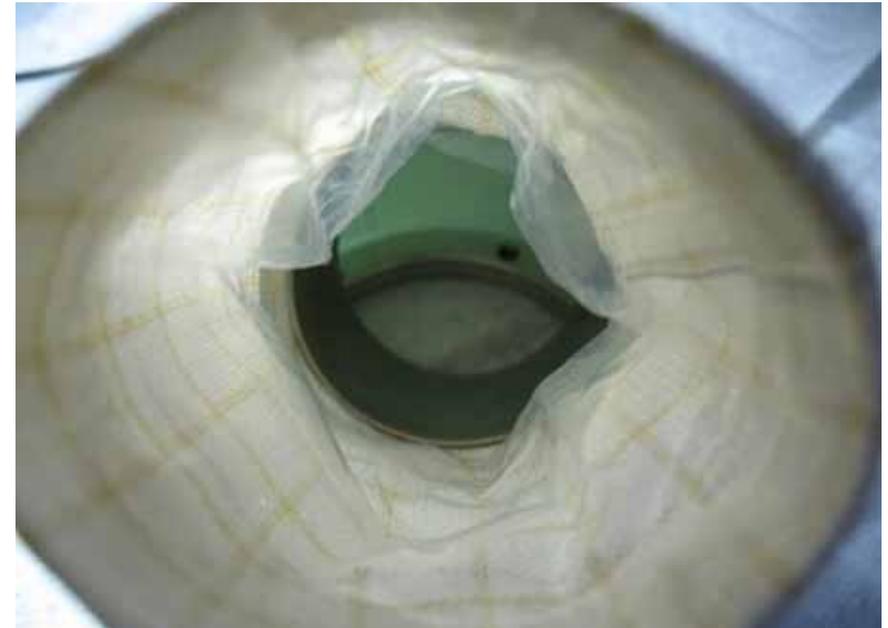
B side: The ortho-fabric flexible tube and the PTFE liner looked good. The ortho-fabric tubes will be reused in test #7B. The PTFE liners will be replaced.

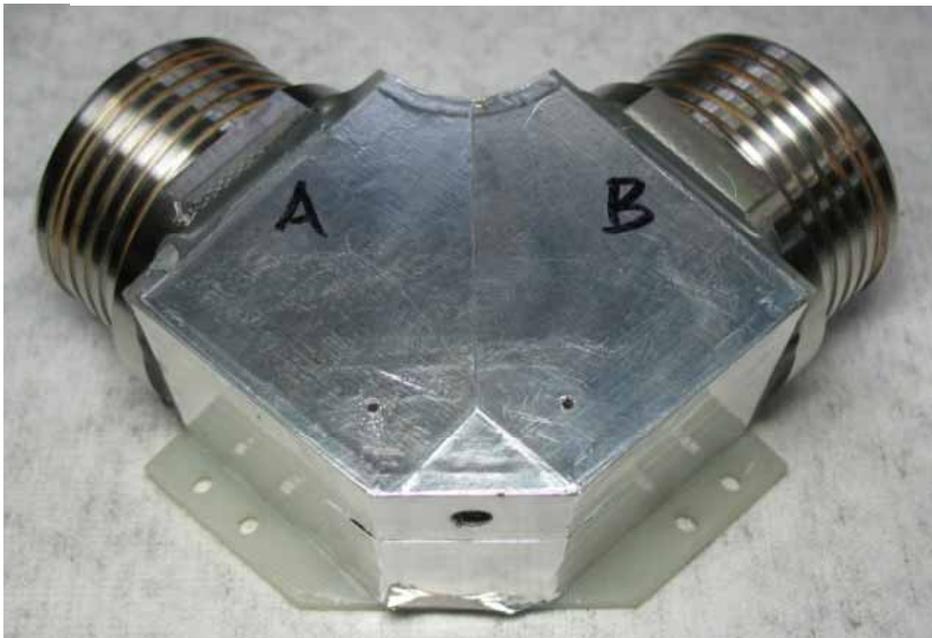
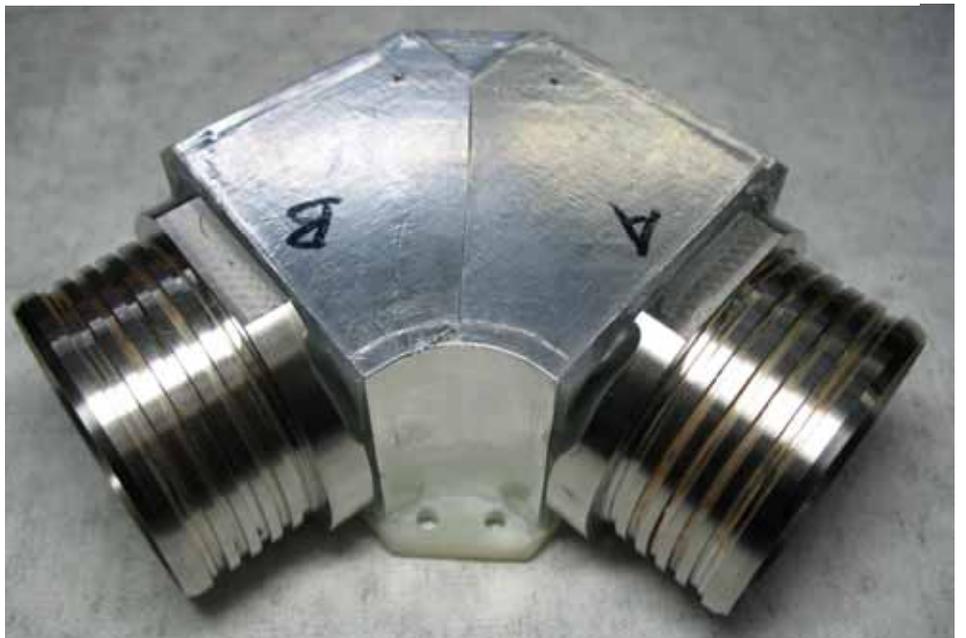
Close-ups of BD03
after removal.

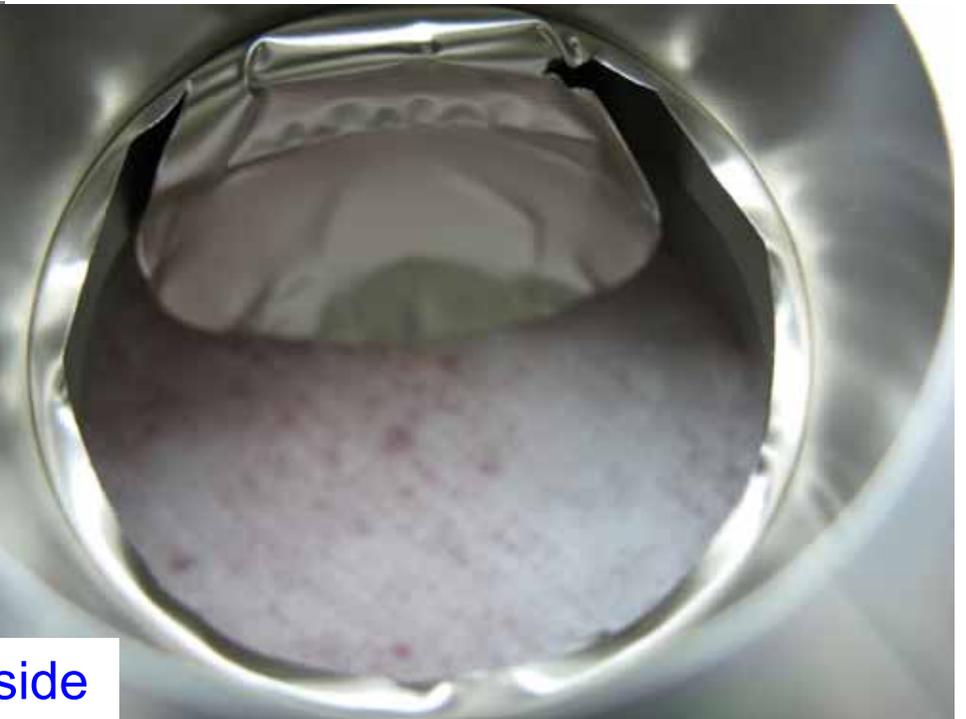
Close-ups of BD06A after removal. The membrane folded back, significantly tore away from the hinge line, but remained attached.

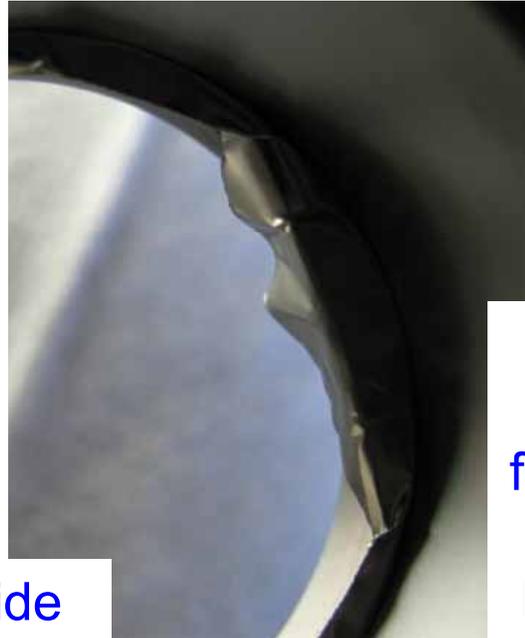
Close-ups of BD06B after removal. The membrane folded back and completely tore away near the hinge line. It was not recovered.

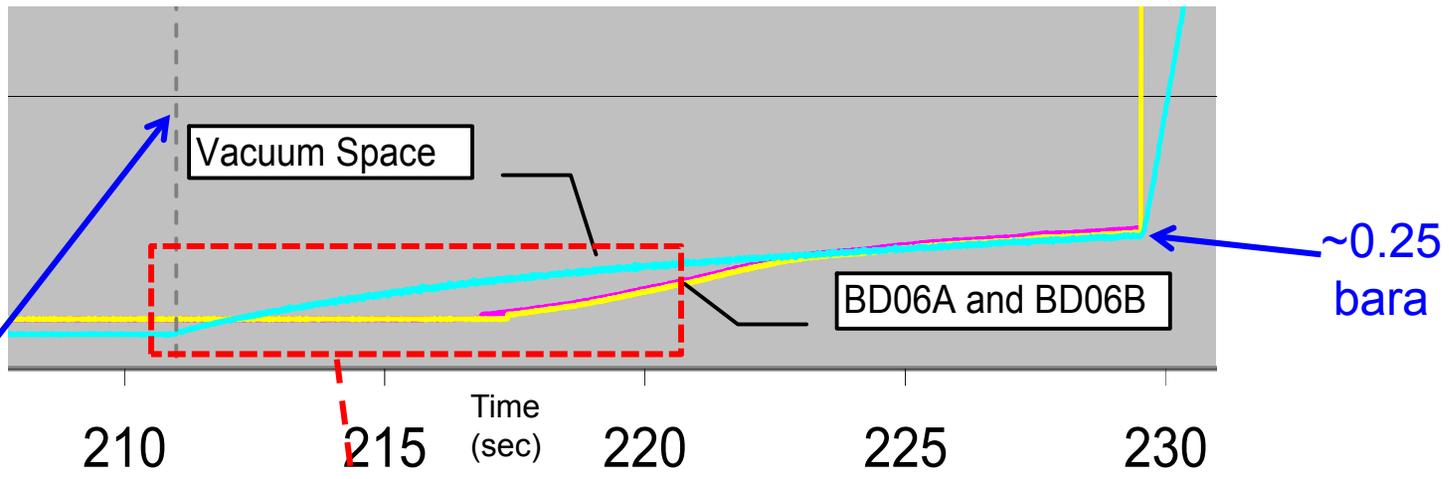
- The results of test #7A indicate the PTFE was negatively pressurized to 0.103 bar (~1.49 PSIG) as shown in the next slide.

Maximum *negative* differential pressure on flexible tubes/PTFE liners: ~0.103 bar (~1.49 PSIG)

- As a result of the negative pressure on the PTFE liner demonstrated in test #7A, the Angled Adapters used in Test #7B will have 1/8" (3.175 mm) holes drilled in them as shown below to improve the venting.
- Another advantage of this is to improve the evacuation during the final pumpdown of the flight Vacuum Case after welding.
- These holes will be drilled when the flight BD06A & BD06B assemblies are installed after the VC is pressure tested.

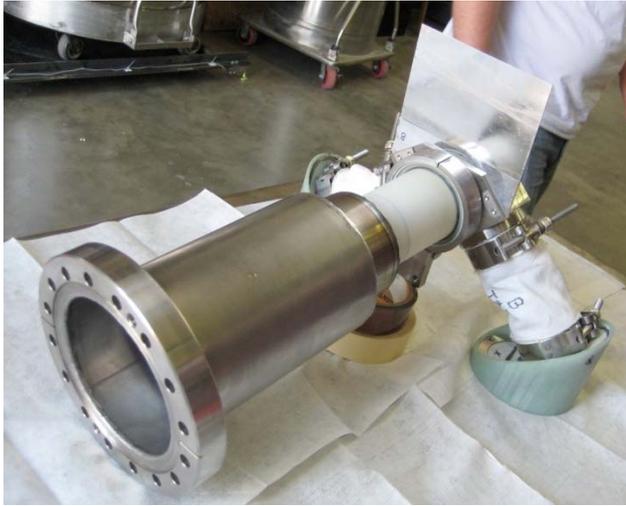
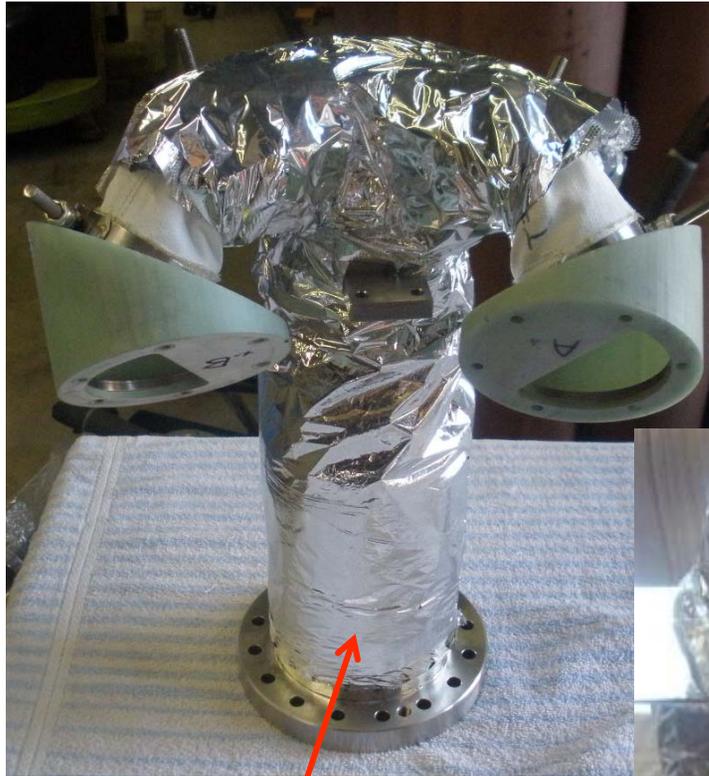
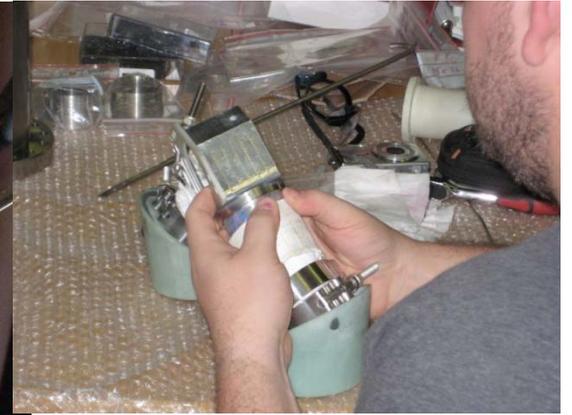
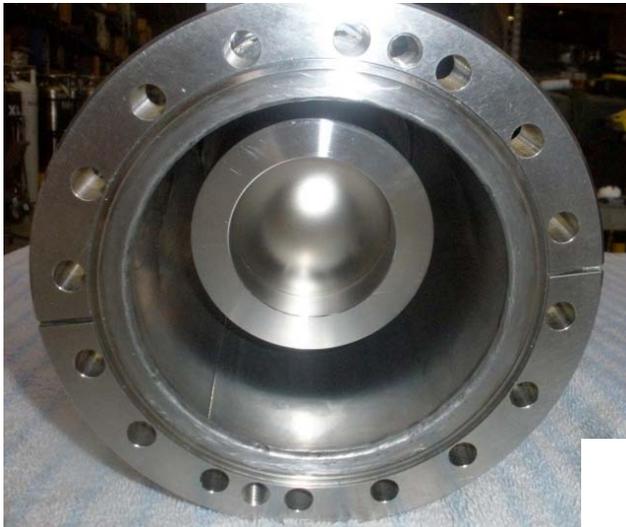
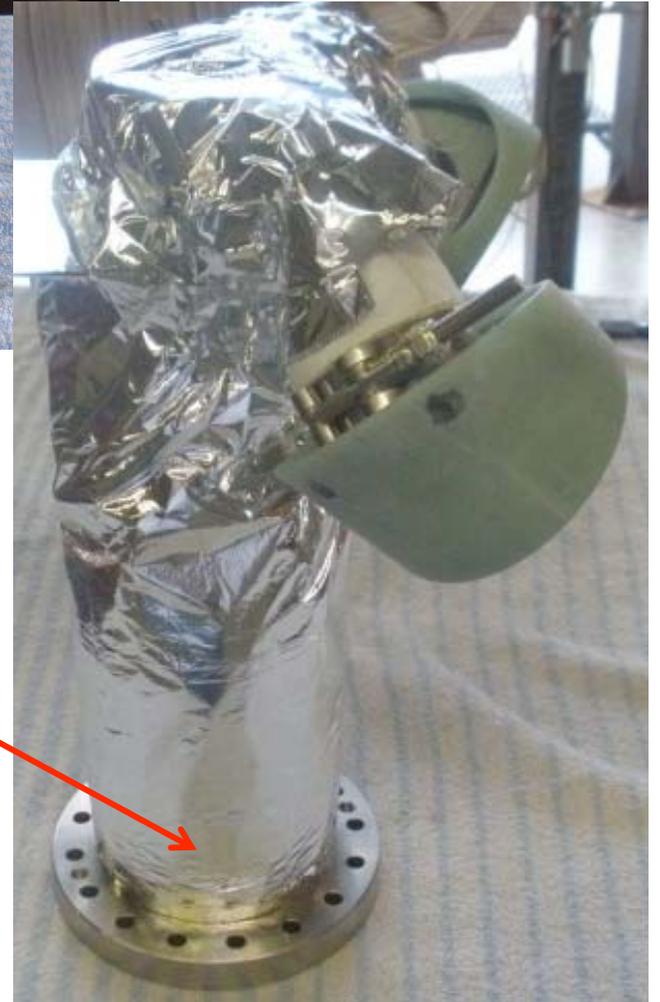
Note: The detached BD03 membrane is resting against the Test #7B BD03 membrane in these two photos.
