National Aeronautics and
Space Administration

November 17, 2009

SUBJECT: AMS Burst Disk Vent Duct Redesign and Certification

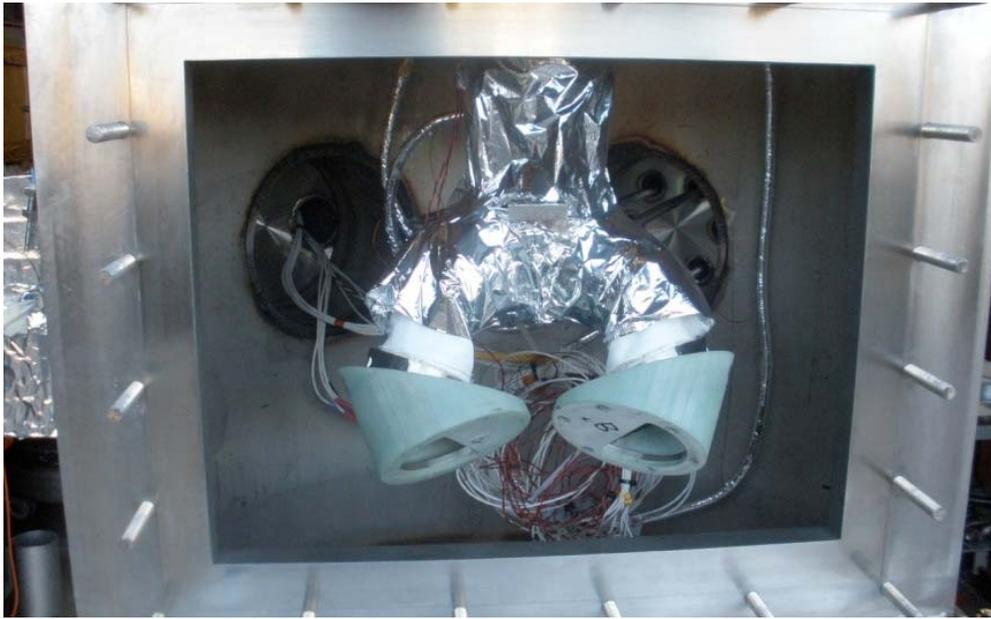
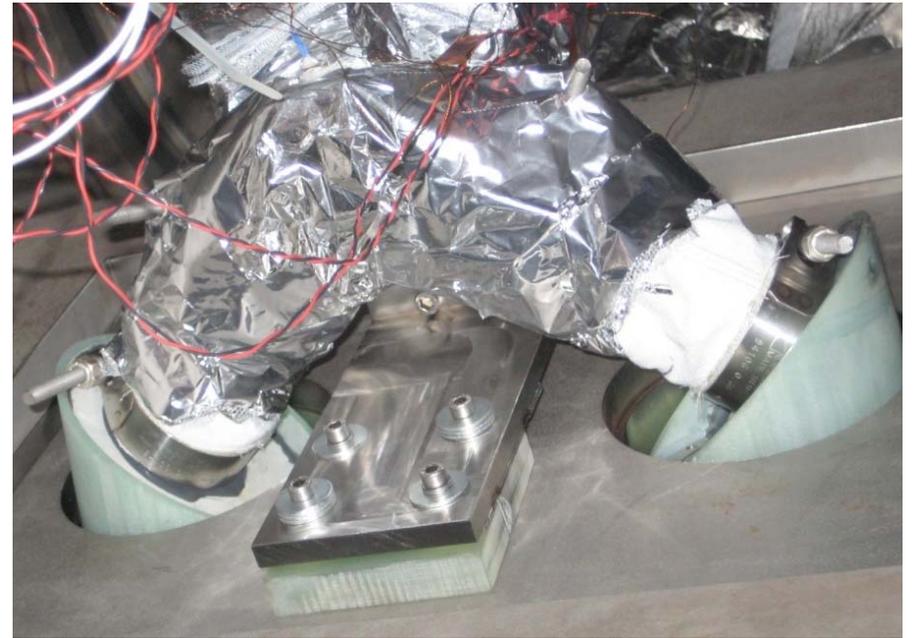
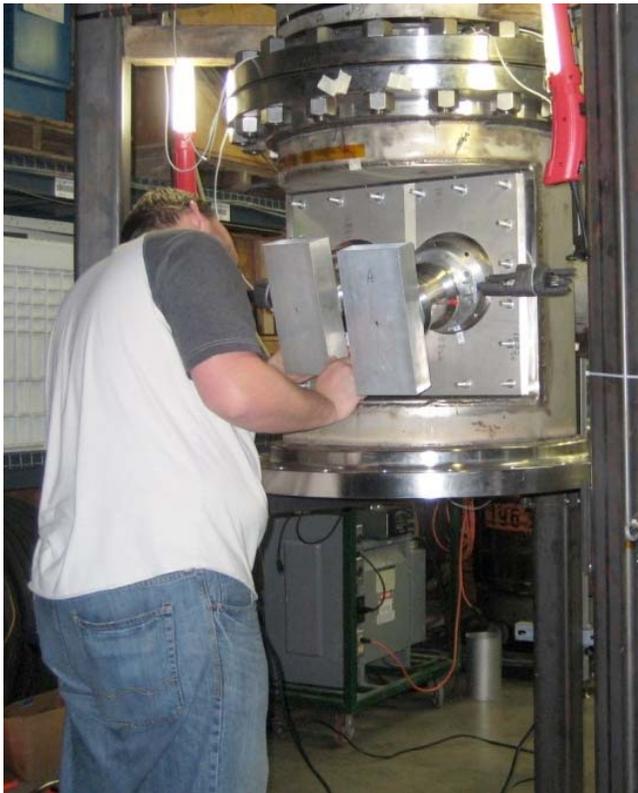
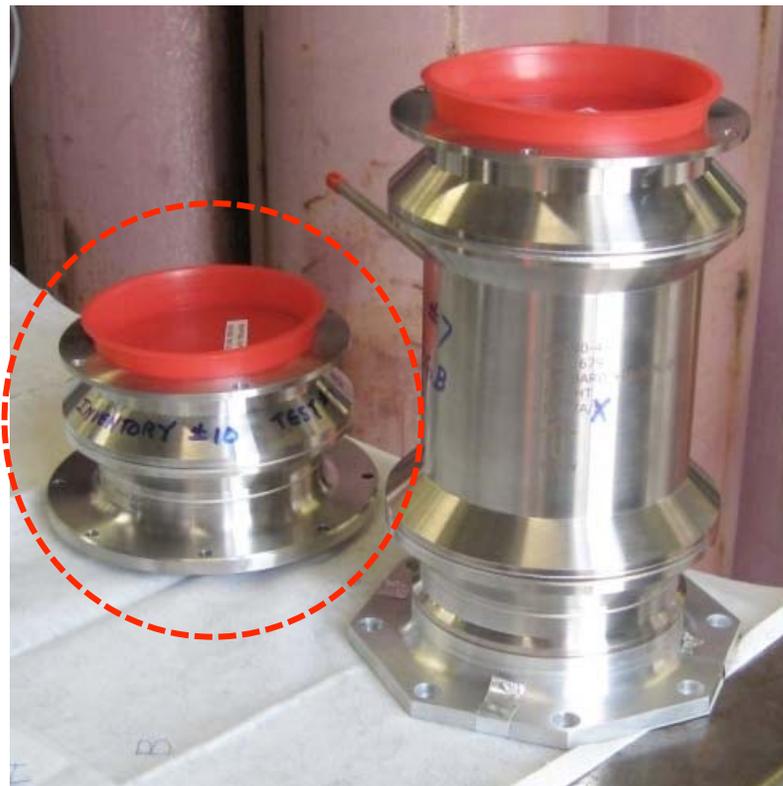
This is the first test to use a new flight-like BD06 in the "A" position. The "B" position has the remaining BD07A/B assembly with the "B" disc removed.

1/8" diameter (3.175 mm) holes were drilled in the Angled Adapters to reduce the negative differential pressure on the PTFE Liners and to improve conductance during pumpdown.

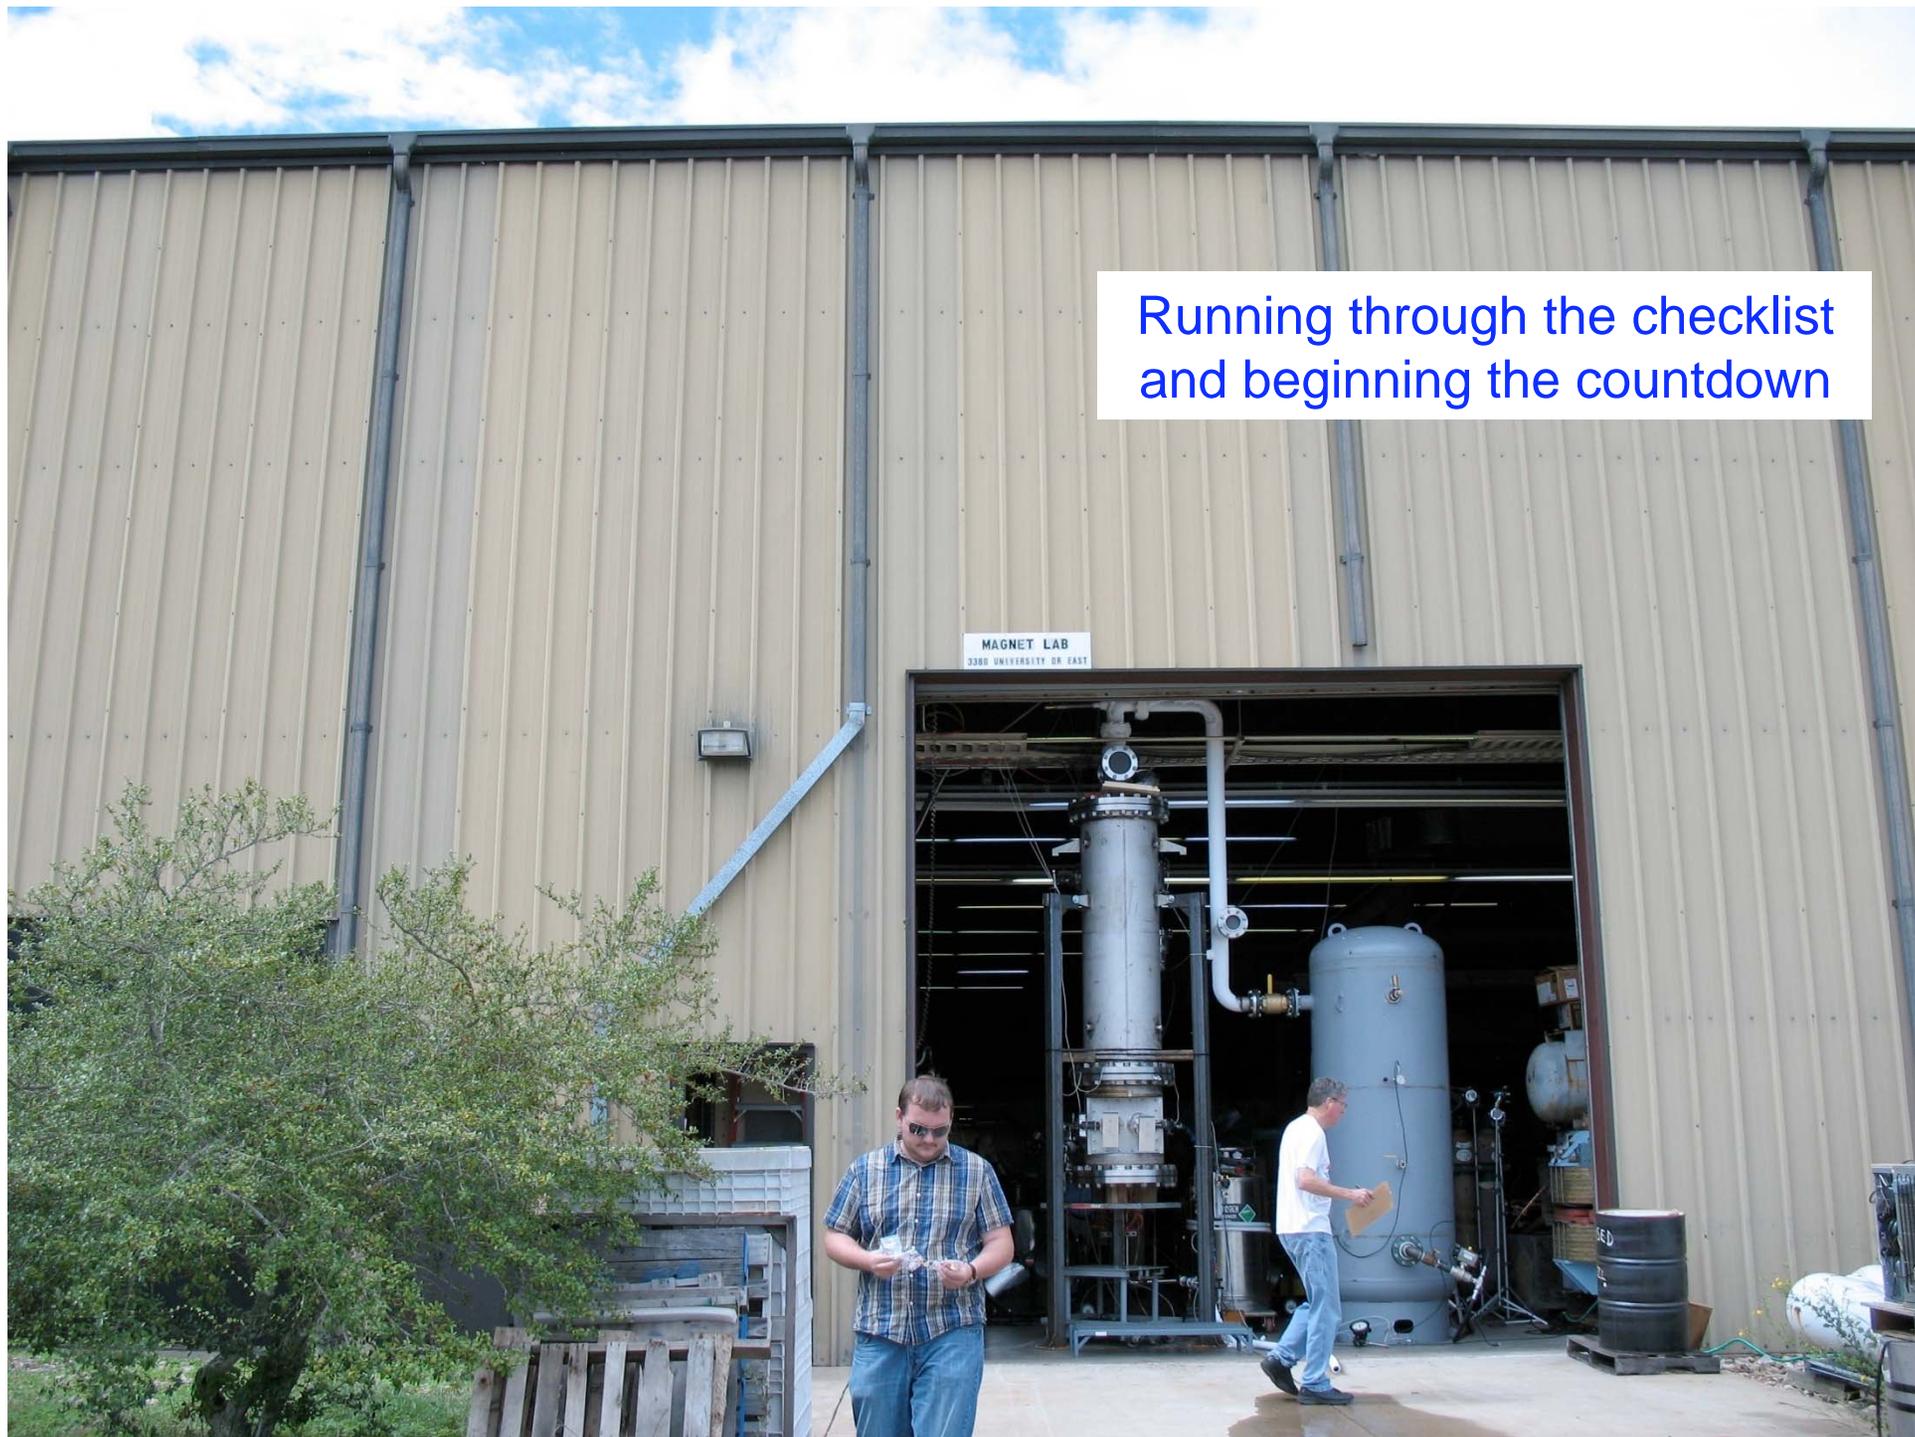
BD03 rupture occurred ~17 seconds after the loss of vacuum was initiated.

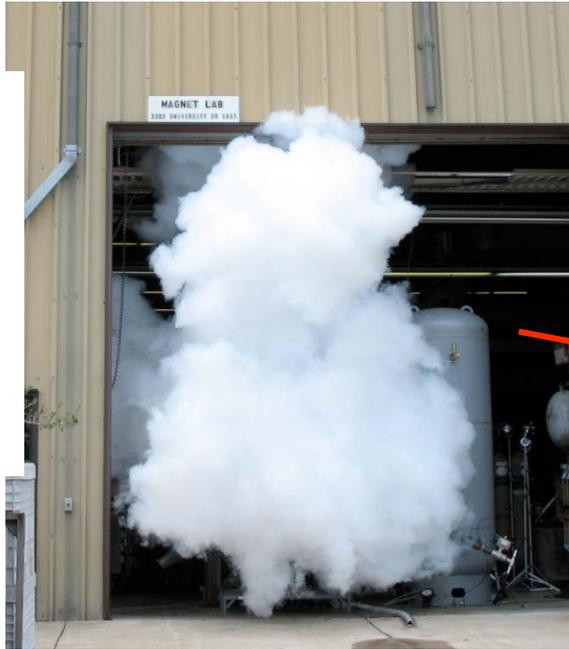
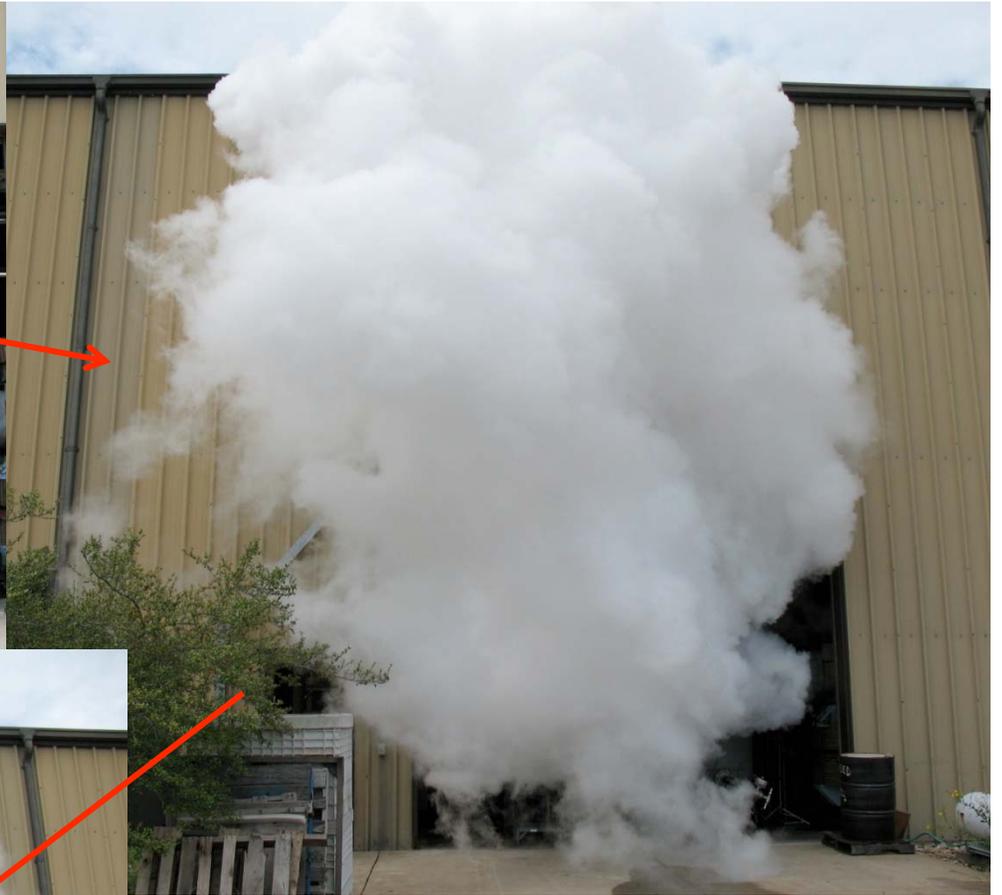
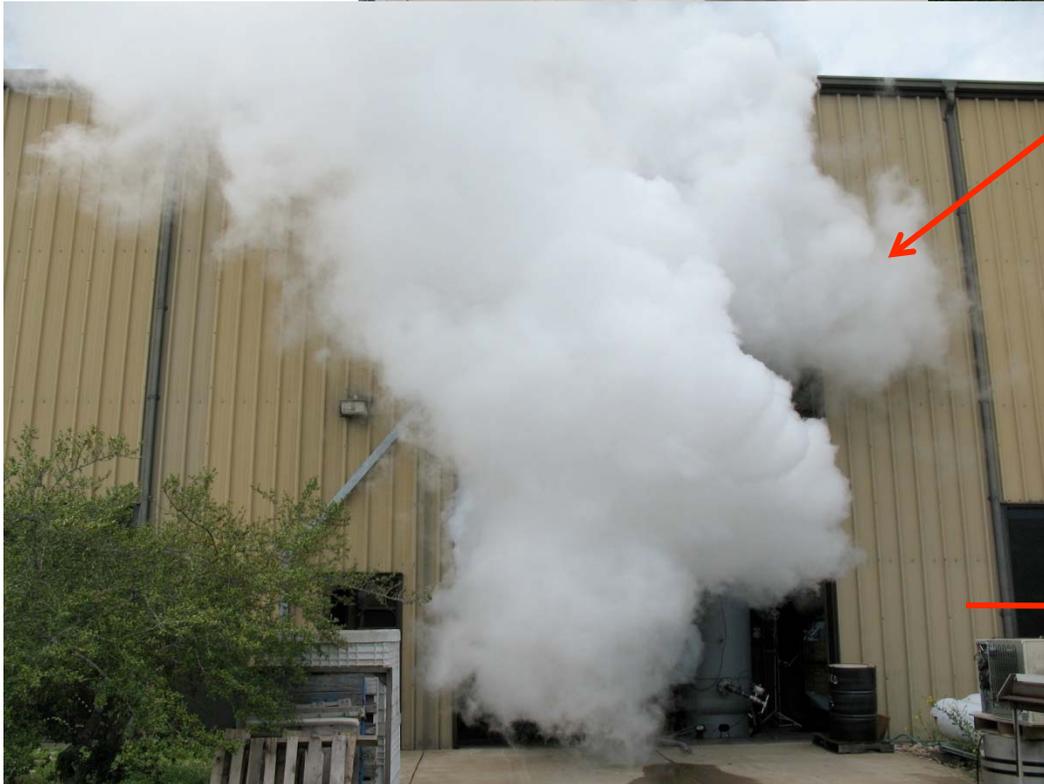
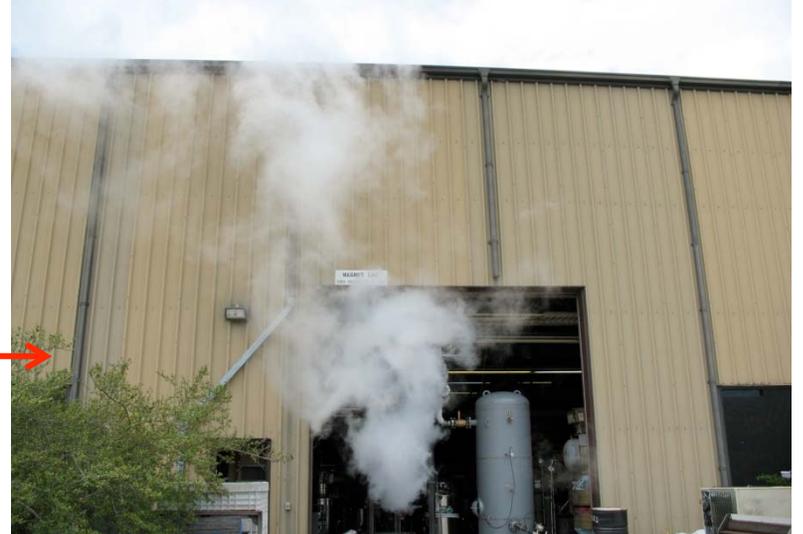
As before, the external hardware was quite frosty after the test. The exhausts were wrapped in plastic to minimize the moisture drawn in during the warmup.

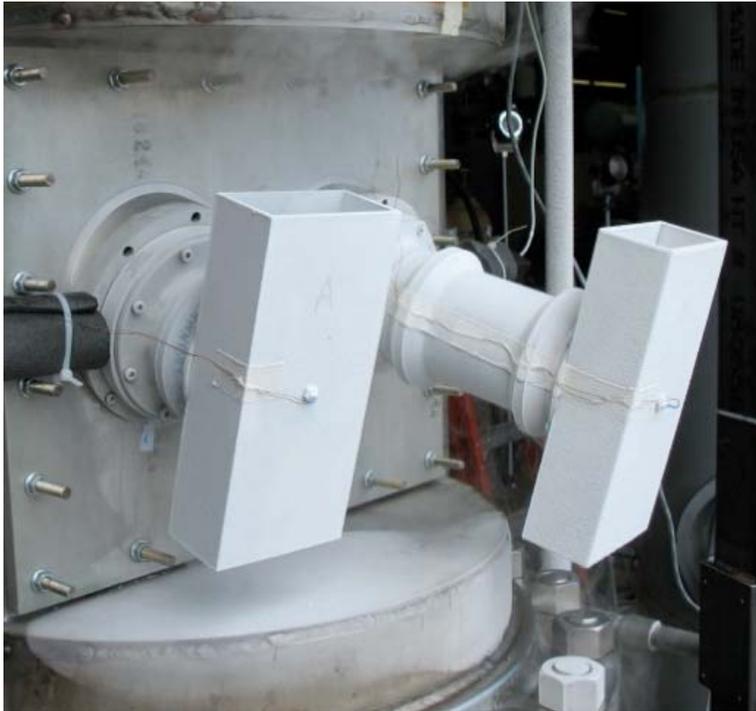
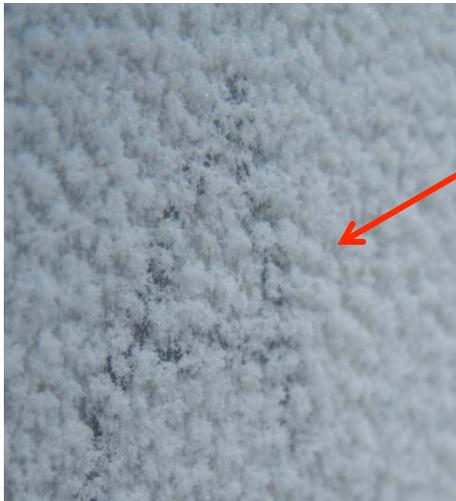
The frost became so thick, the letter "A" was almost completely obscured.

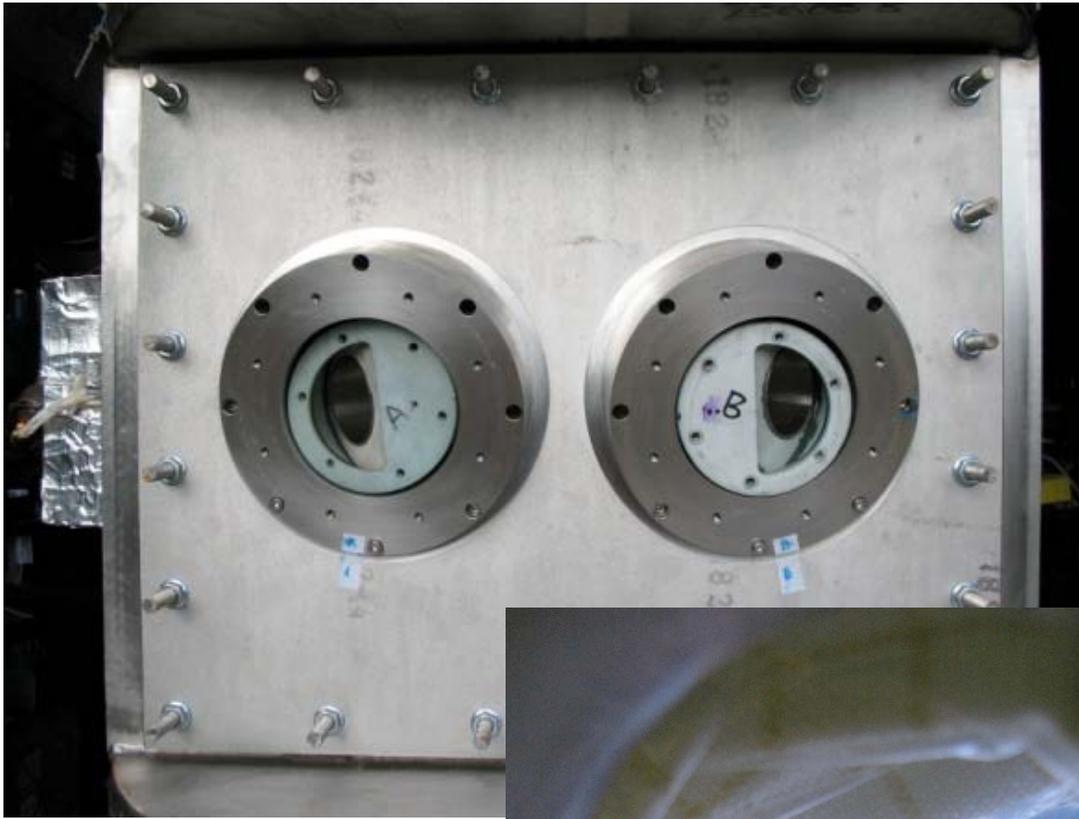
Initial inspection of the flexible tubes during disassembly indicated the PTFE was intact.

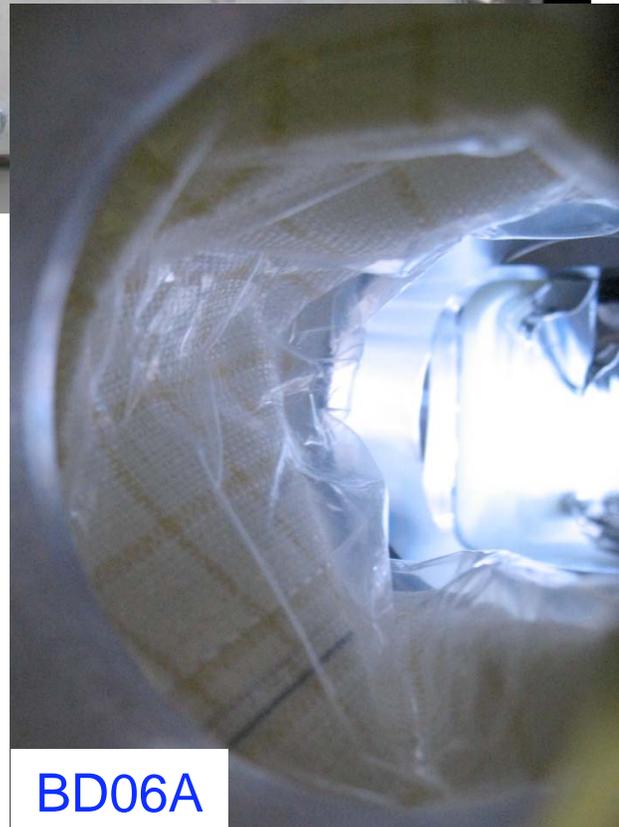
The new BD06A flight-like assembly performed as expected. The membrane folded back at the hinge line but remained attached. The membrane caused minimal obstruction to the shortened Zero-thrust Tee.

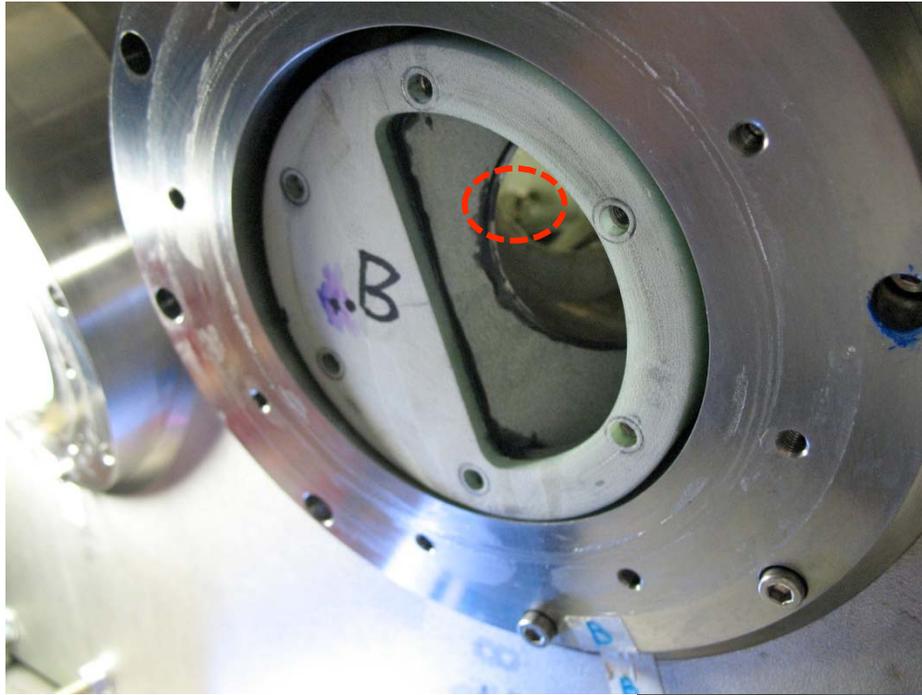
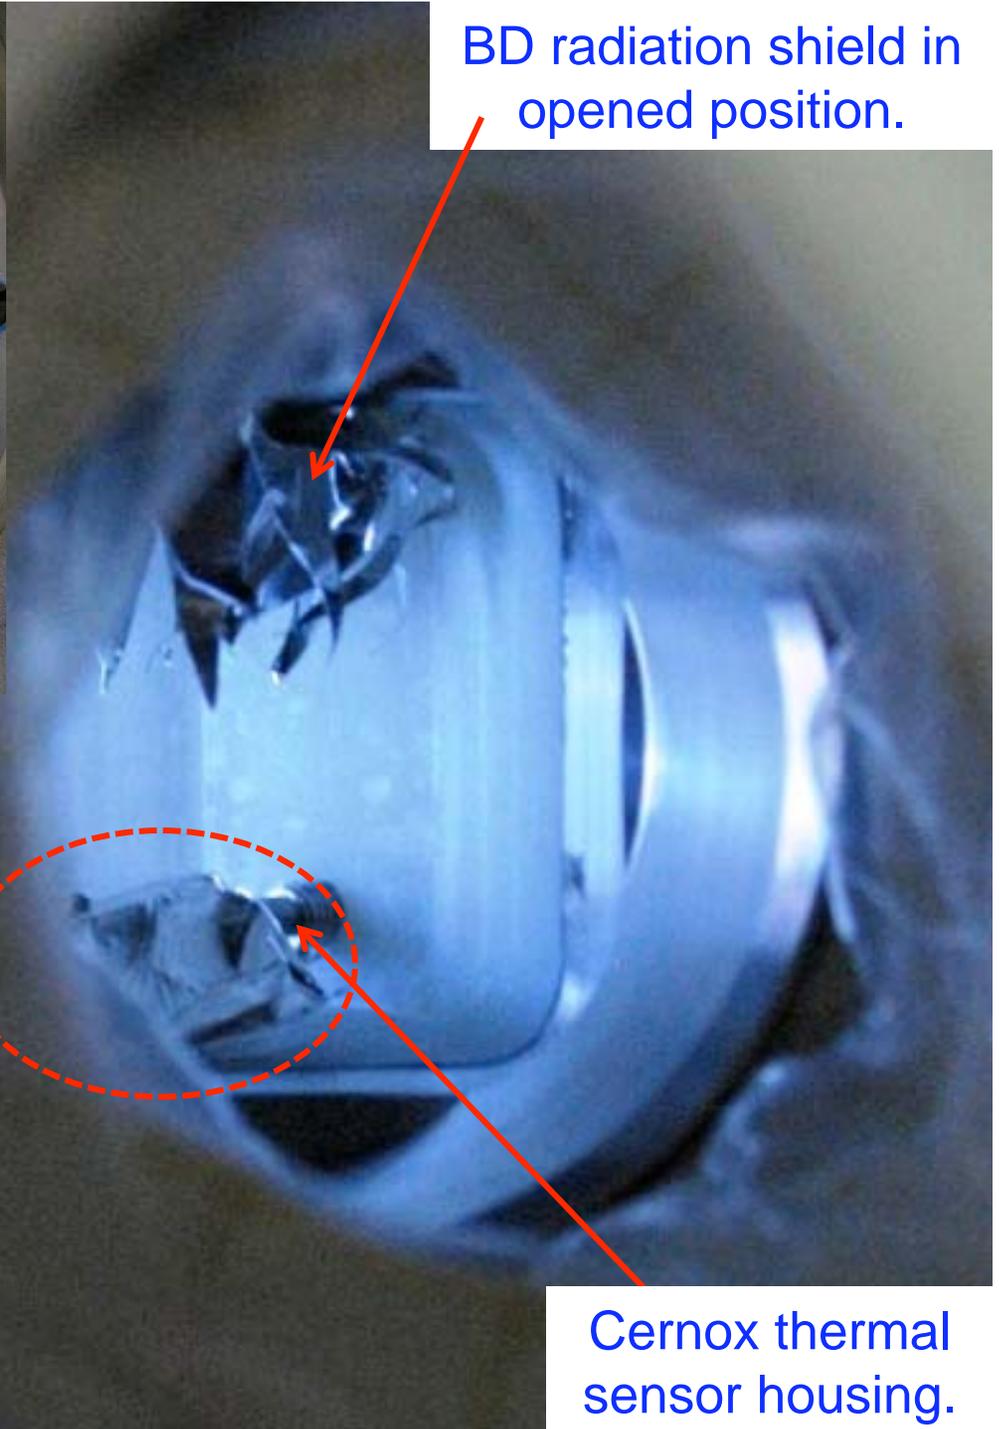
BD radiation shield in opened position.

Further inspection revealed the location of the BD03 disc membrane from the test at Culham that was placed on top of the BD radiation shield before this test. It had become lodged on the housing of the Cernox thermal sensor. The flight system does not have the sensor so the membrane would likely have exited the ductwork.

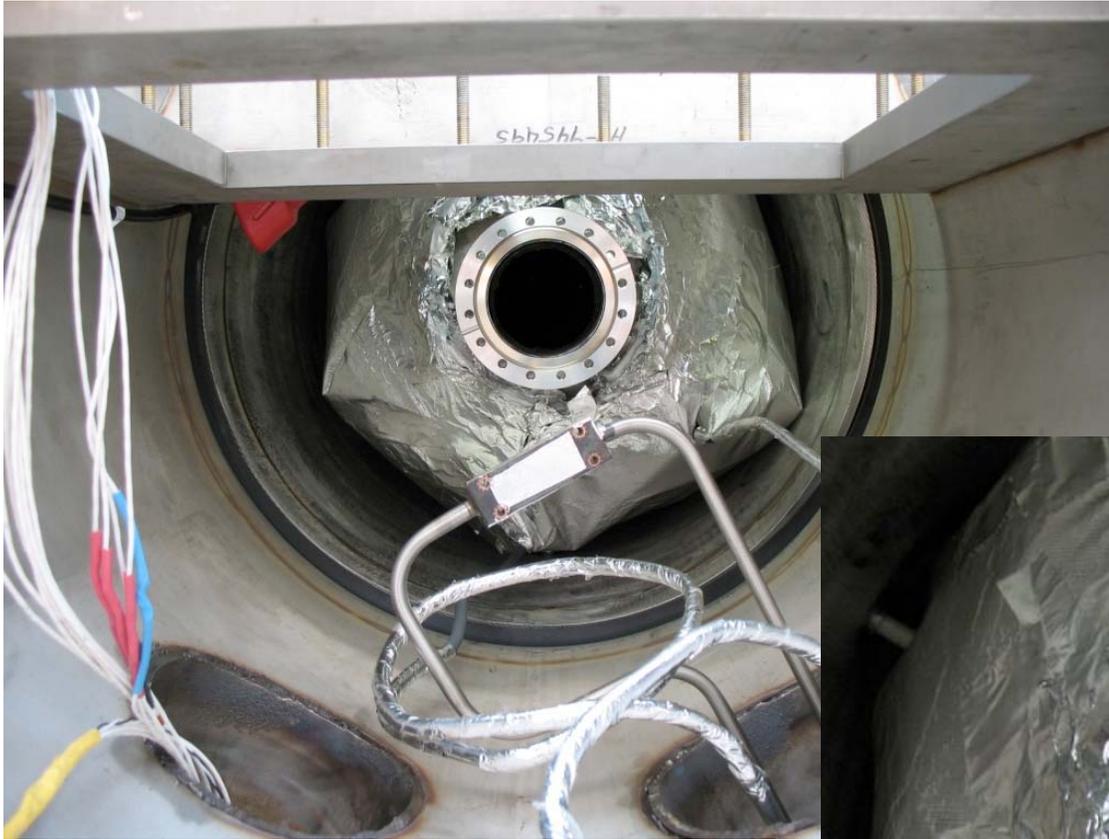
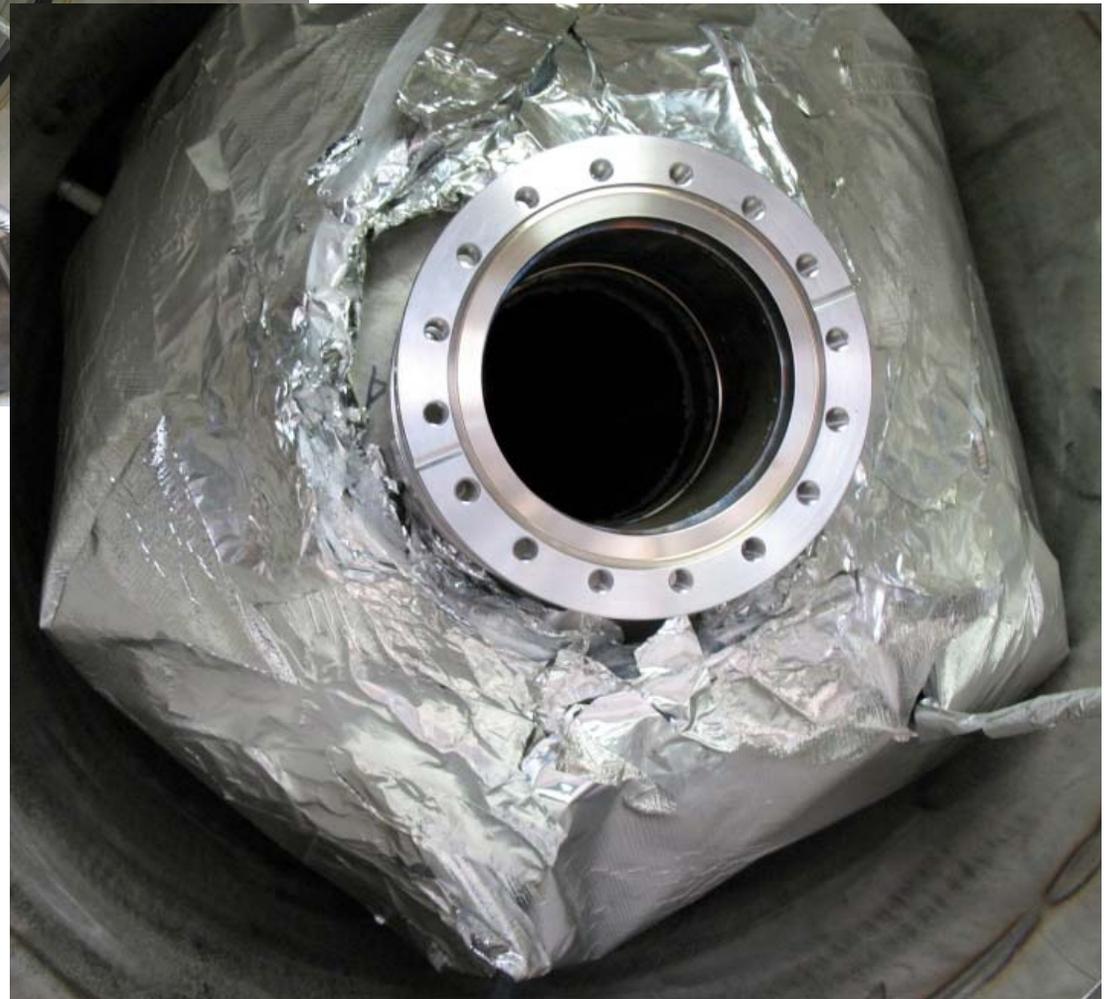
The MLI had minimal damage.
Part of one layer was torn from
the bottom of the Tee Box

The MLI on the LHe vessel was still intact after several tests.

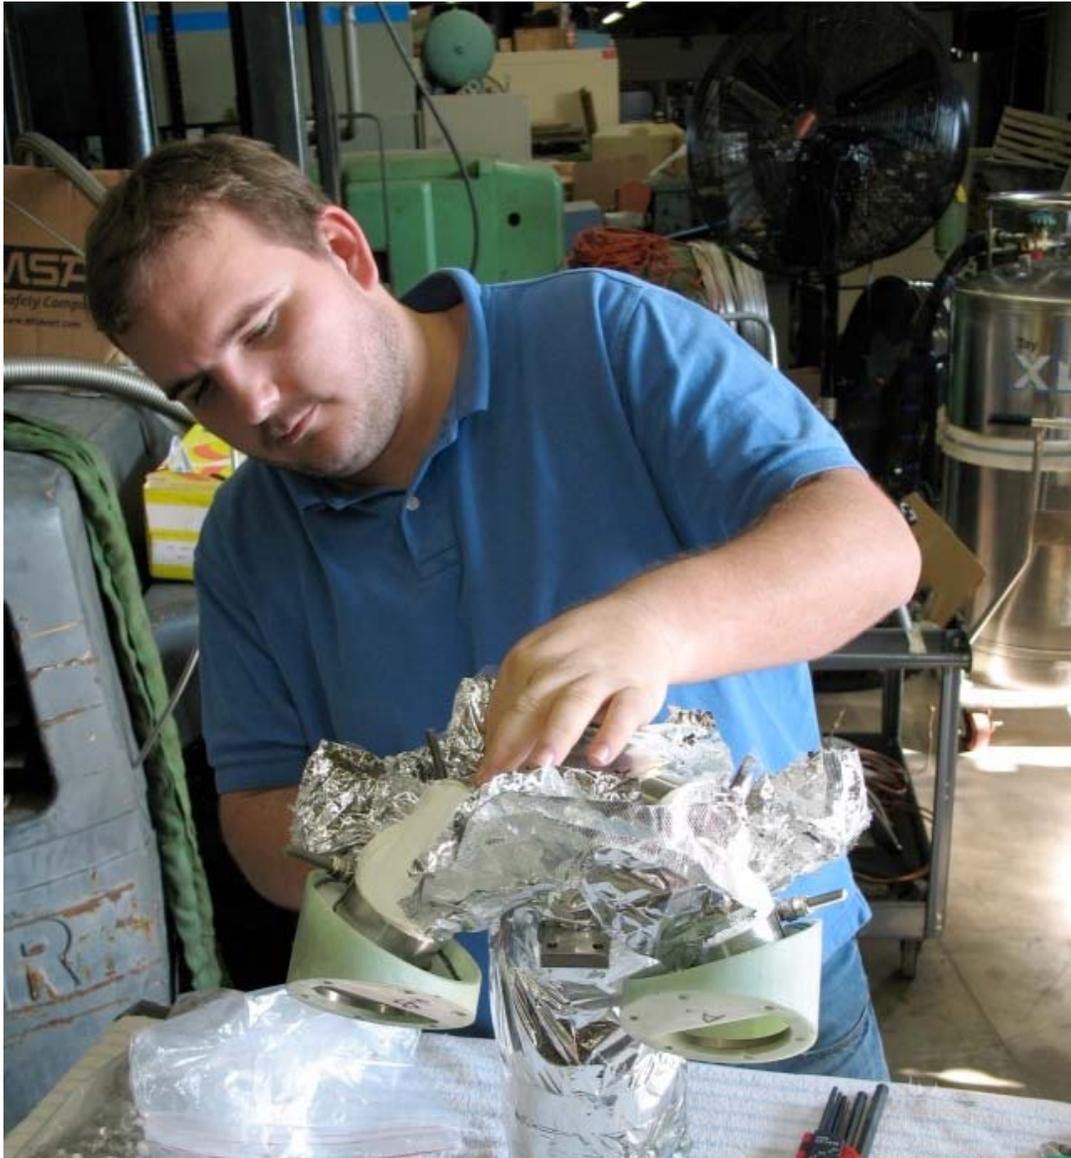
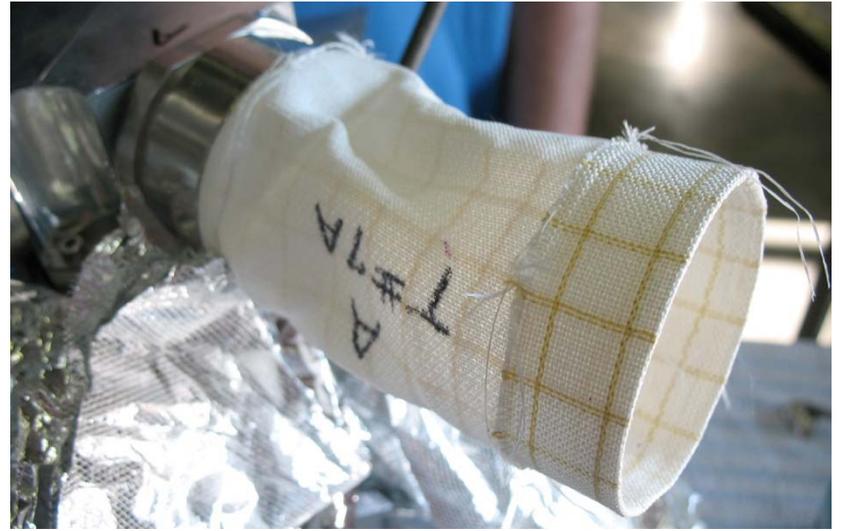
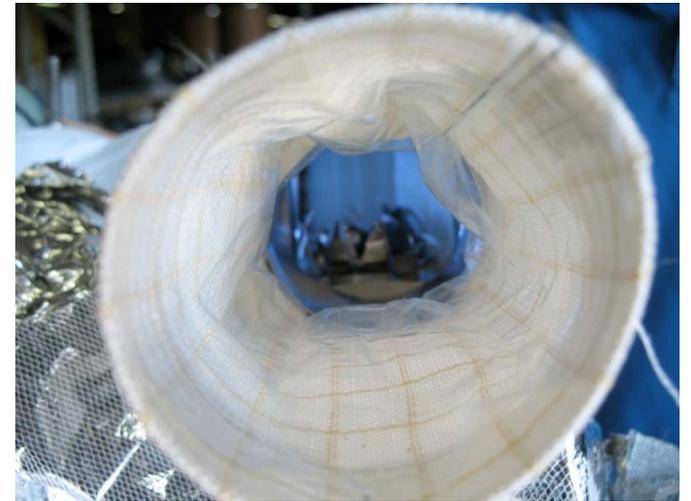
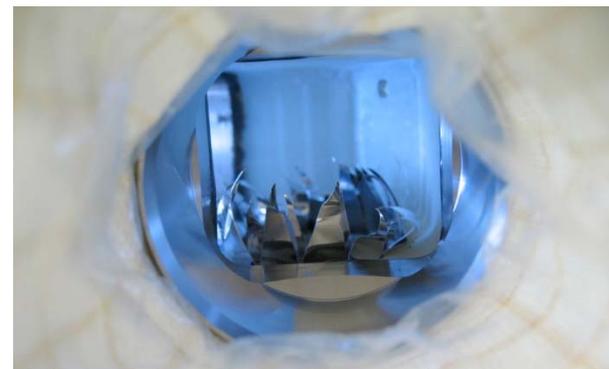
Continued
disassembly
revealed nothing
significant.

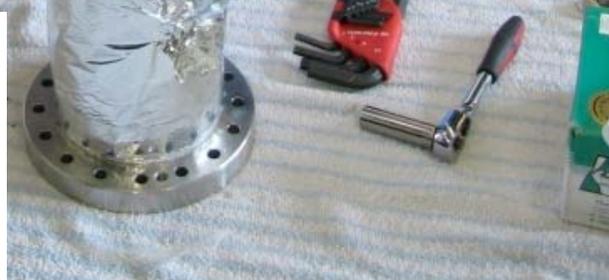
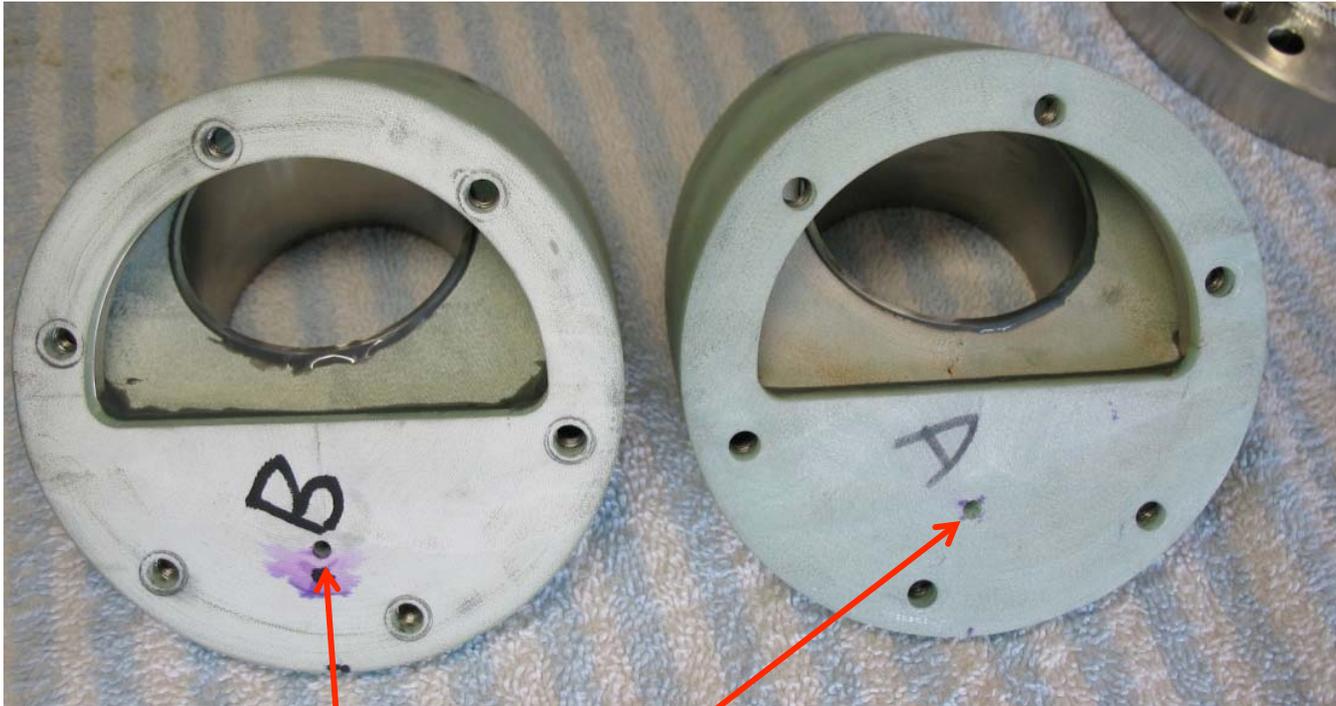
The Angled Adapter assemblies were fine.

1/8" diameter vent holes.

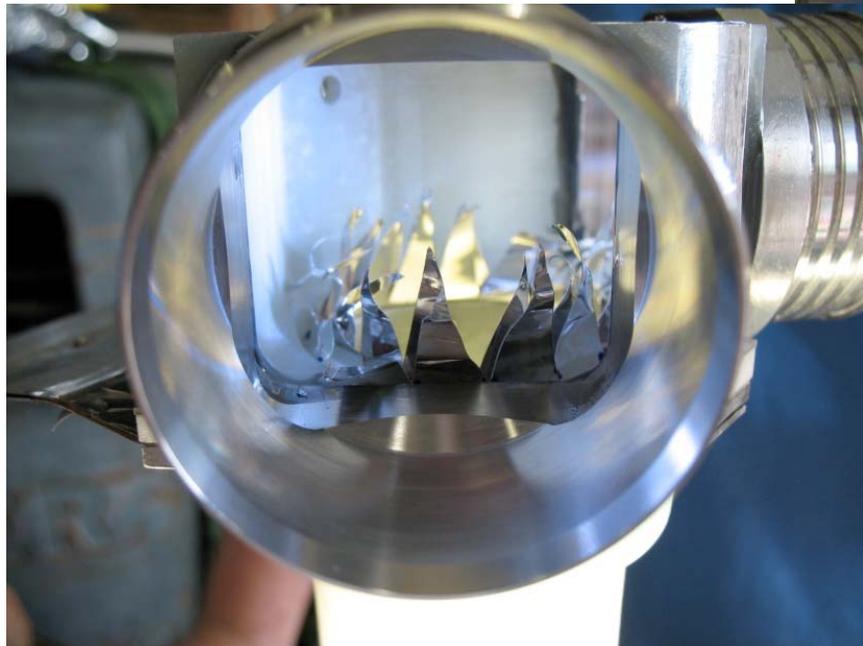
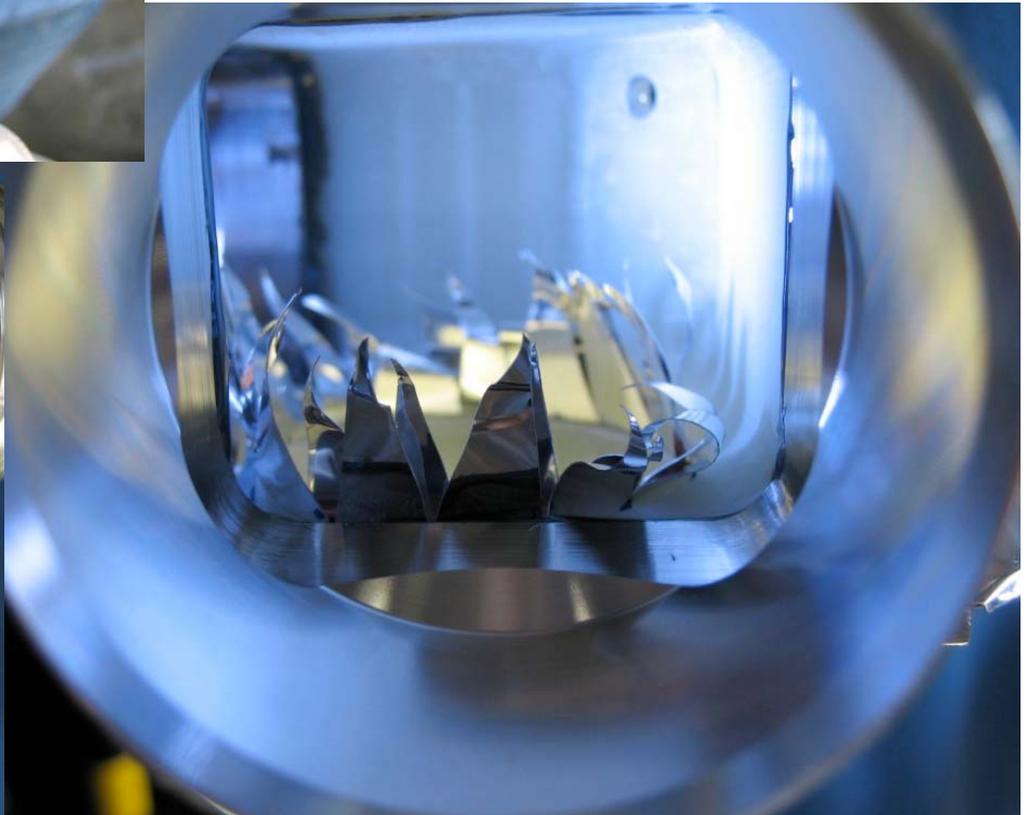
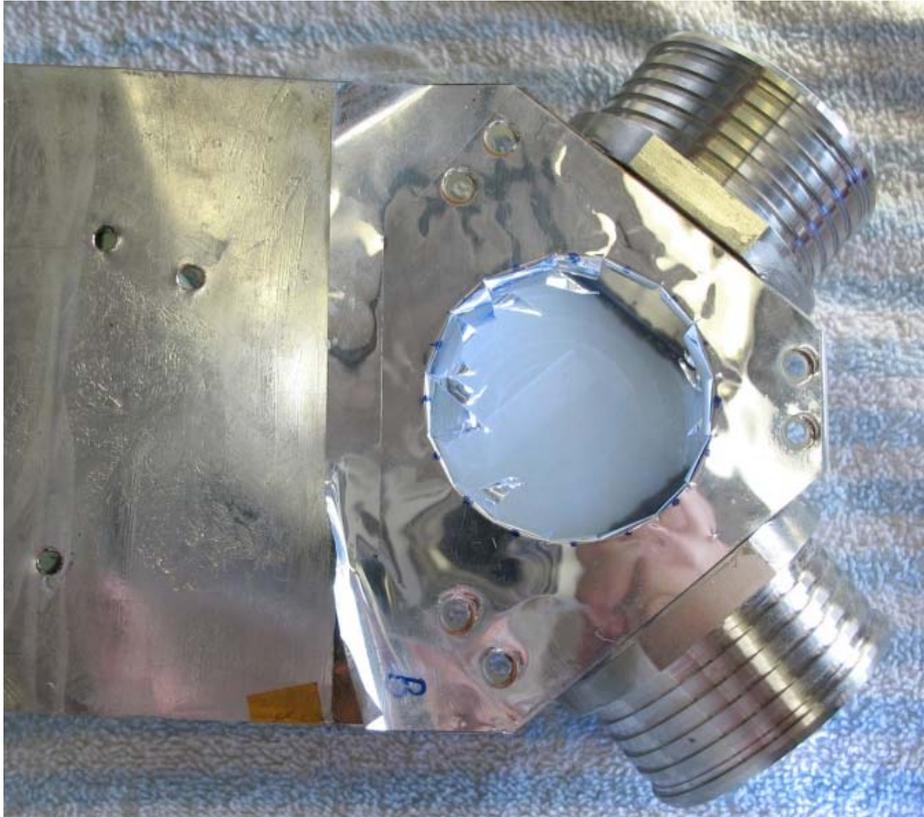
It appeared that this test generated no detached debris, despite the attempt to “sabotage” it with the separated BD03 membrane.

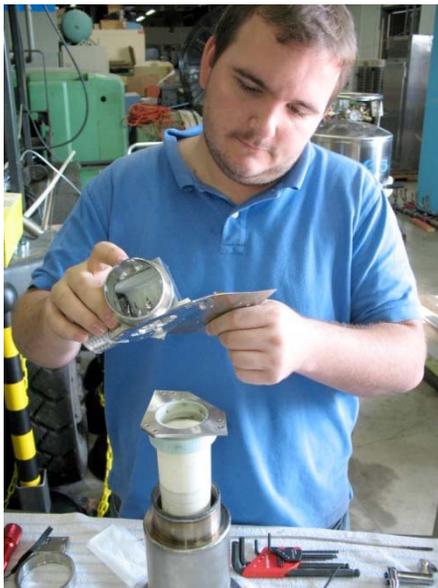
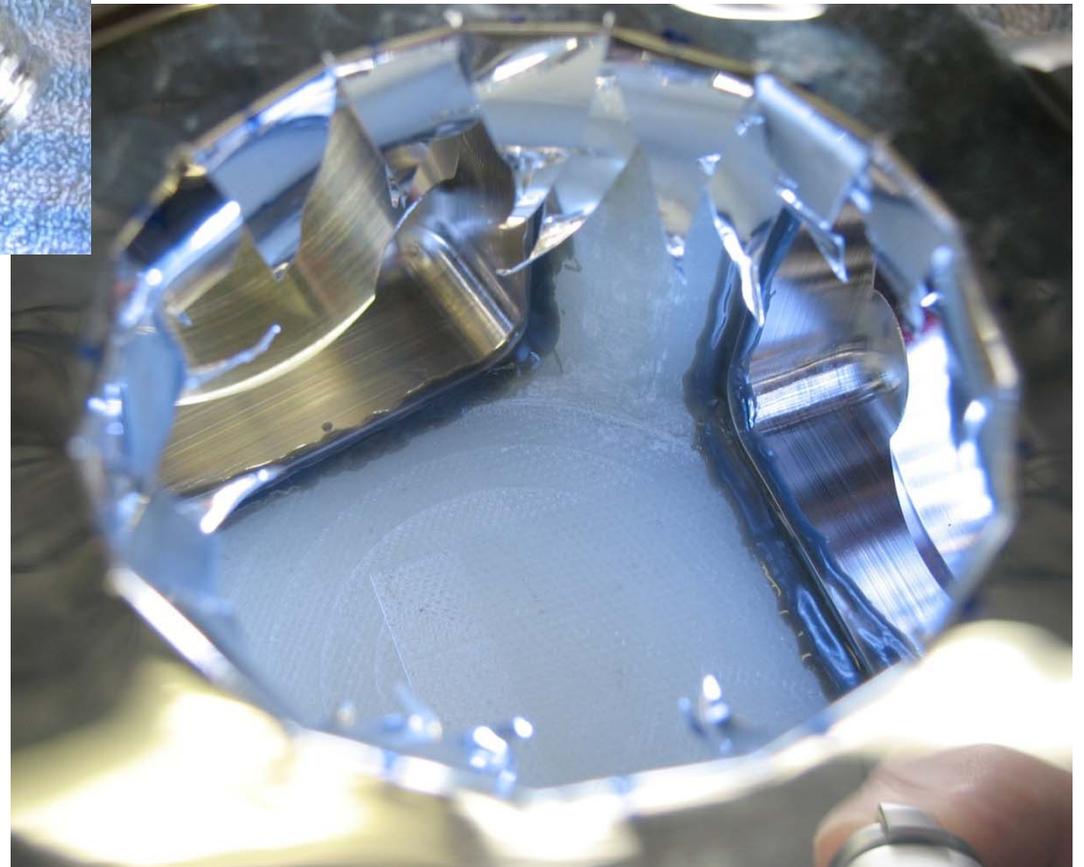
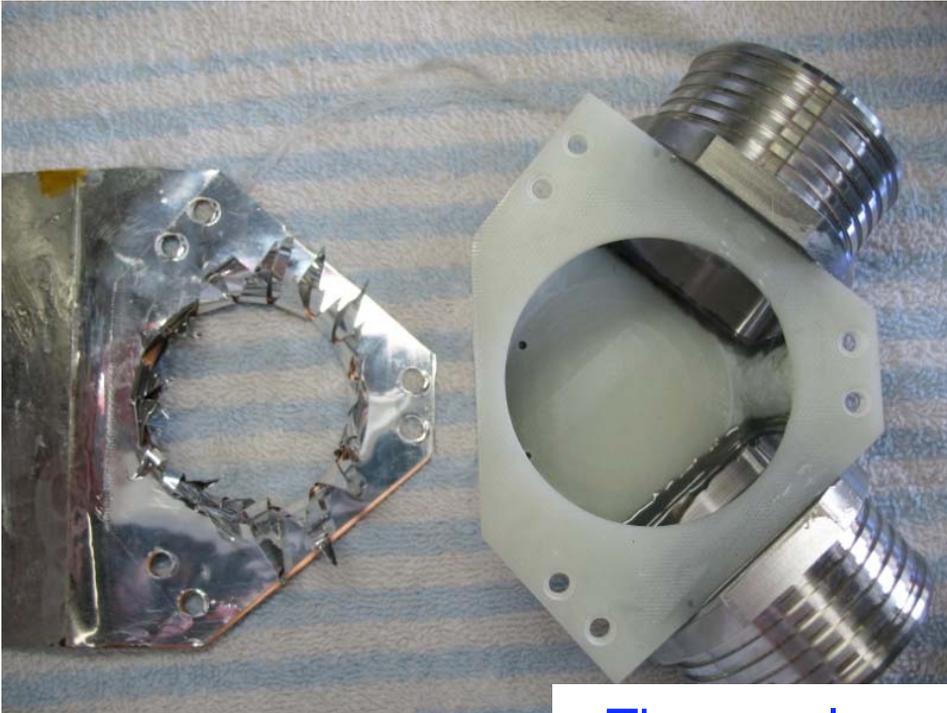
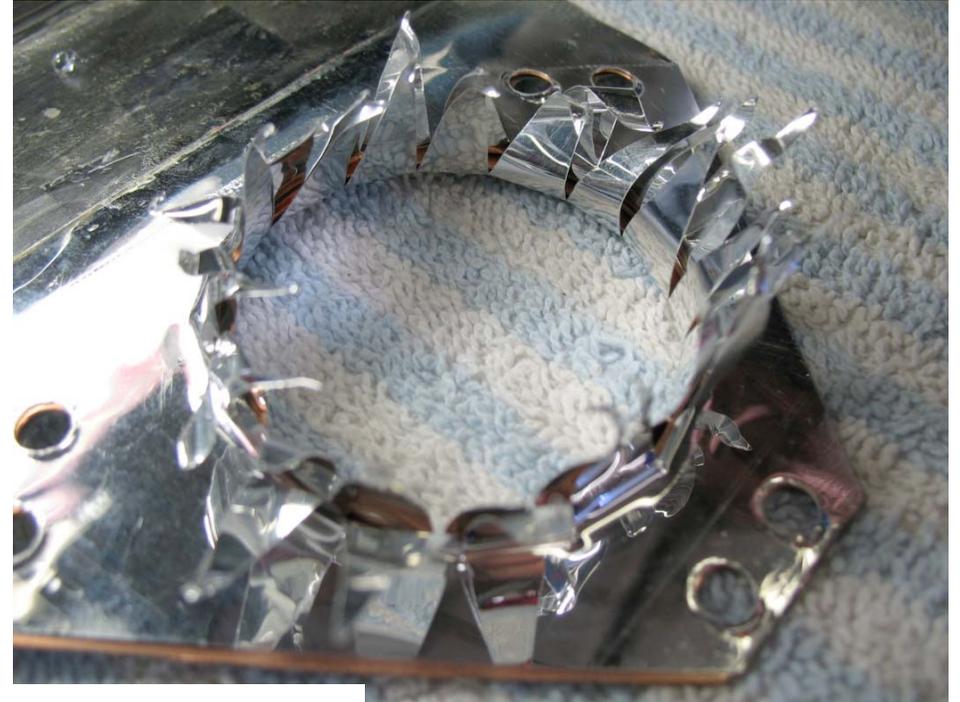
The usual opening pattern...
