National Aeronautics and
Space Administration

November 17, 2009

SUBJECT: AMS Burst Disk Vent Duct Redesign and Certification

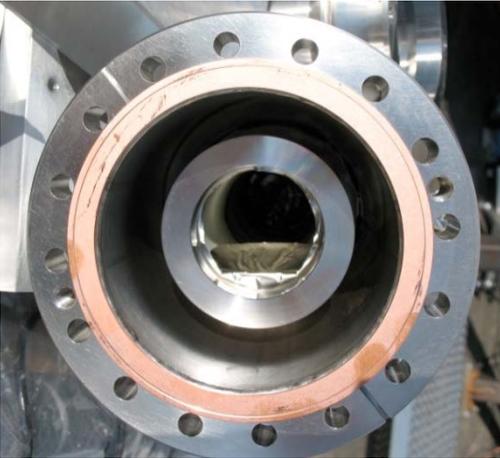
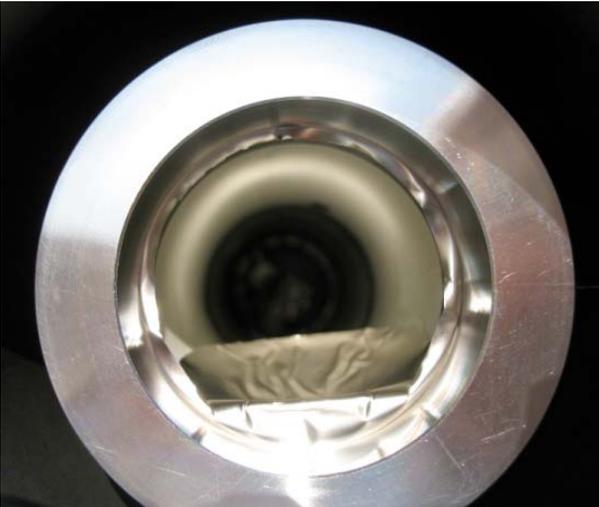
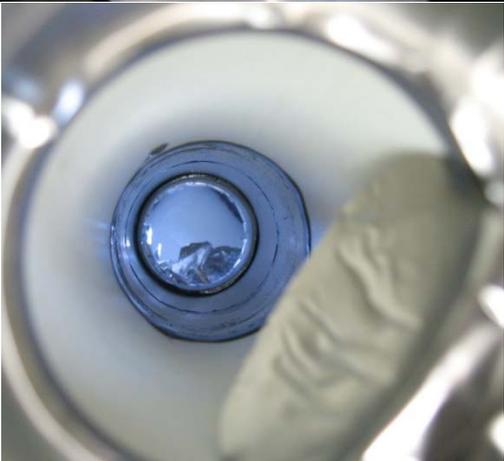
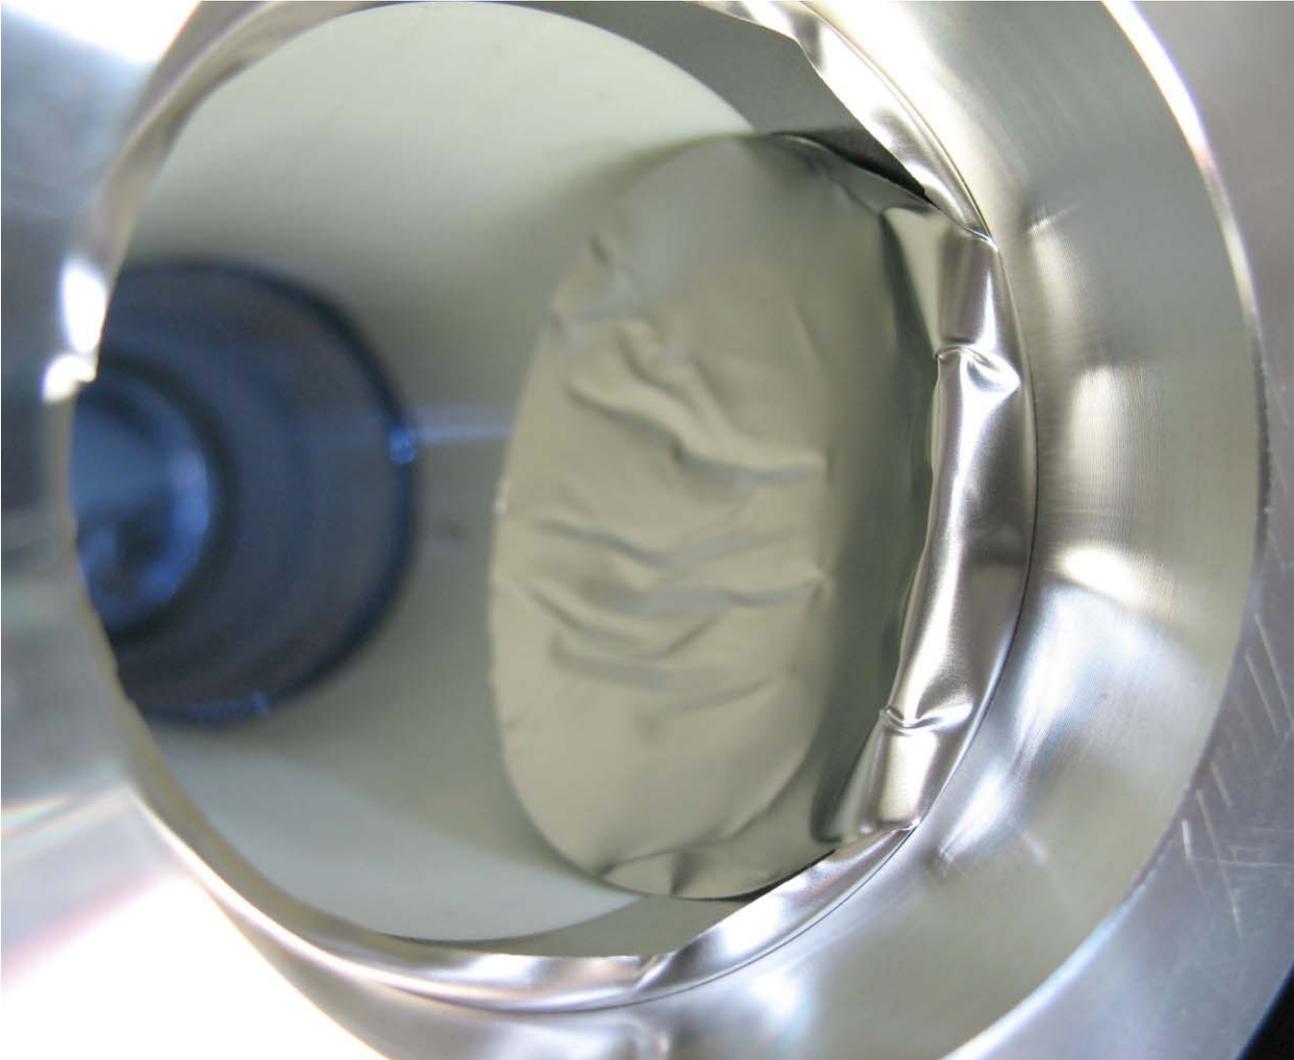
Inspection of the exhaust side of the BD03 flight-like assembly revealed nothing unusual either.

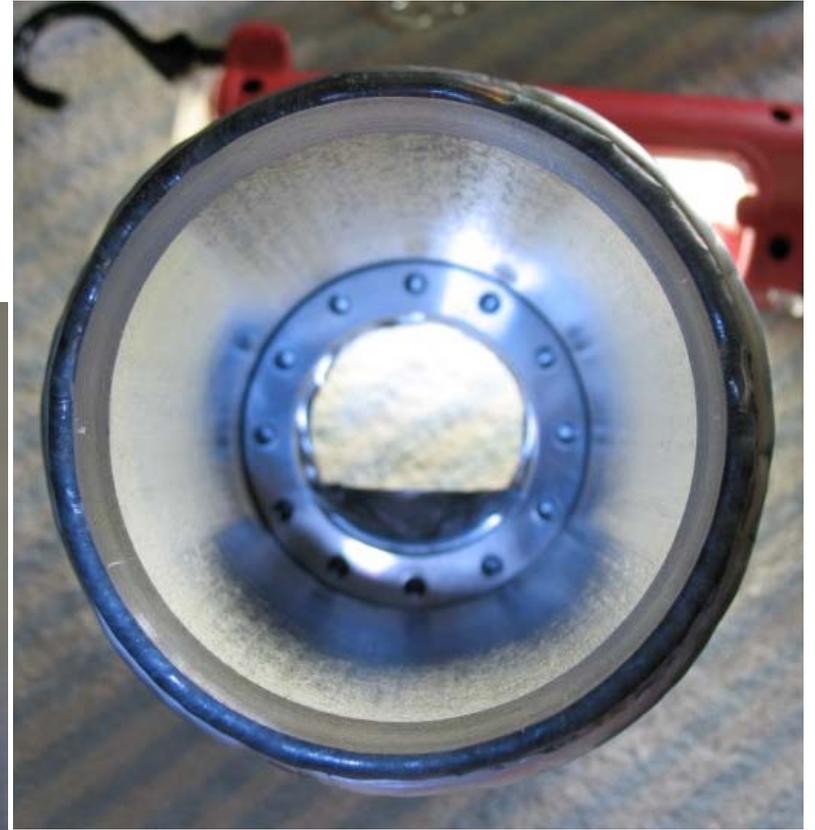
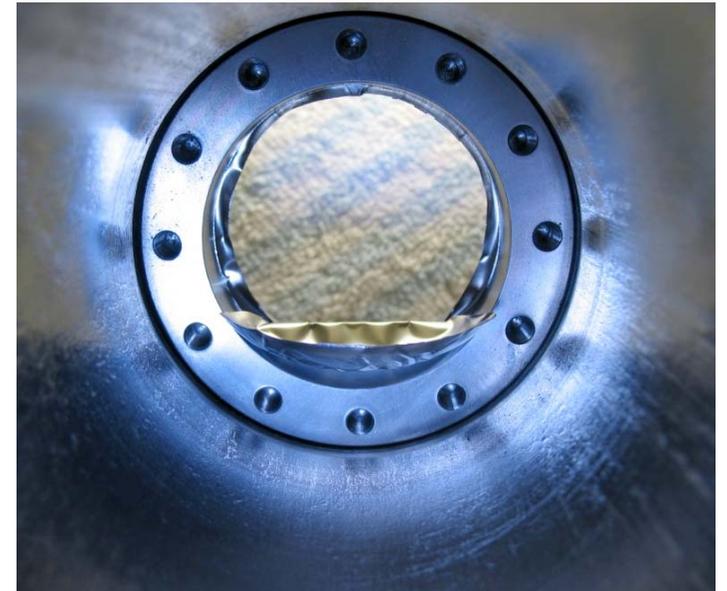
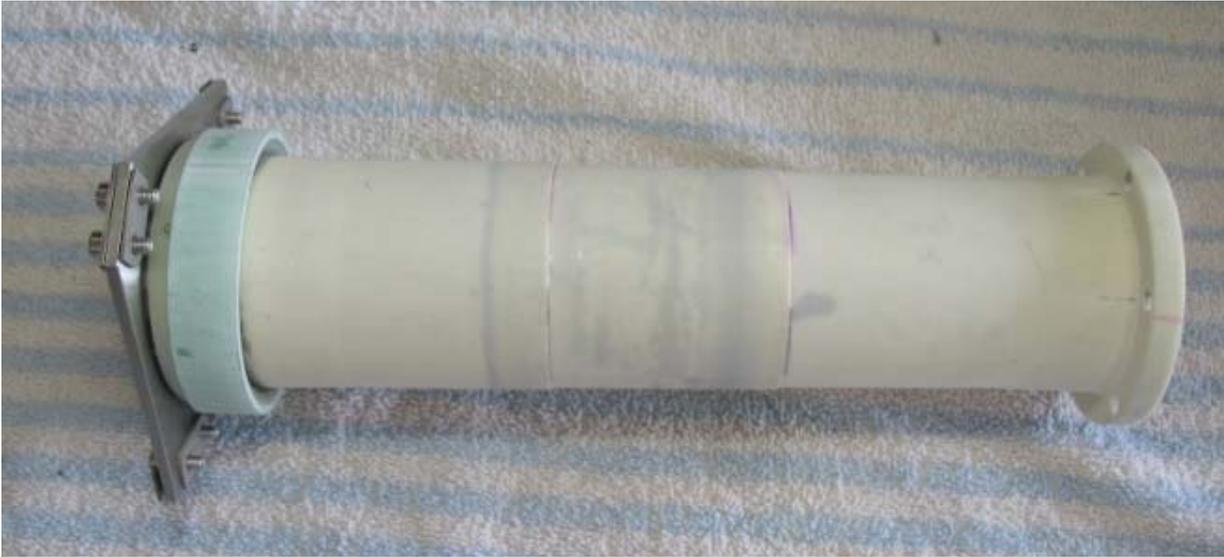
The only thing of note was that the external collar on the Telescoping Tube was found to be at an angle. This may have occurred during removal from the test set-up. It was realigned and the entire assembly will be reused in Test #8.

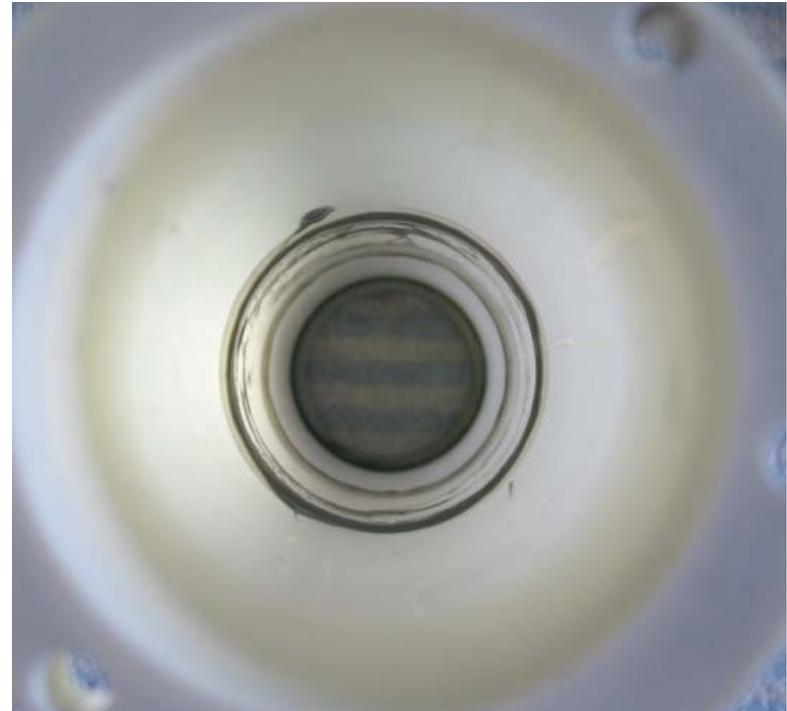
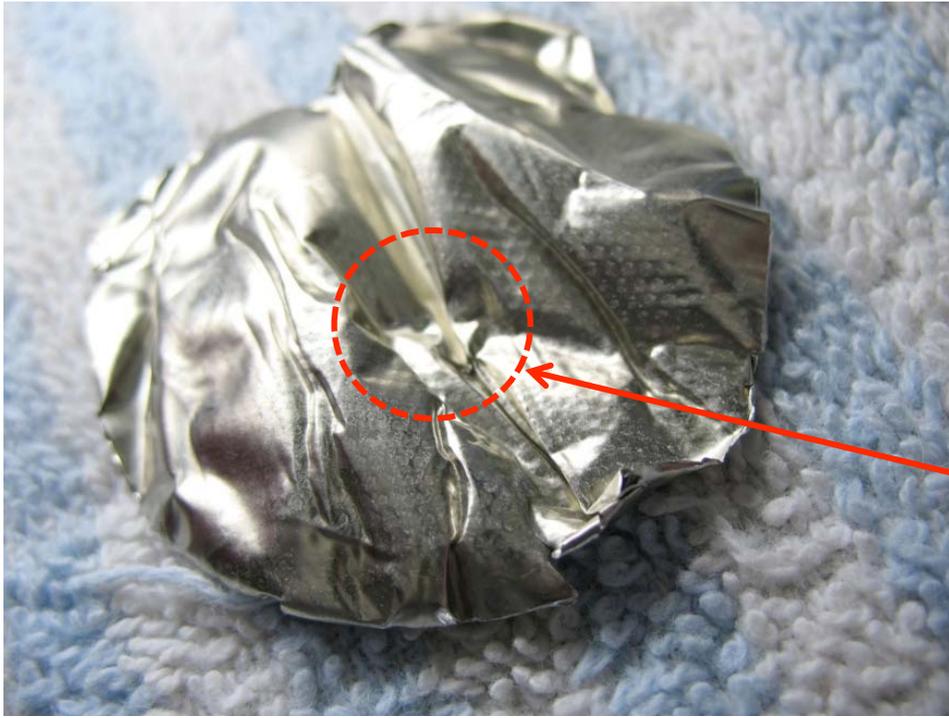
This is the detached BD03 membrane from the test at Culham installed on top of the BD radiation shield prior to the test.

This imprint is from the Cernox temp sensor housing.

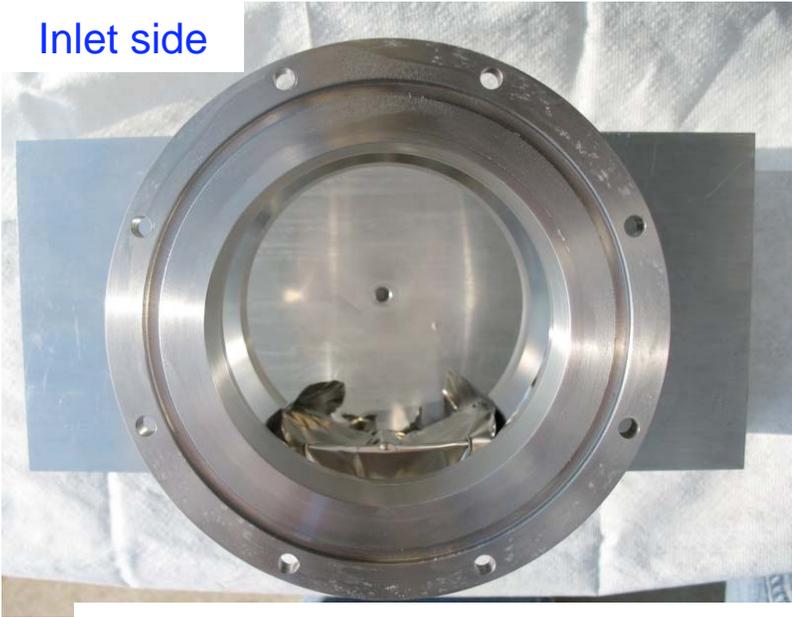
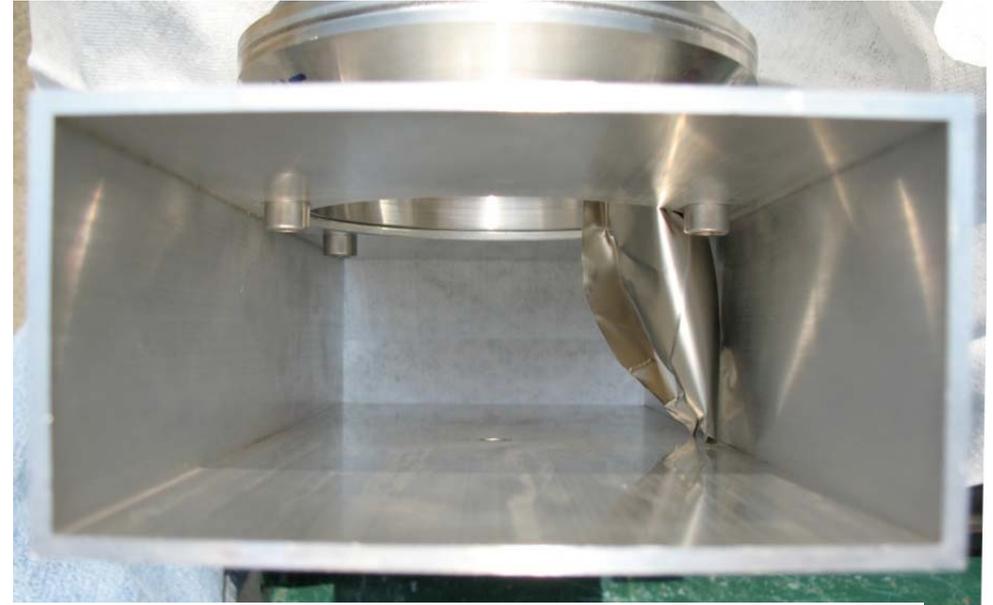
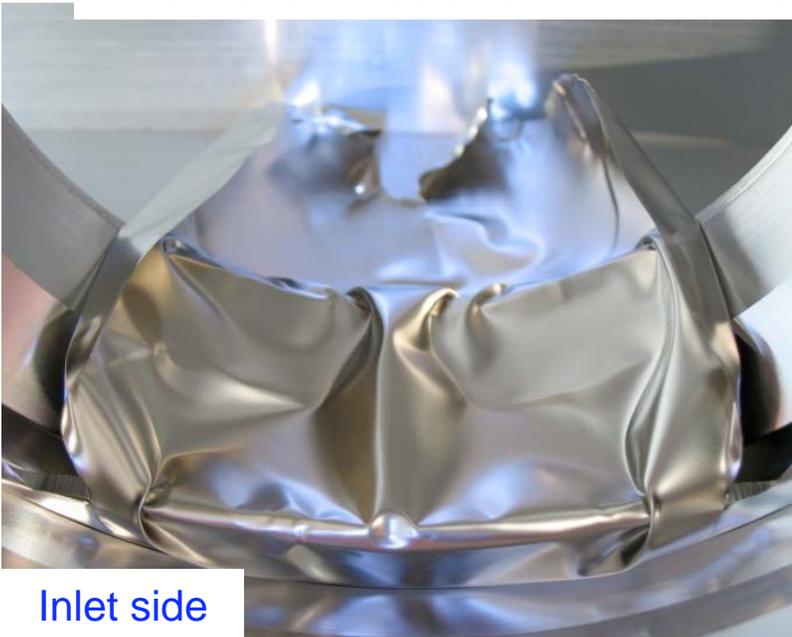
Inlet side

The new BD06A flight-like assembly performed as expected. The membrane folded back at the hinge line but remained attached. The membrane caused minimal obstruction to the shortened Zero-thrust Tee.

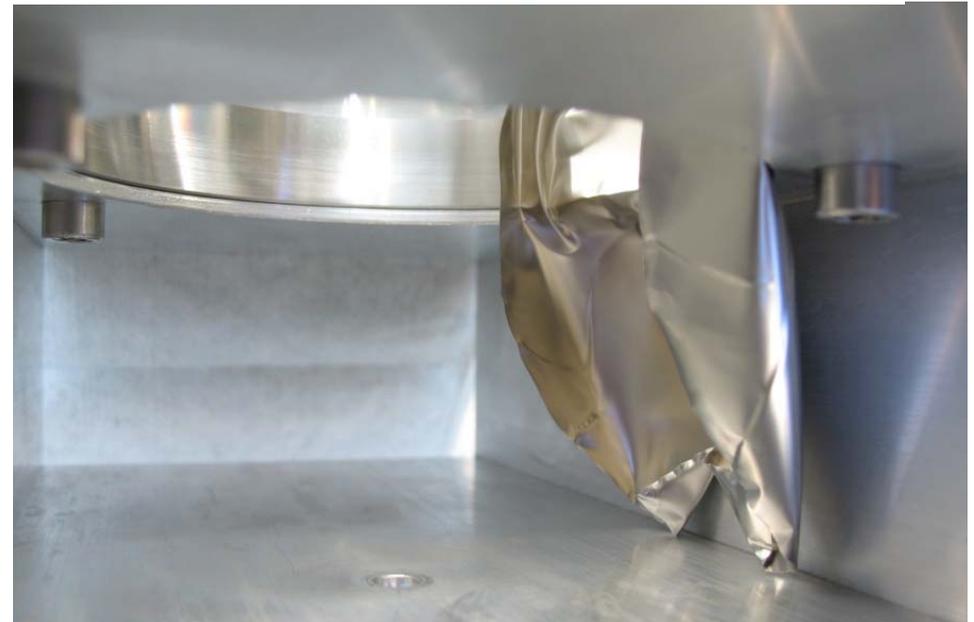
Views of the BD06A
assembly outlet side
with the Zero-Thrust
Tee removed.

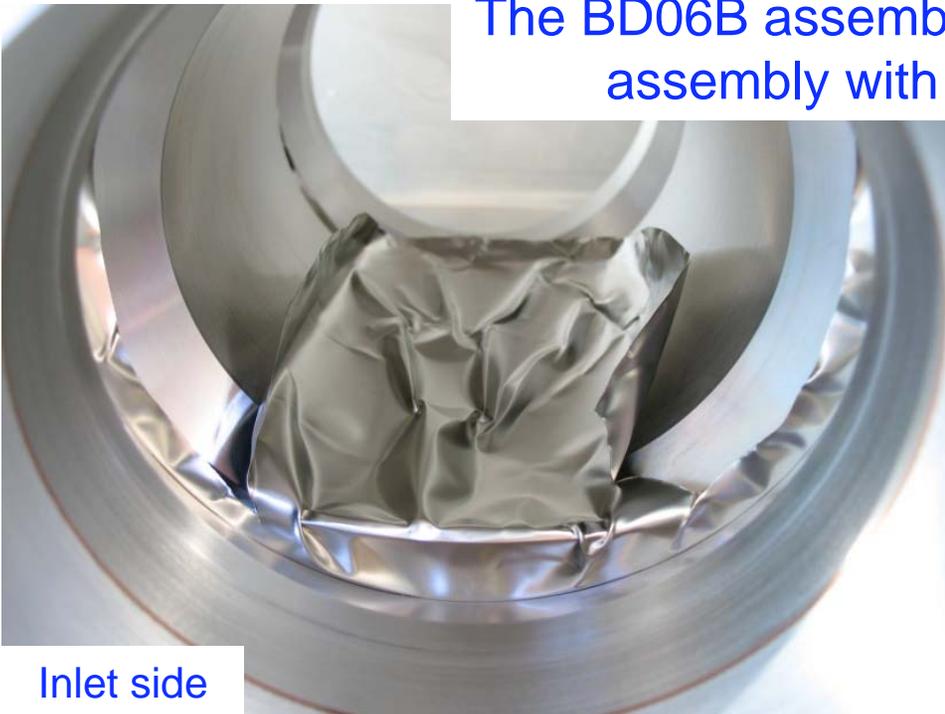
Inlet side

The BD06B assembly was a previous BD07A/B assembly with the "B" disc removed.

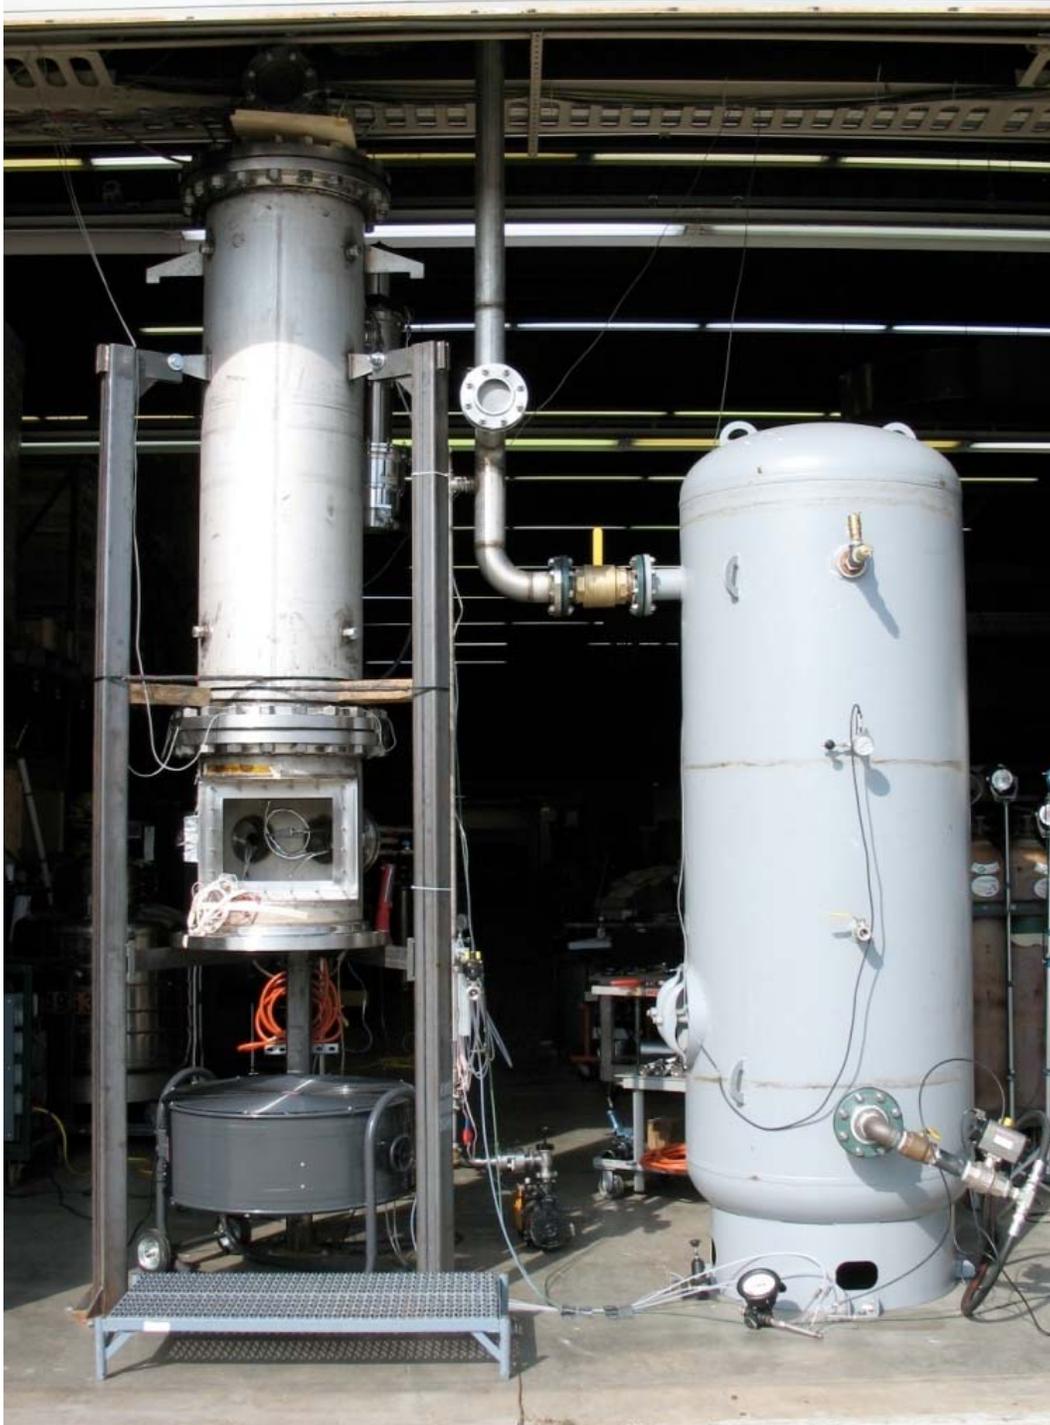
A large fan was placed under the test hardware to accelerate the drying prior to reassembly for Test #8.

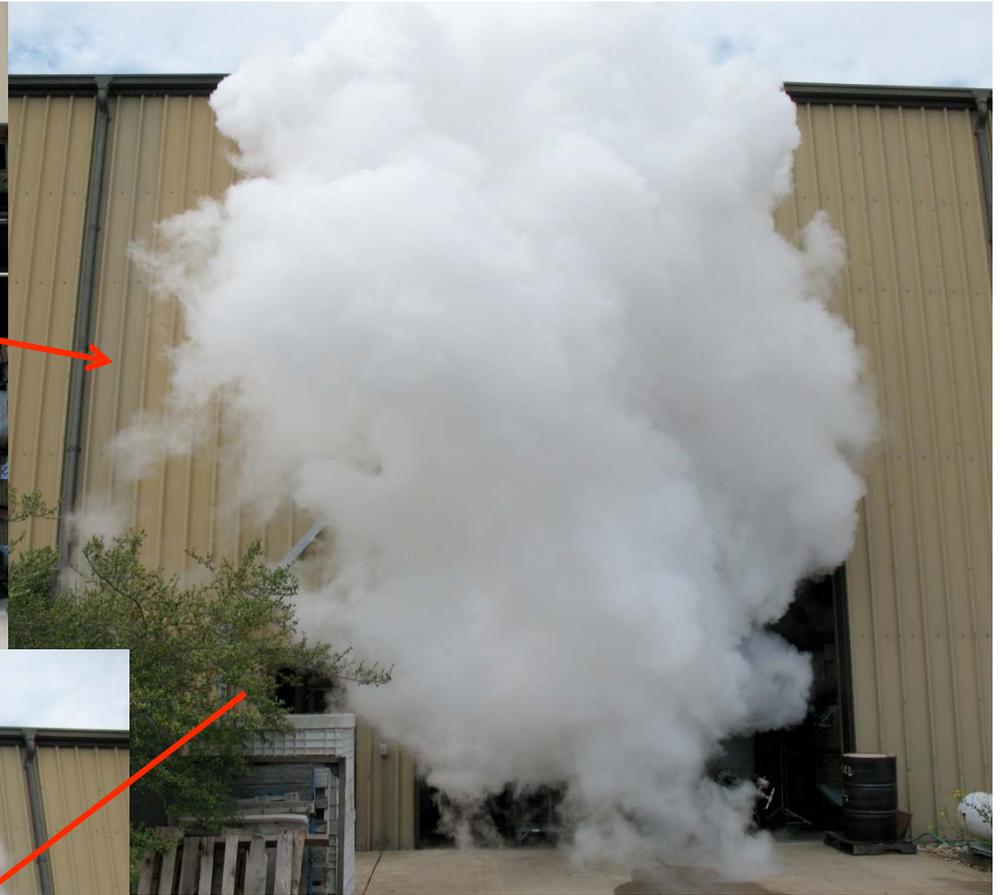
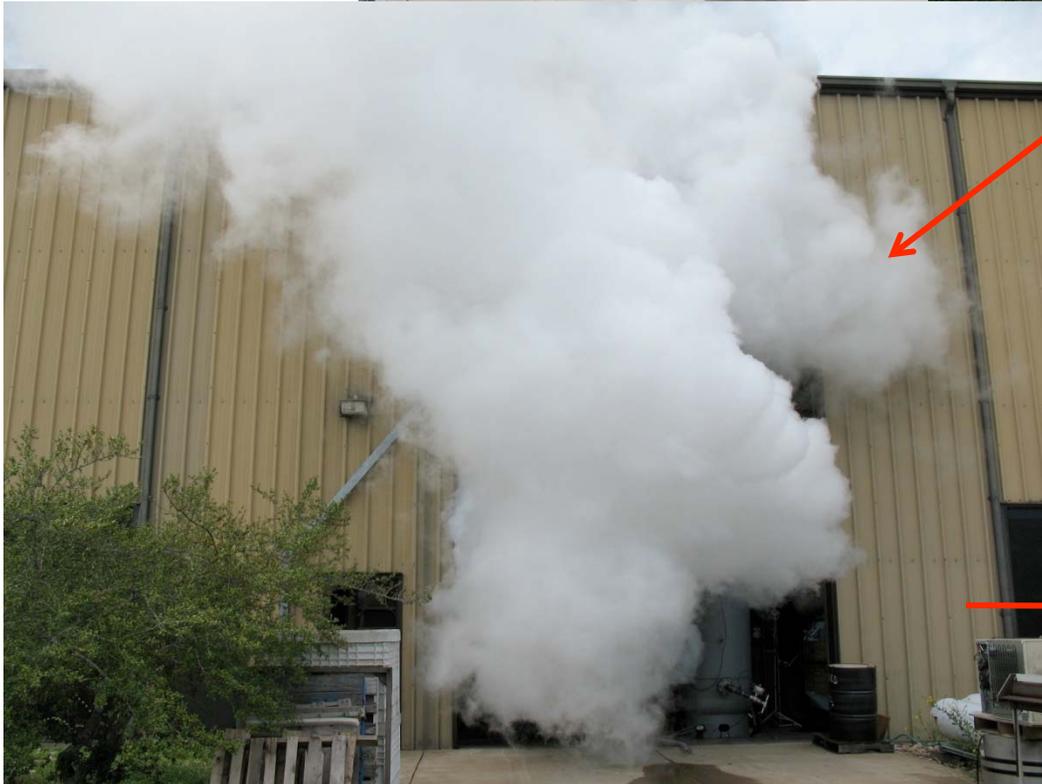
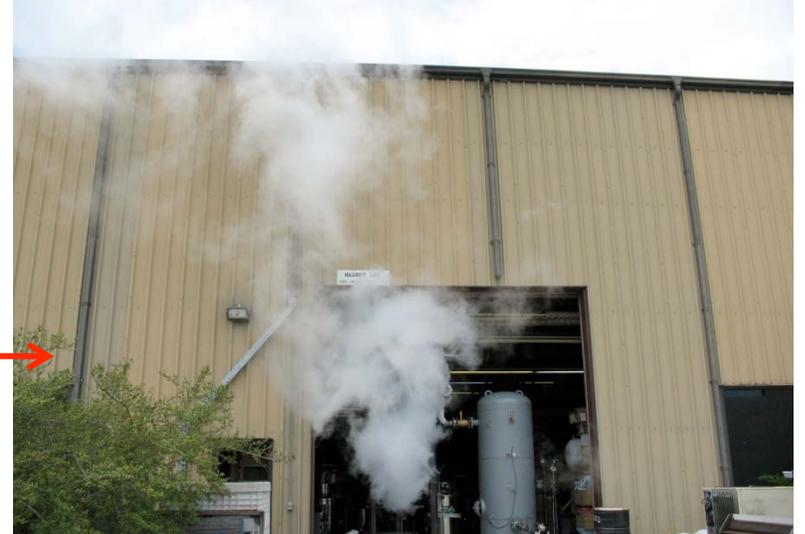
BD03 rupture occurred ~17 seconds after the loss of vacuum was initiated.

As before, the external hardware was quite frosty after the test. The exhausts were wrapped in plastic to minimize the moisture drawn in during the warmup.

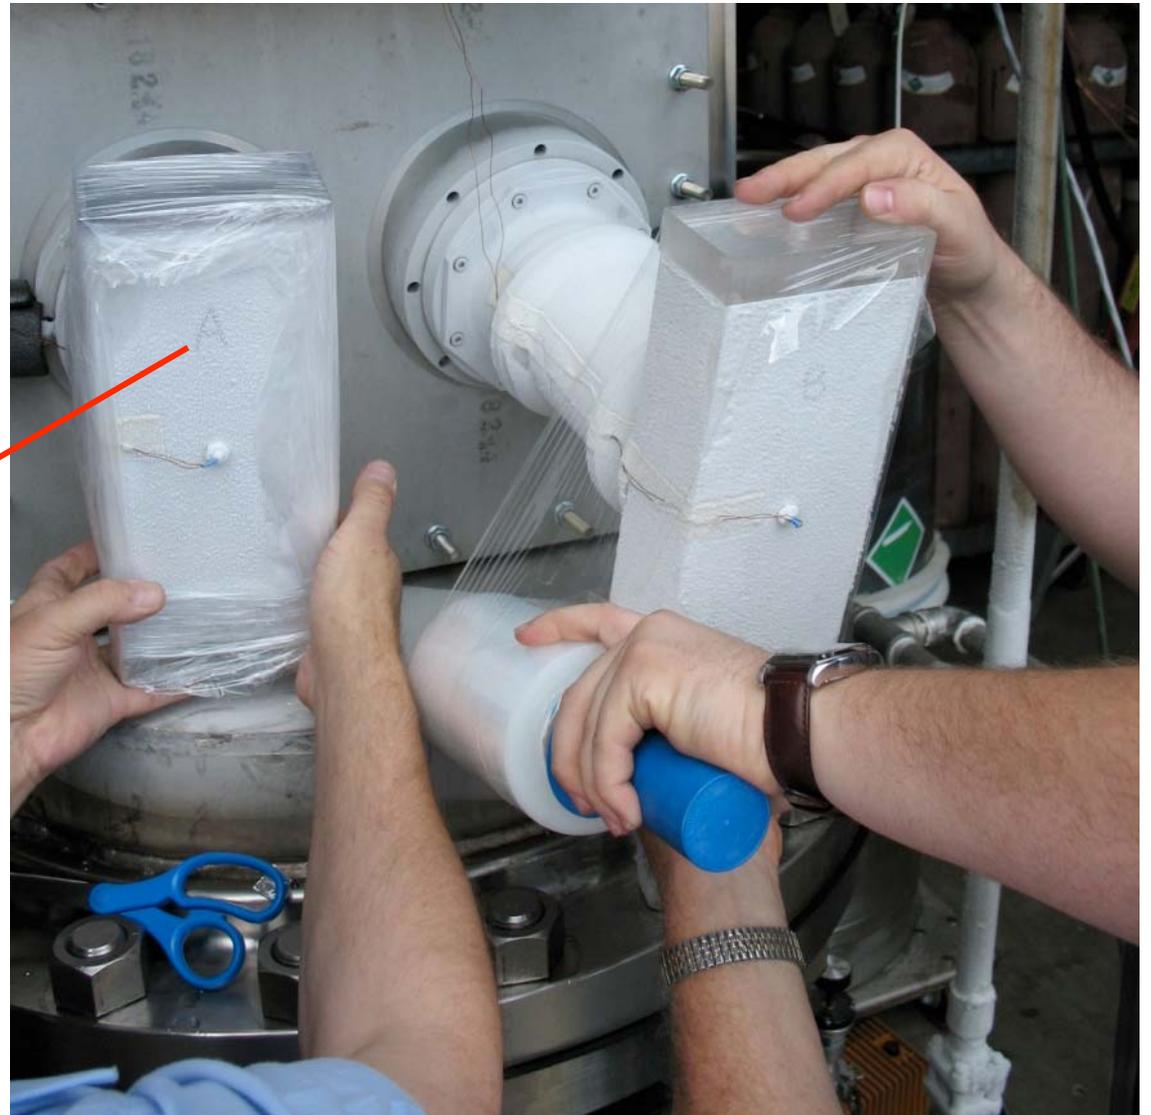
The frost became so thick, the letter "A" was almost completely obscured.

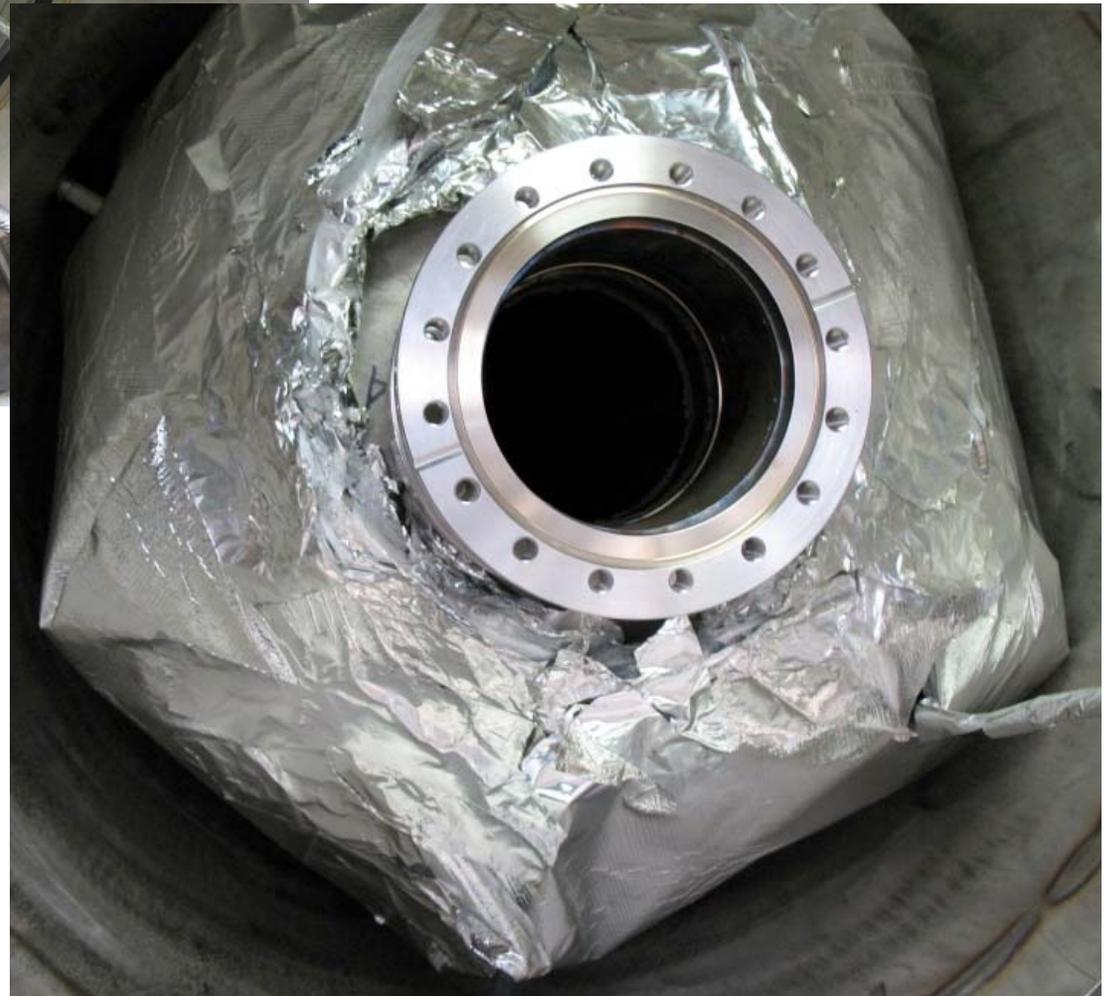
The MLI on the LHe vessel was still intact after several tests.

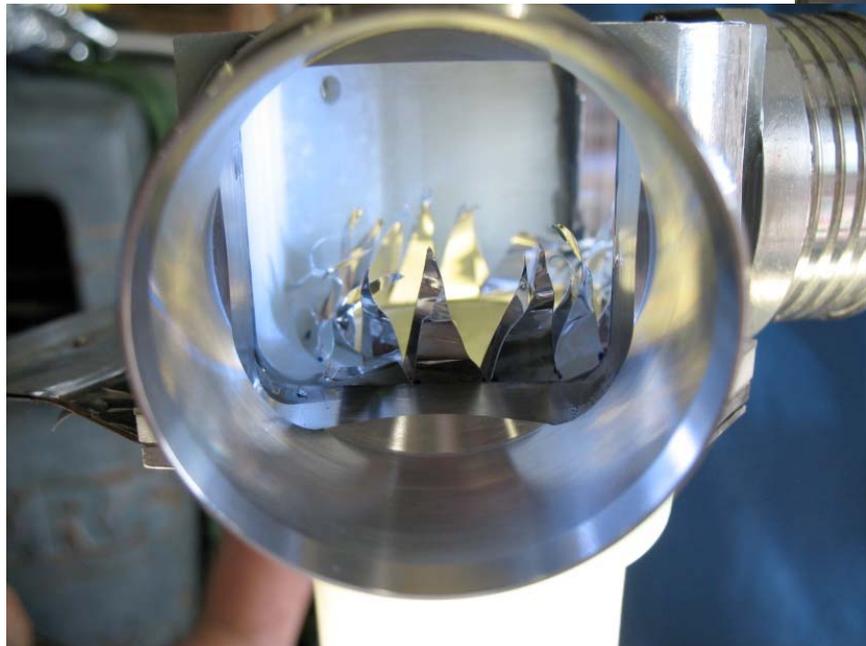
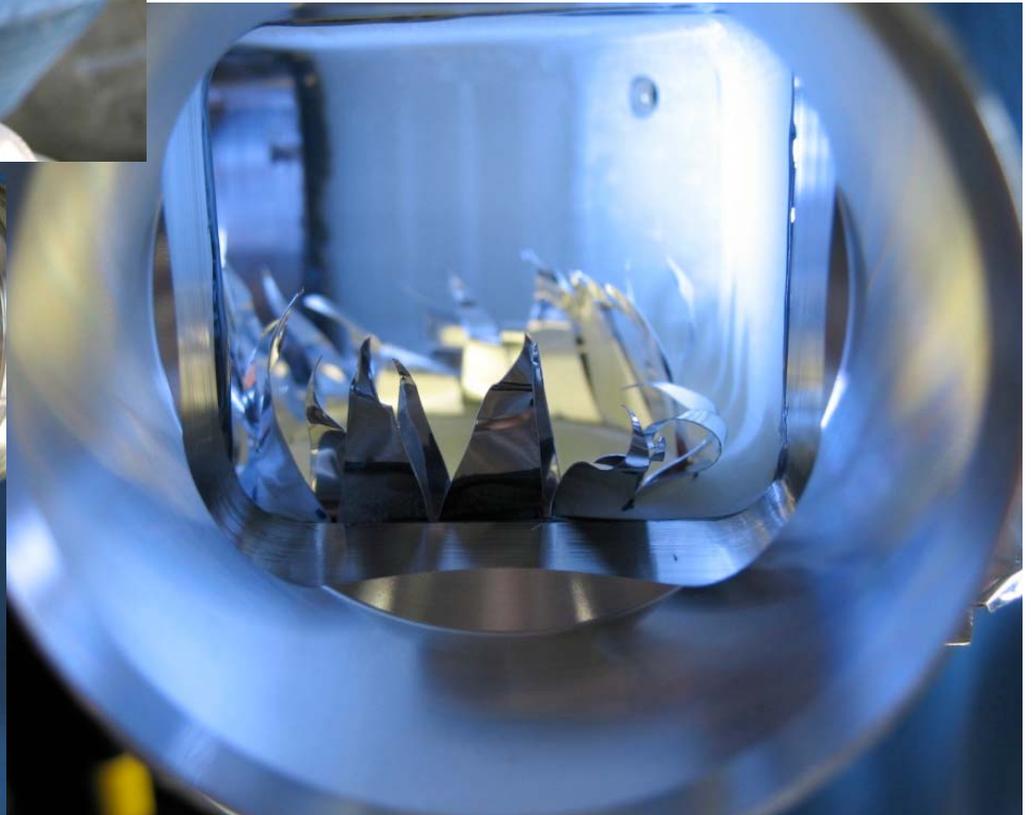
The BD radiation shield opening pattern was similar to previous tests. The tips of the triangles were also intact.

It appeared that this test generated no detached debris, despite the attempt to “sabotage” it with the separated BD03 membrane.

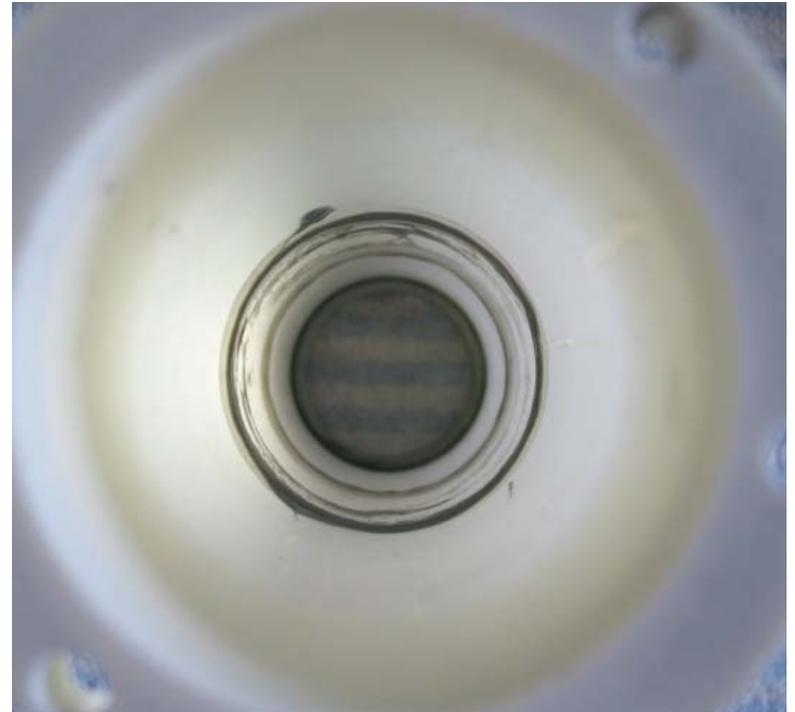
The only thing of note was that the external collar on the Telescoping Tube was found to be at an angle. This may have occurred during removal from the test set-up. It was realigned and the entire assembly will be reused in Test #8.

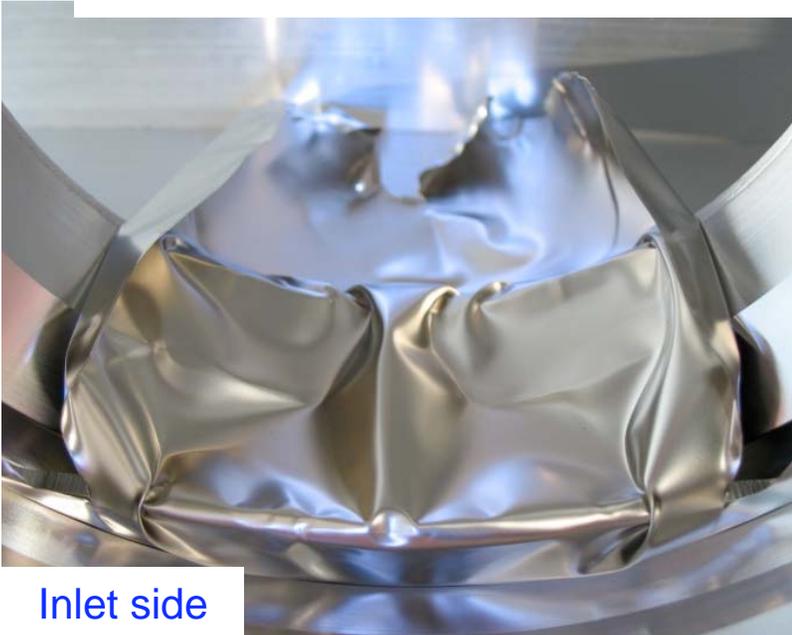
The new BD06A flight-like assembly performed as expected. The membrane folded back at the hinge line but remained attached. The membrane caused minimal obstruction to the shortened Zero-thrust Tee.

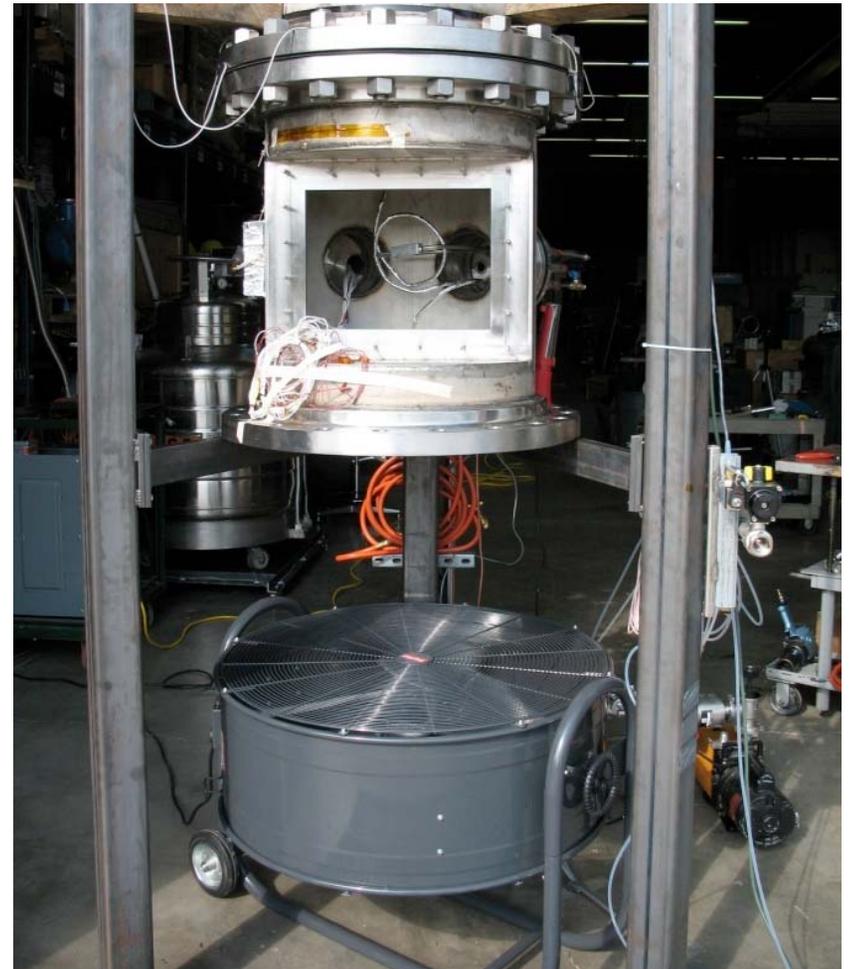
A large fan was placed under the test hardware to accelerate the drying prior to reassembly for Test #8.
